**Talon Hill Apartments
1640 Peregrine Vista Heights
Colorado Springs, Colorado 80921**

PROPERTY CONDITION ASSESSMENT

**REAL ESTATE ADVISORY, LLC
PROJECT # 075562**

April 26, 2007

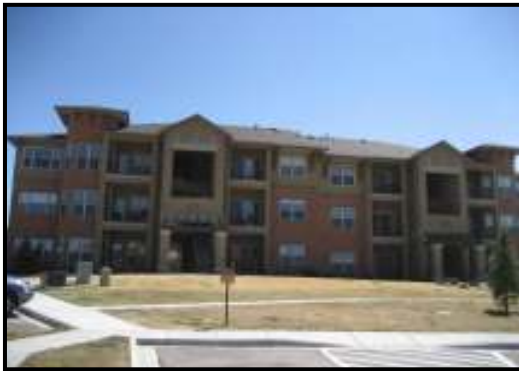
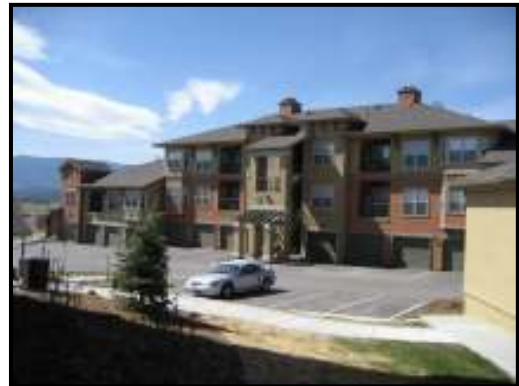
REA noted no deficiencies with respect to structural systems at the Property, and no significant expenditures are anticipated during the term. No indications of current termite infestations were noted during the assessment. Mr. Rocky Sundling, Property Regional Manager, reported that the buildings are covered by a termite treatment contract with Terminex. The contract includes annual inspections and treatments as needed.

On all buildings, framing above the foundations is trusses on center with gypcrete wood decking. Exterior walls typically consist of stucco with faux stone accents and limited Hard-plank siding over 2x4 wood studs at various spacing (typical exterior shown at top picture).

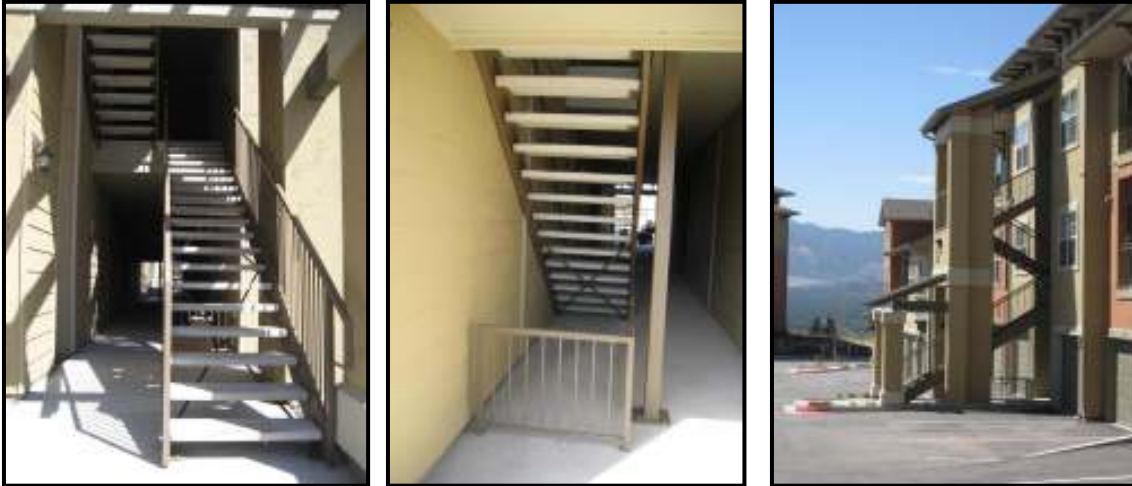
REA did not observe significant damage or deficiencies associated with stairways, landings, balconies or patios. The Property does not contain elevators. During the term considered, REA does not anticipate significant capital expenditures regarding these components.

All of the Property apartments are garden apartments (i.e., flats). The apartments are accessed from common breezeways. The breezeways have concrete slab-on-grade first floors and wood framed upper-floor landings with concrete slab floors. Stairways consist of steel framing with pre-cast, bolted-on concrete treads; stairway railings consist of painted metal (typical breezeway shown at top). The breezeway/ landing walls and ceilings are finished with cementitious siding. The breezeways are lighted by ceiling-mounted, photocell-activated lights and battery-pack emergency lights. The breezeway and landing components were noted to be in good condition. The components are covered by building roofs so that they are not directly exposed to rain. In addition, the breezeway stairs feature a 3-foot metal walk-in prevention railing for a handicapped individual.

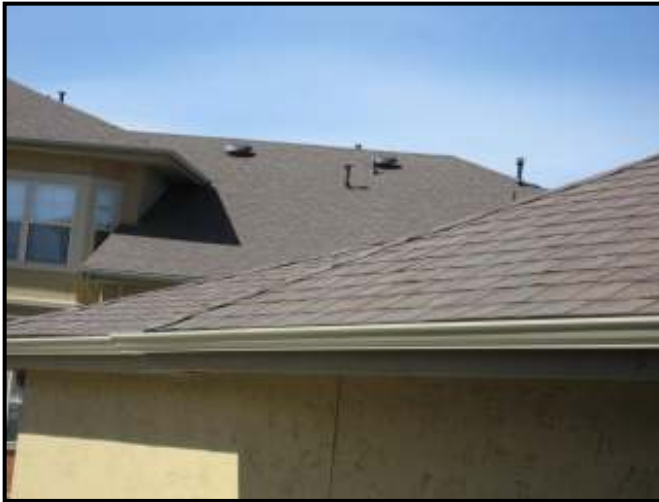
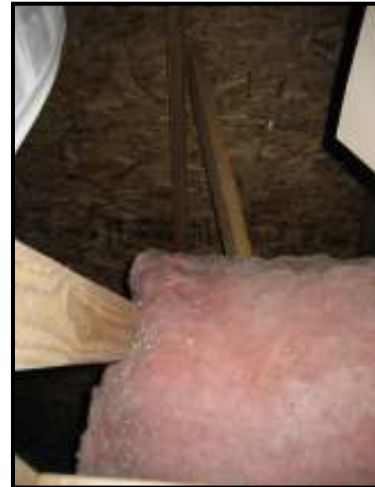
Because the roofs are approximately one year old and were observed to be in very good condition, no significant expenditures are anticipated for roof replacement during the term considered. In addition, the Property management personnel did not report concerns with the roofing.

The buildings have wood framed, sloped roofs. Roofing consists of high definition composition roof shingles supported by wood trusses and 15/32" sub-roof plywood decking and asphalt shingles. The roof shingles are rated for 30 years. The clubhouse building features a concrete tile roof. The attic spaces are ventilated by continuous ridge vents, intermittently spaced off-ridge vents, perforated vinyl soffits and louvered gable vents. Attic ventilation appeared to be good. Aluminum gutter and downspout systems are present at horizontal roof lines. The gutters direct stormwater to downspouts, which in turn mostly discharge to splash blocks at grade or to asphalt paving. Property personnel reported no current or persistent roof leakage problems. No evidence of fire retardant roof sheathing was observed or reported at the Property.

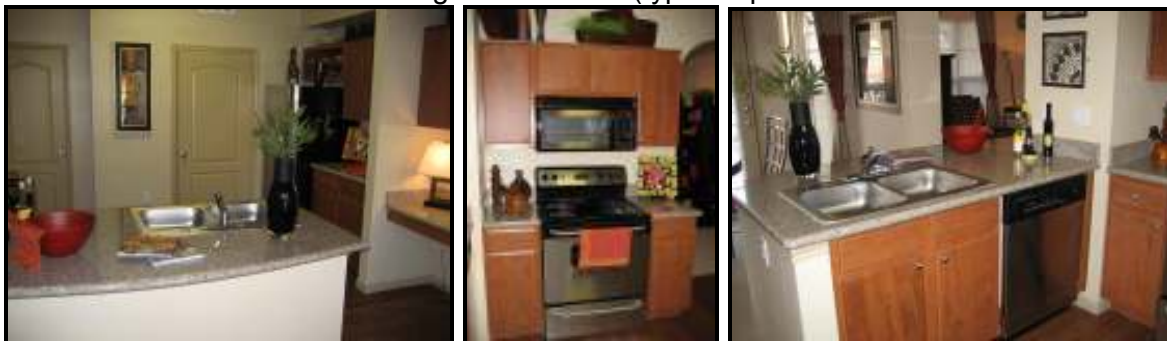
Interior finishes were noted to be in good condition (typical apartment kitchen shown at below).

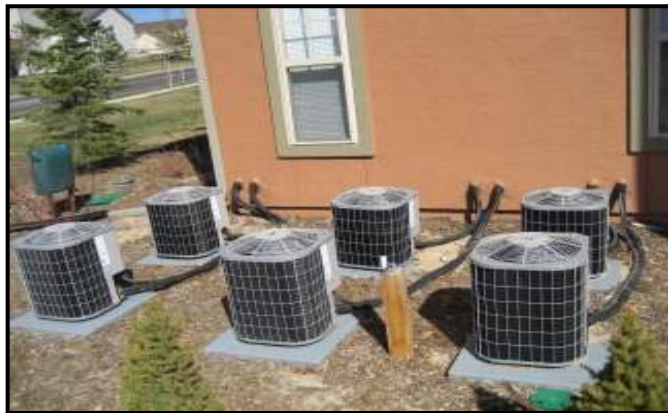
HVAC equipment was noted to be in good condition with no significant tenant complaints reported by Property management. REA anticipates some capital expenditures during the term for HVAC equipment replacement and costs are accounted for in the Replacement Reserve Worksheet.

Heating and cooling is provided to each individual apartment by a thermostatically controlled, electric heat pump system (typical aquatherm heating system in the ceiling at bathrooms and water heater shown at right). Condensing units are located on pads outside the buildings. The cooling capacities are rated at approximately 1.5 to 2.5 tons.

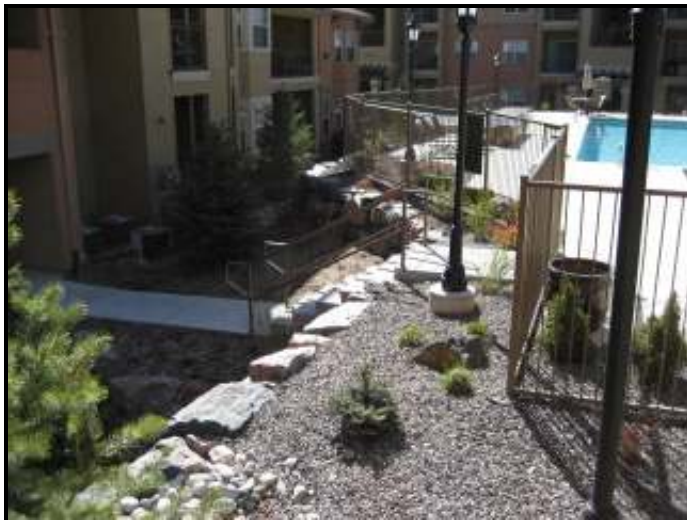
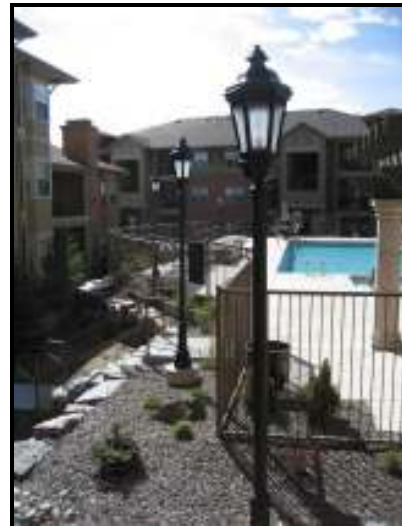
No significant deficiencies were noted regarding retaining walls. REA does not anticipate capital expenditures during the term considered regarding retaining walls.

Retaining walls at the Property are limited to the leasing office/clubhouse area and Buildings 1, 3, 5 and 6. Most of the natural stone retaining walls have painted metal fences atop them to serve as fall barriers. The walls were observed to be in good condition.

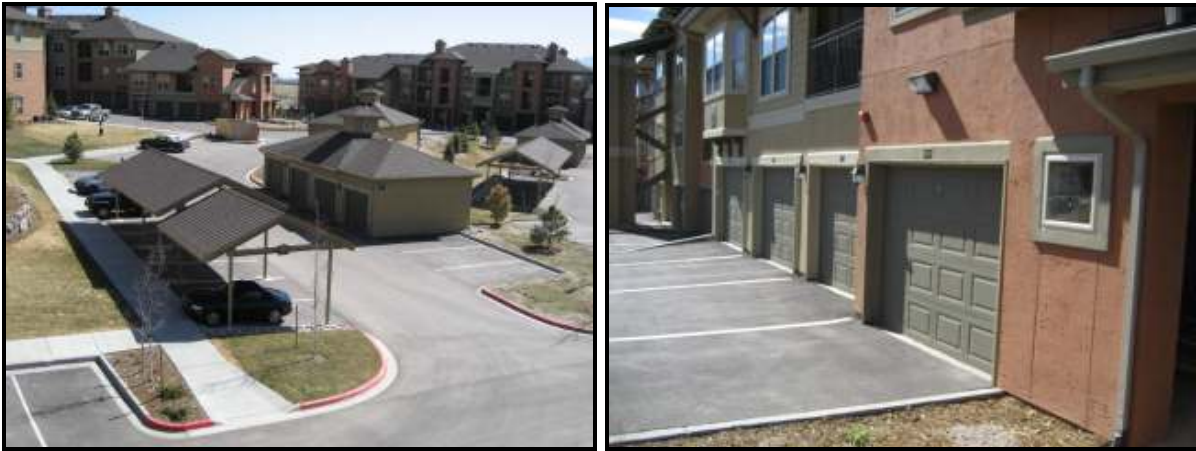
REA noted no deficiencies regarding driveways, parking lots or sidewalks (typical asphalt paving and curbing shown at right). During the term considered, REA anticipates periodic sealing and striping of the asphalt. No other significant capital expenditures are anticipated during the term. Costs for sealing and striping are accounted for in the Replacement Reserve Worksheet.
