## **REPORT OF PROPERTY CONDITION ASSESSMENT GREENSTAR RECYCLING**

**12.13 ACRE MAINTENANCE AND FABRICATING FACILITY**

**2742 E Market Street, Des Moines, Iowa**

**K-PLUS PROJECT NO. 22132**

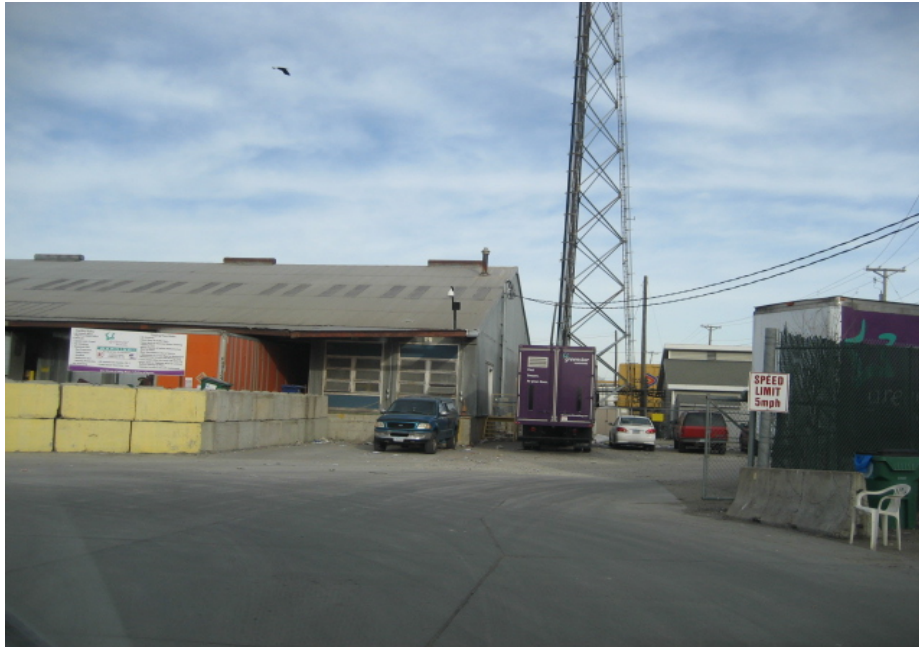
**Photograph No. 1**

Main entrance access to the Property is via driveway located along the side of the East Market Street

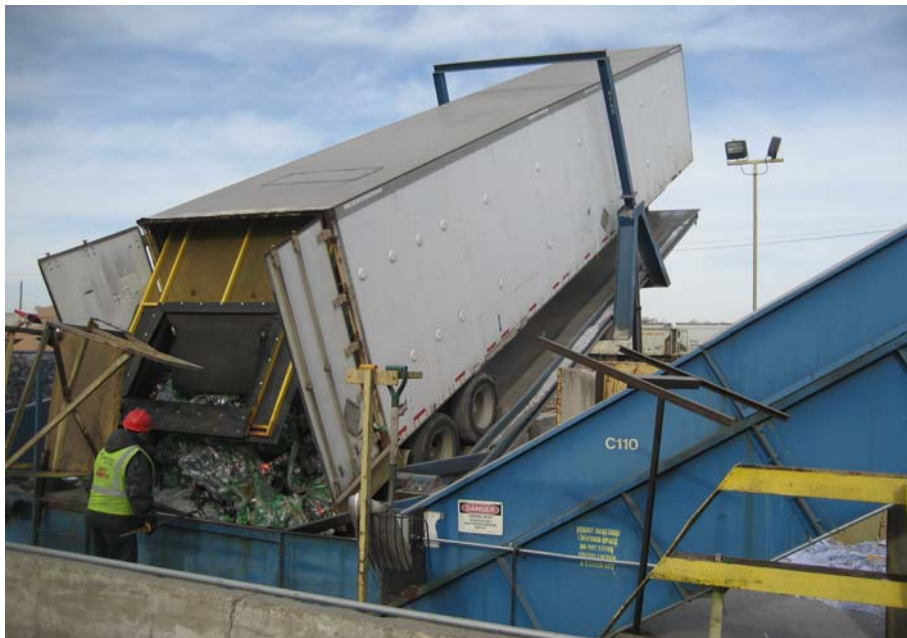
**Photograph No. 2**

Trailer lift and initial hopper and conveyor system

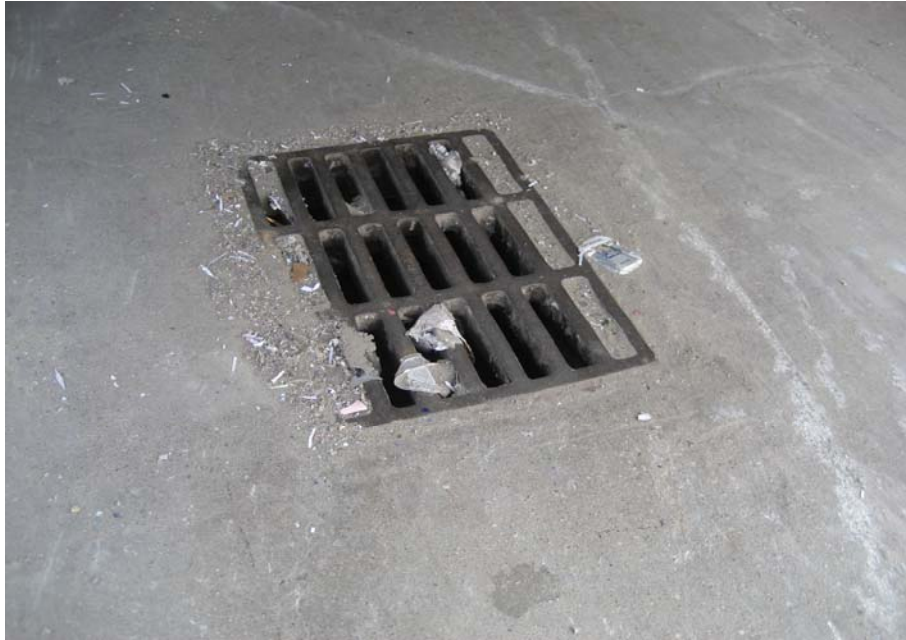
**Photograph No. 3**

Surface water runoff via drop inlets with sediment trap positioned within the northern portion of Building 1

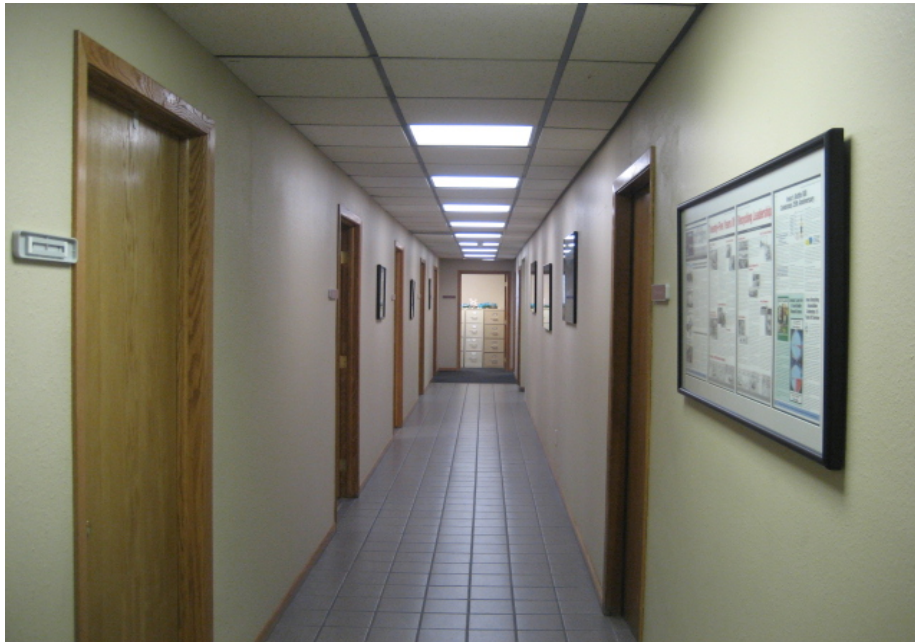
**Photograph No. 4**

Offices common area in Building 2

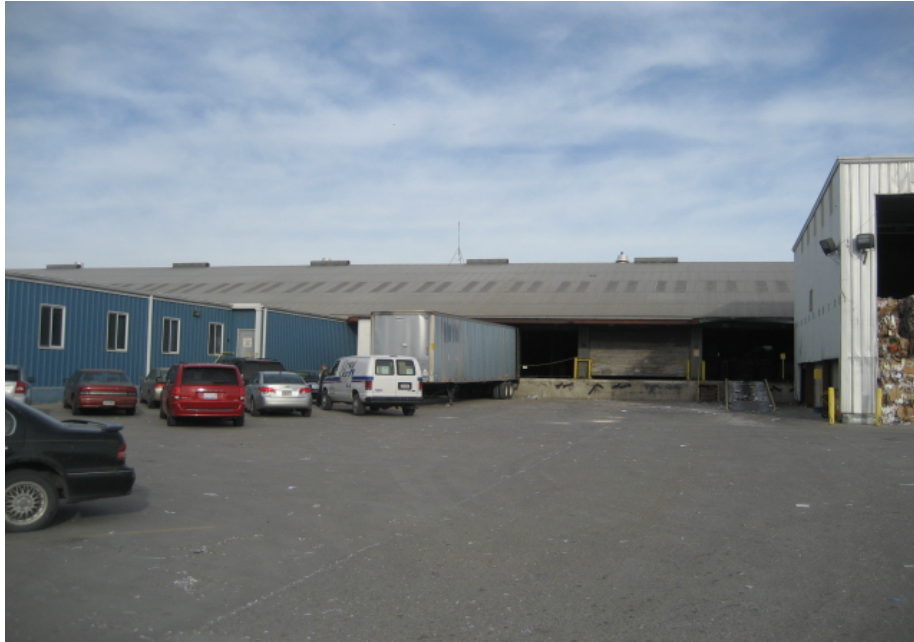
**Photograph No. 5**  
View of facility from the southeast

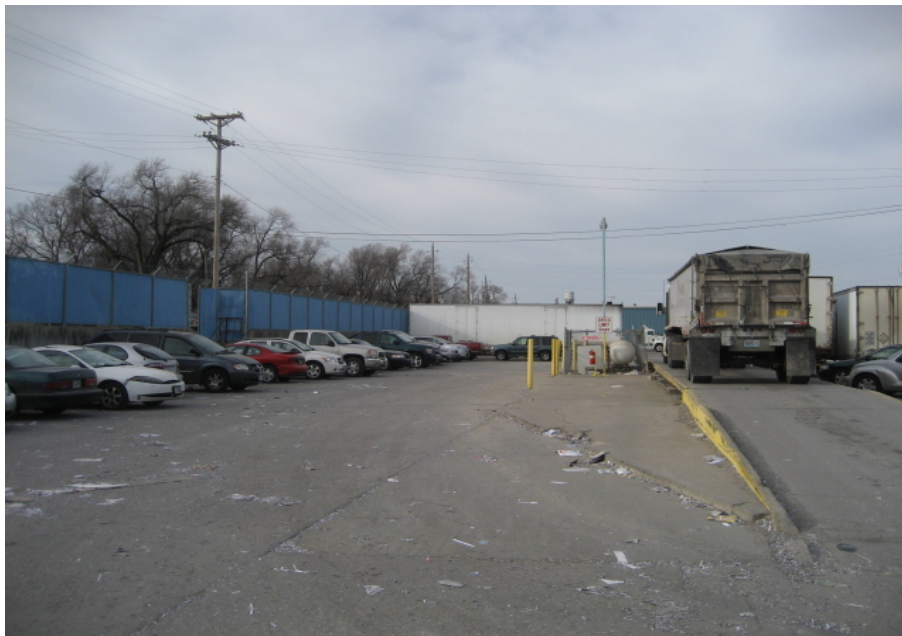
**Photograph No. 6**  
View of east concrete access drive and trailer weight station.

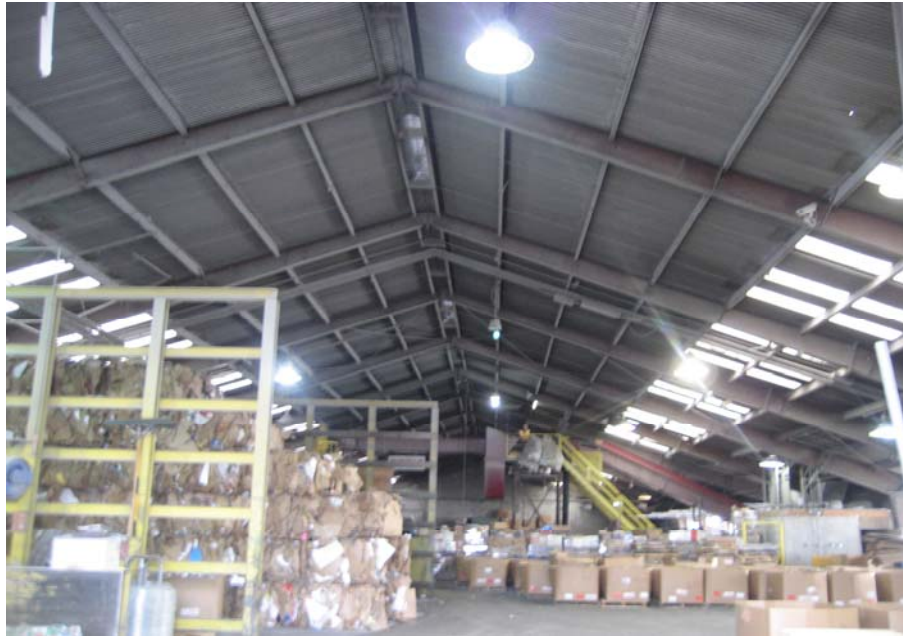
**Photograph No. 7**

Typical construction CMU with prefinished metal panels above with a steel frame  
Building 2

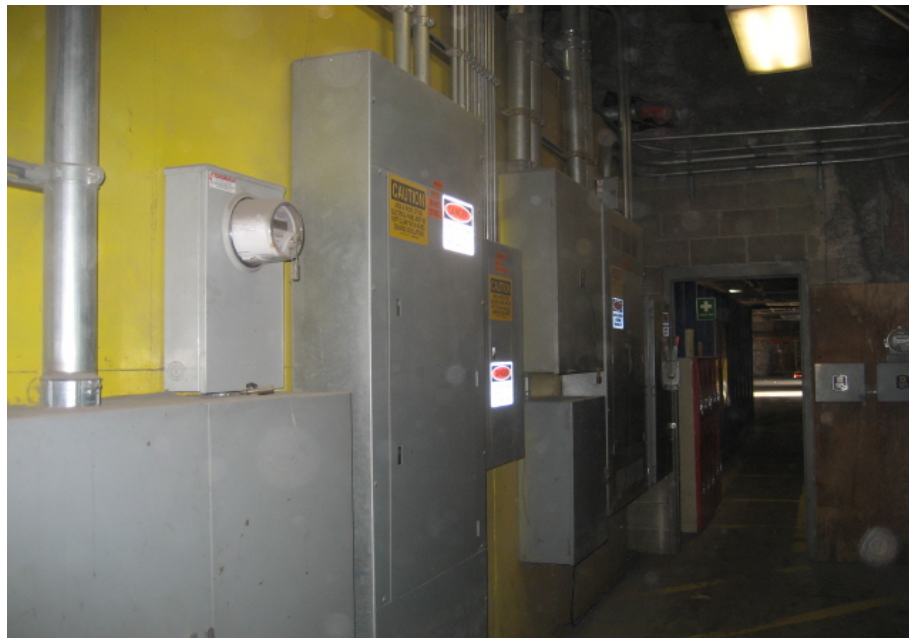
**Photograph No. 8**

Main electrical service disconnect

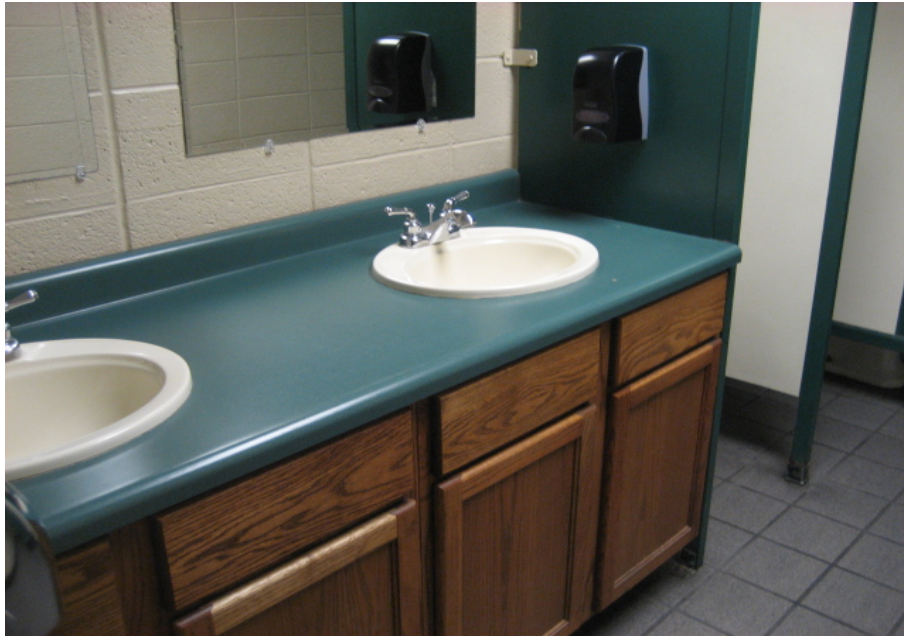
**Photograph No. 9**  
Existing restrooms

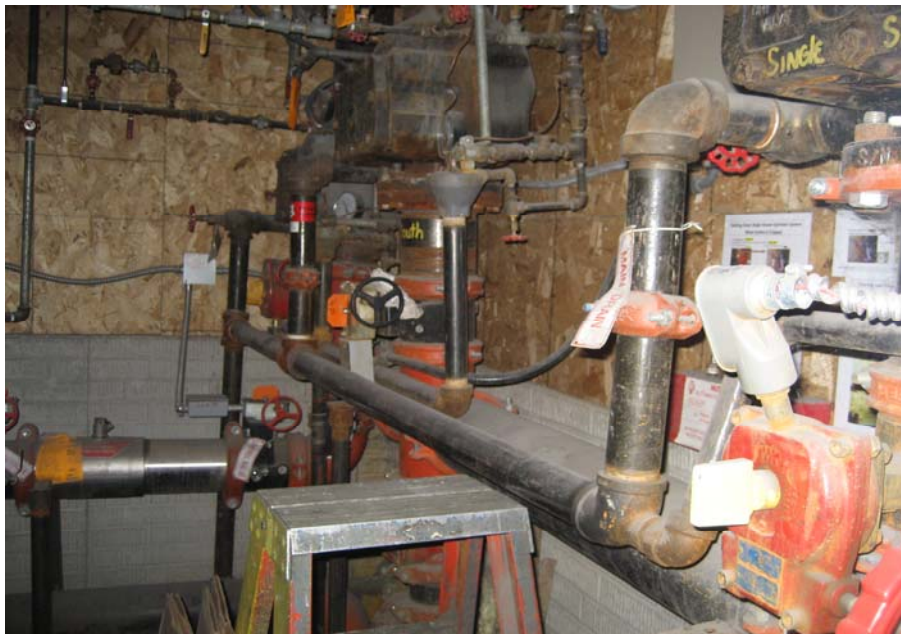
**Photograph No. 10**  
Fire backflow system

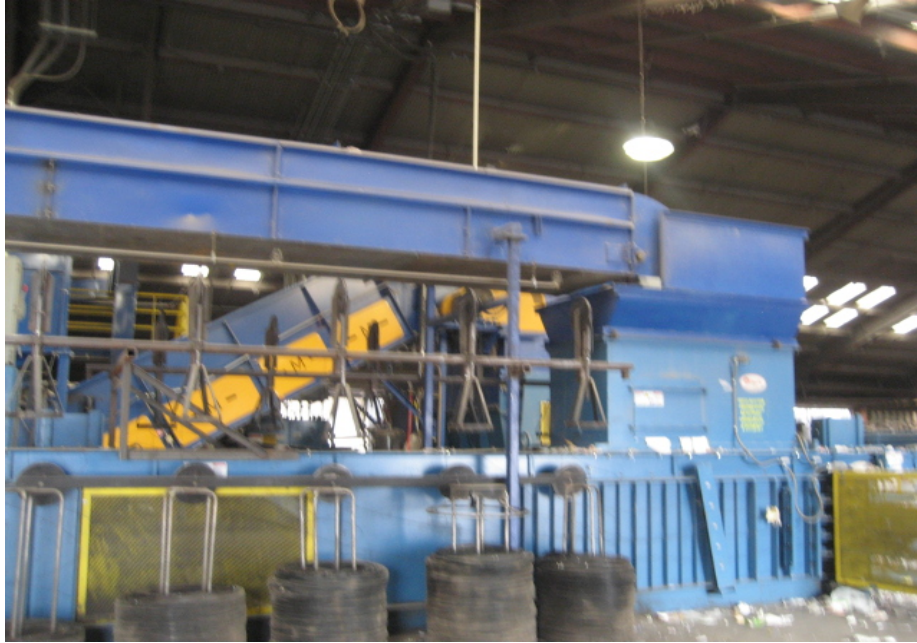
**Photograph No. 11**

Southwest Building 2 interior - production and warehouse area

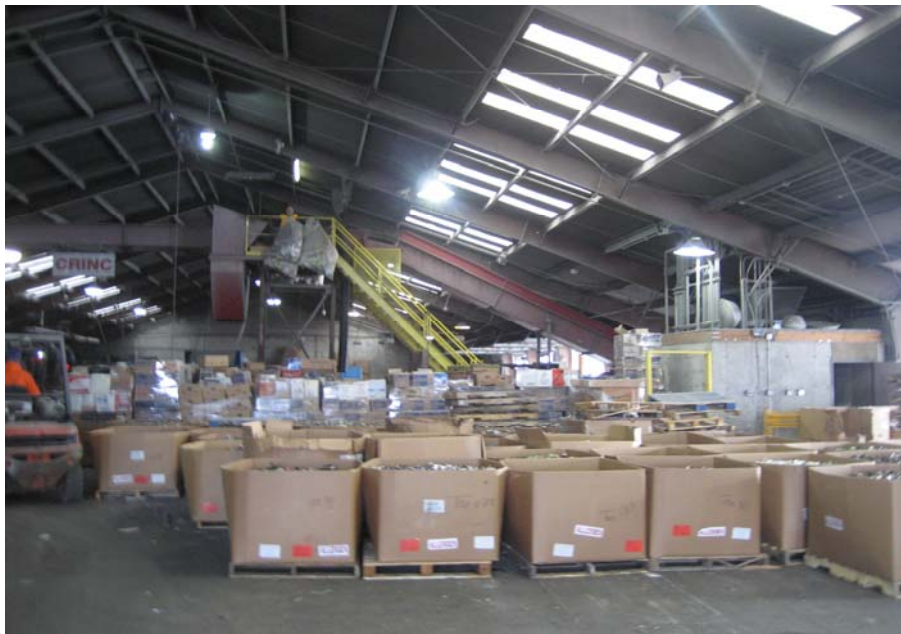
**Photograph No. 12**

Tennant Crinc Building 2 - production and warehouse area

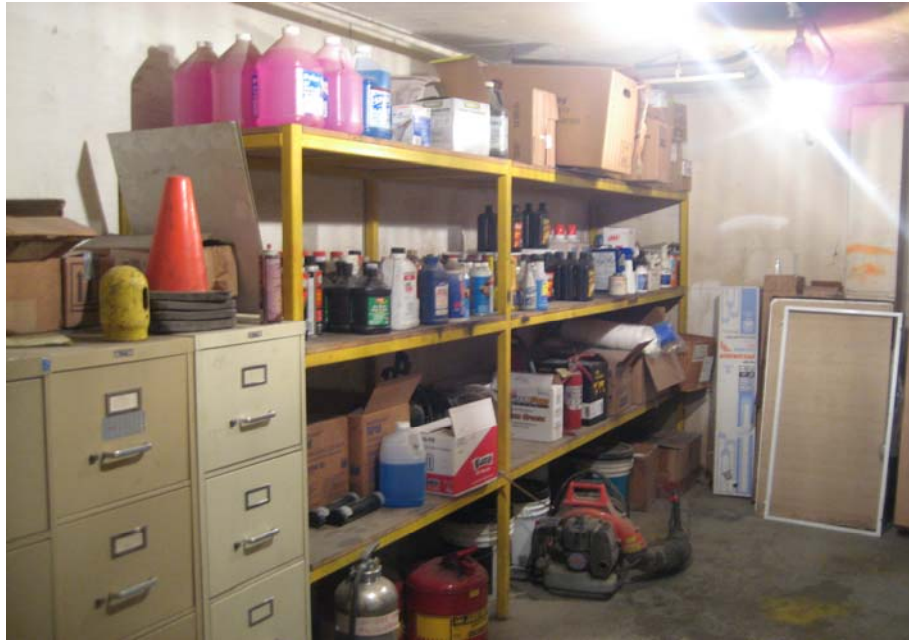
**Photograph No. 13**  
Existing flammable storage cabinet

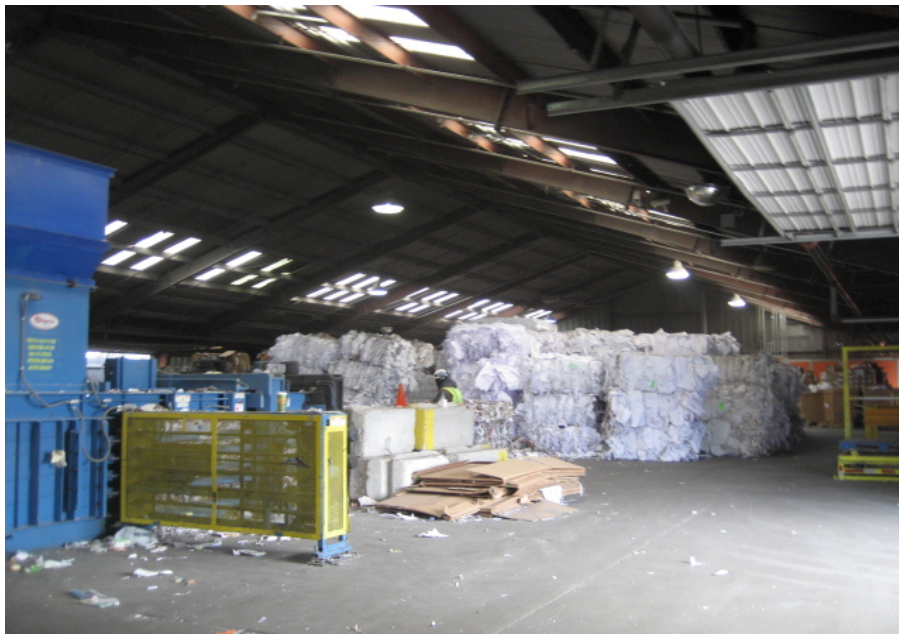
**Photograph No. 14**  
View of production and warehouse

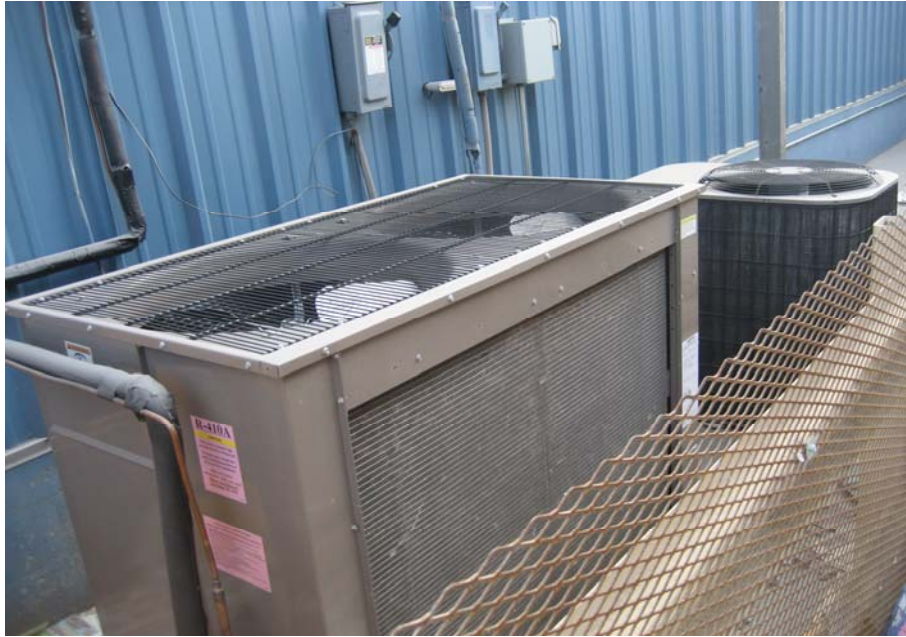
**Photograph No. 15**  
Typical HVAC units

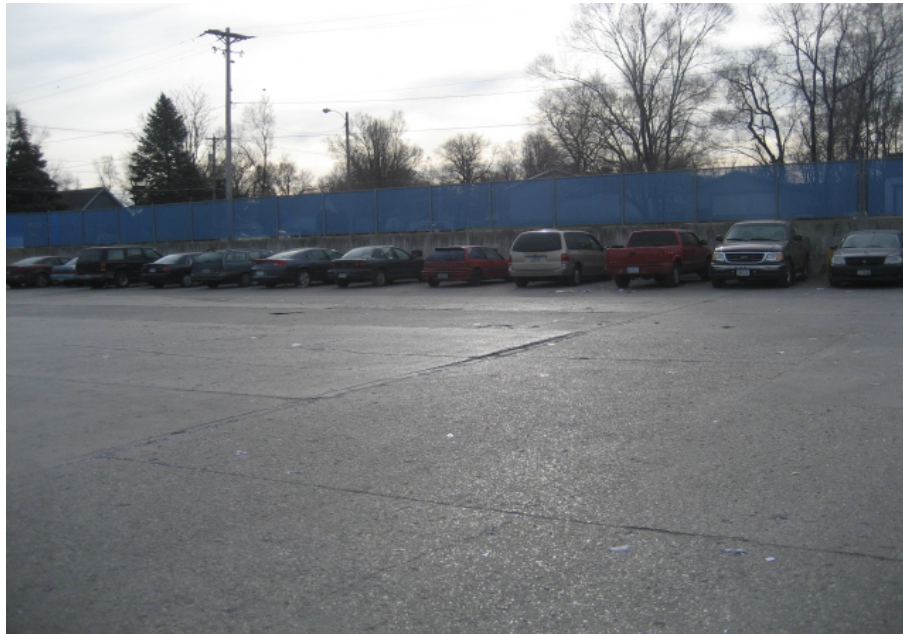
**Photograph No. 16**  
Typical concrete surface parking areas

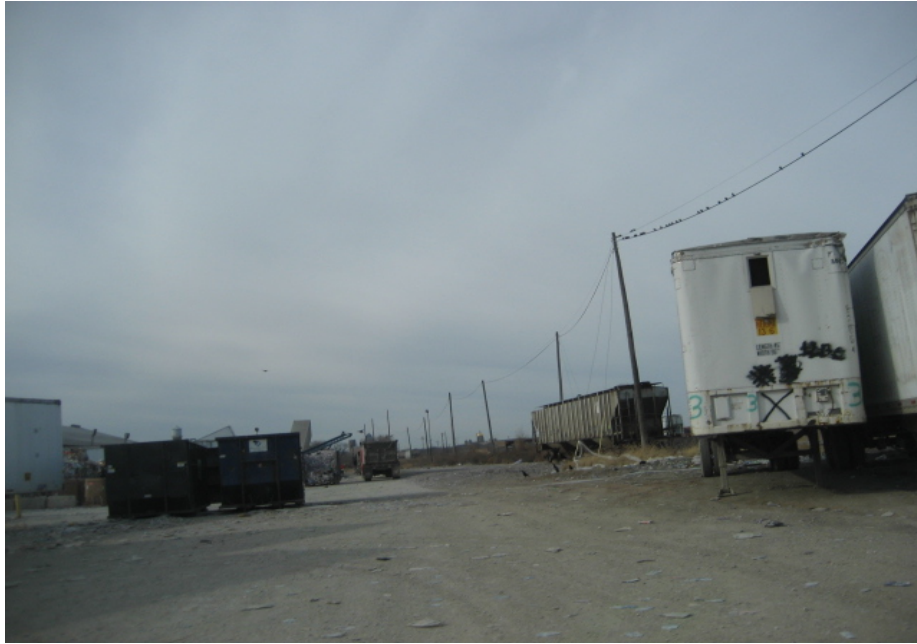
**Photograph No. 17**  
Typical gravel driveways north of Building 2

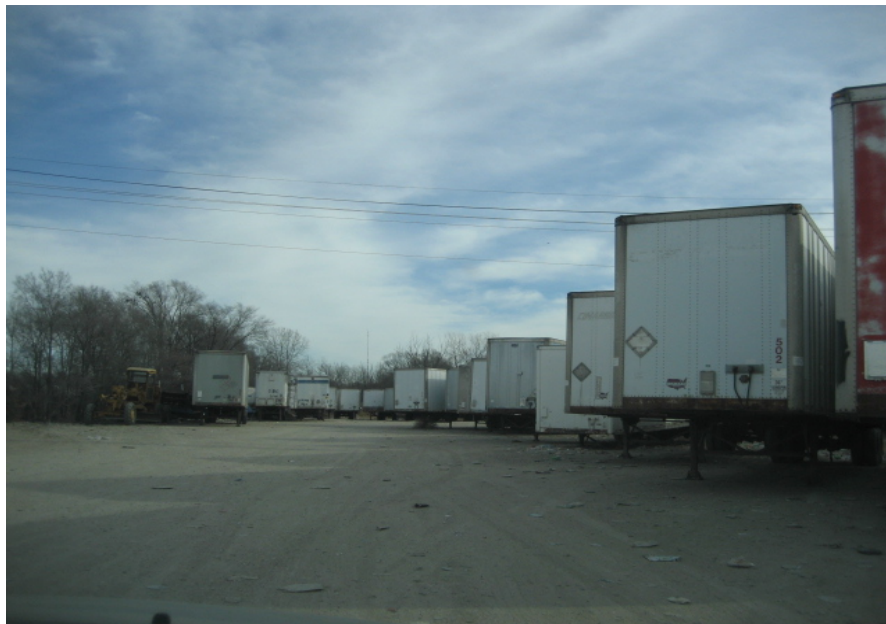
**Photograph No. 18**  
Typical trailer parking areas west of Building 2

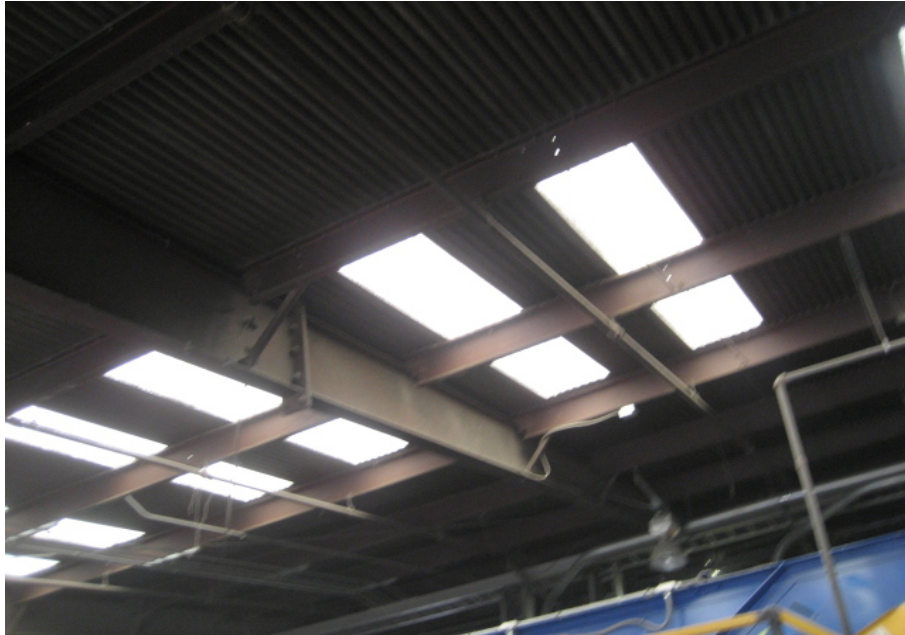
*Observations:* Property management reported isolated repairs were performed for skylights at the beginning of the year to prevent water leakage. No concern was reported after the repairs.

**Photograph No. 19**  
Typical skylights at Building 2

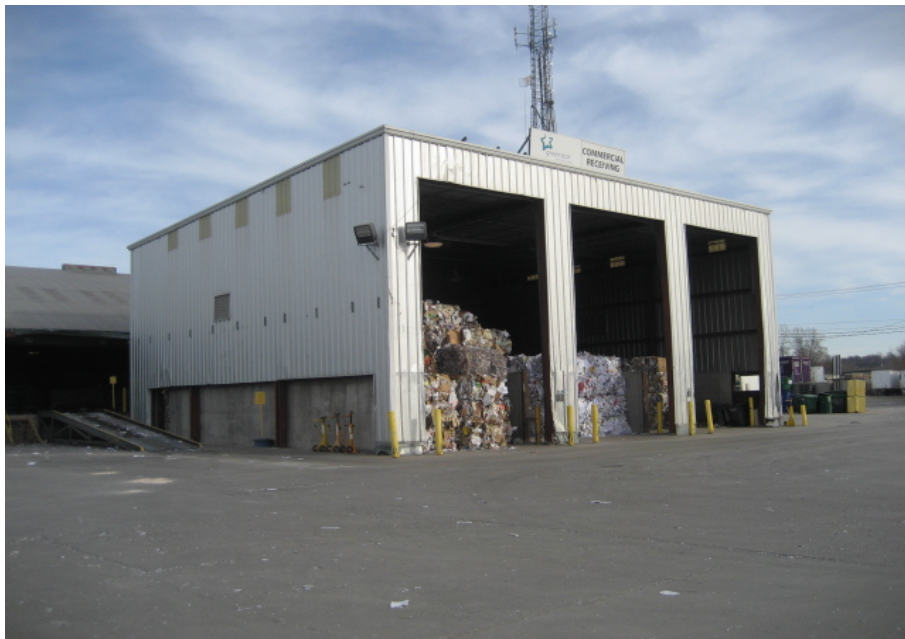
**Photograph No. 20**  
View of typical canopied areas-Building 2

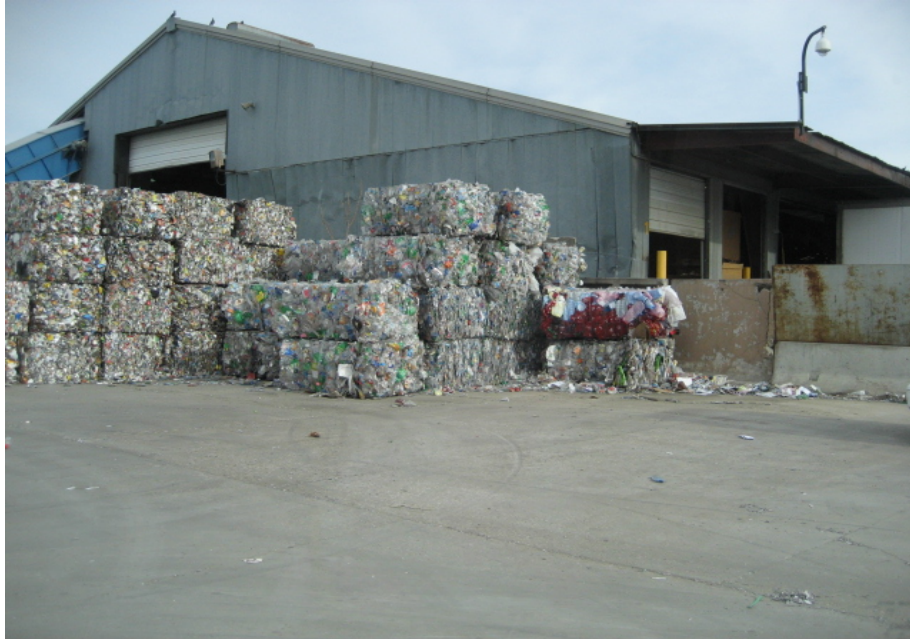
**Photograph No. 21**

View of Building 2 exterior from the west facing east

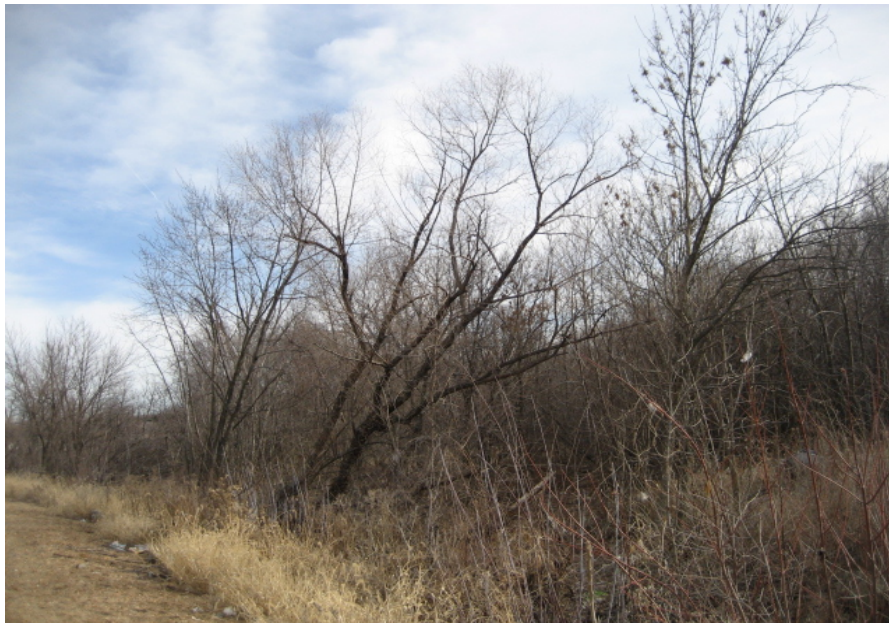
**Photograph No. 22**

View of wooded lot east of property
