**REPORT OF
PROPERTY CONDITION ASSESSMENT
WIKUS SAW TECHNOLOGY, CORP.**

**700 W BELDEN AVE,
ADDISON, IL 60101**

PROJECT NO. 22147

December 27, 2012

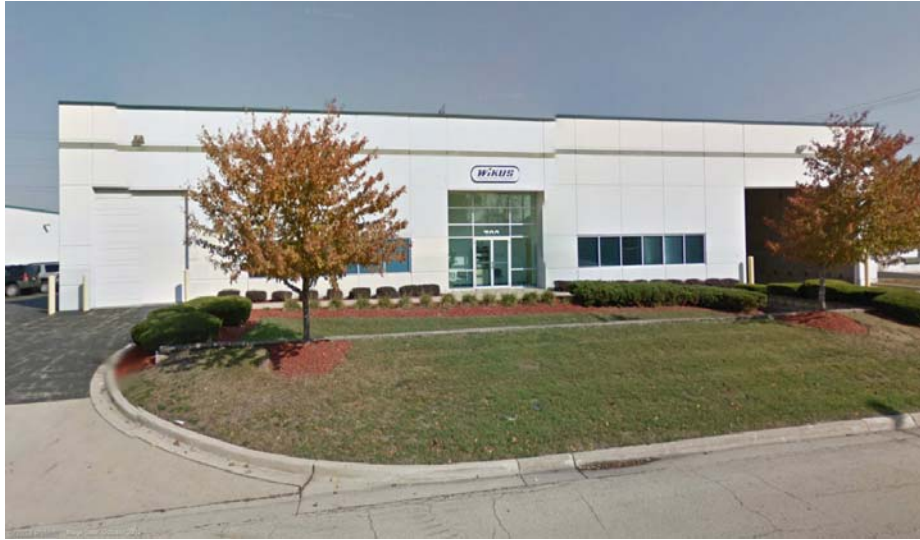
Photograph No. 1

Main entrance access to the Property is via driveway located along the side of the W. Belden Avenue

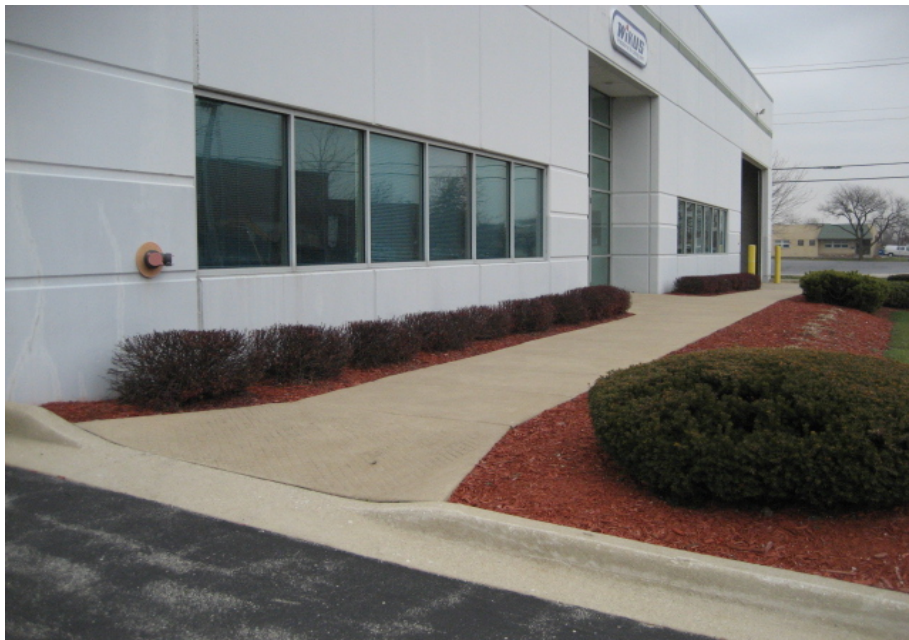
Photograph No. 2

ADA Accessible

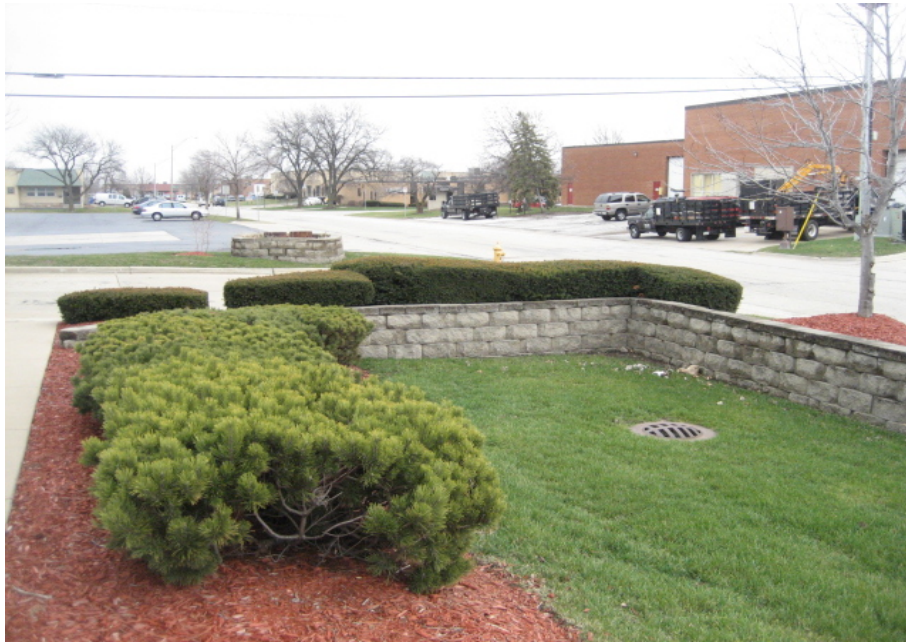
Photograph No. 3

Surface water runoff via drop inlets.

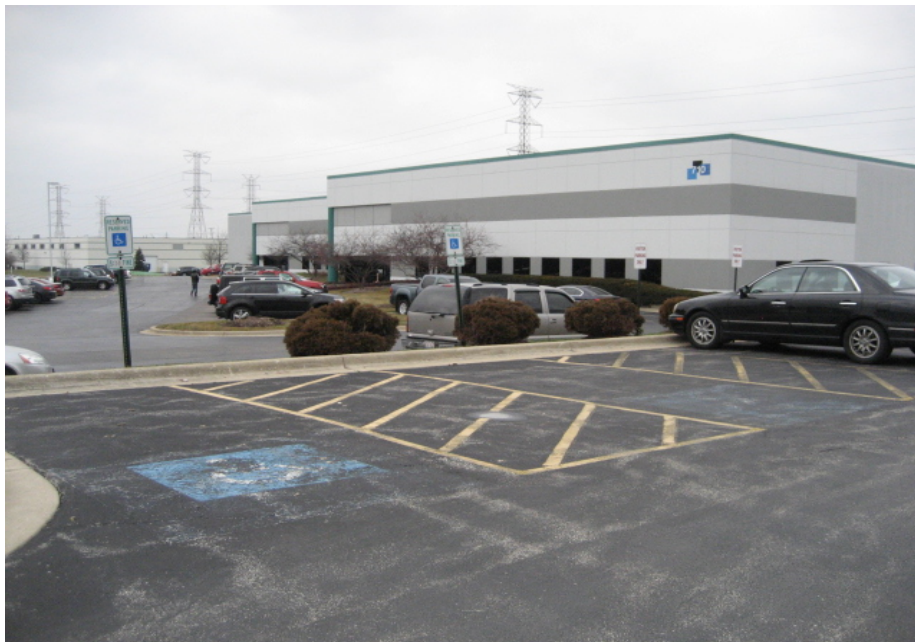
Photograph No. 4

ADA Parking Available at the Property.

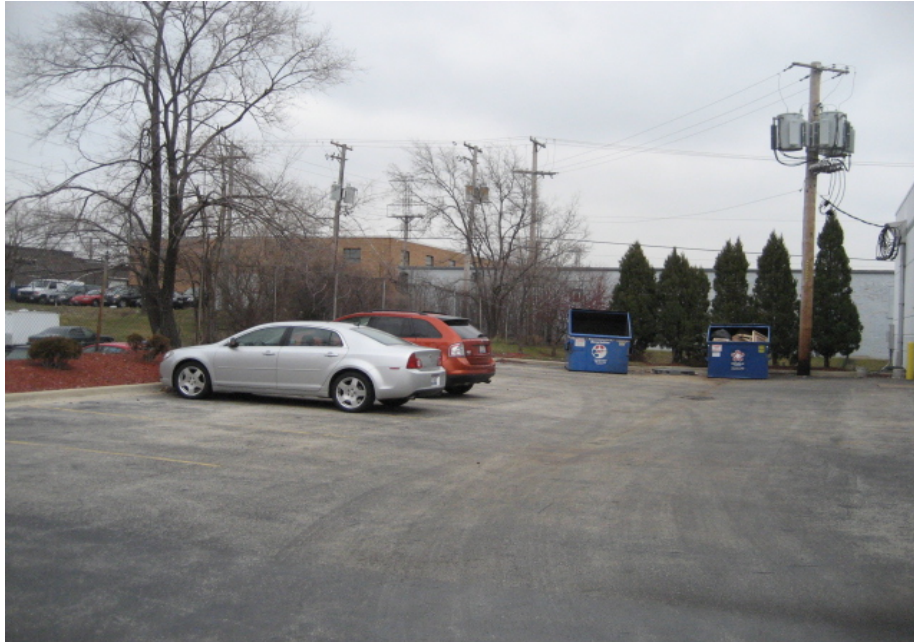
Photograph No. 5

Observations: Open parking is located on the west and north sides of the building. There are no parking garages or parking structures (i.e. carports) at the Property. The driveways and parking areas are paved with asphalt and bounded by concrete curbing. There a total of 32 asphalt-paved (including 2 ADA spaces) parking spaces. Asphalt pavement extended along the west exterior of the building and raps around to north where a trash dumpster was present. K-Plus noted the asphalt drives/parking areas to be in fair condition. Property management reported that the asphalt was approximately sealed and striped in 2005.

Typical Parking and dumpster located north of the Property.

Comments and Recommendations: K-plus anticipates sealing and striping of the parking surfaces over the term.

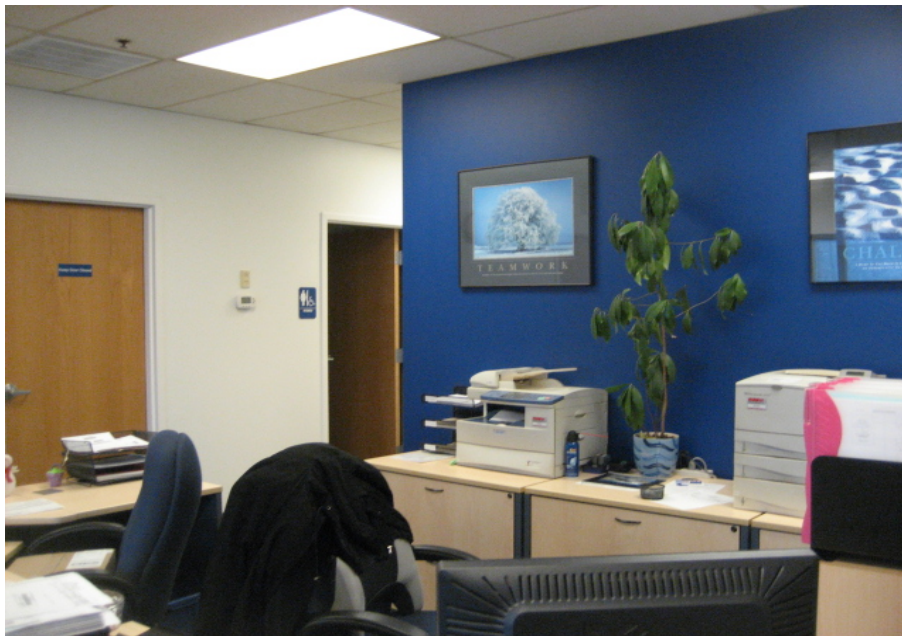
Photograph No. 6

Typical office interior of the Property.

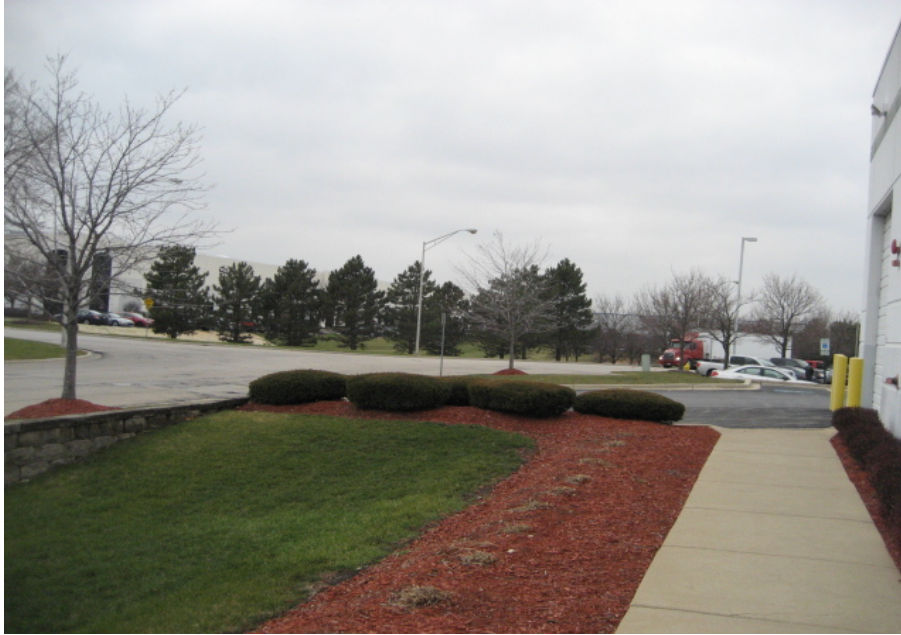
Photograph No. 7
Typical landscaping at the Property.

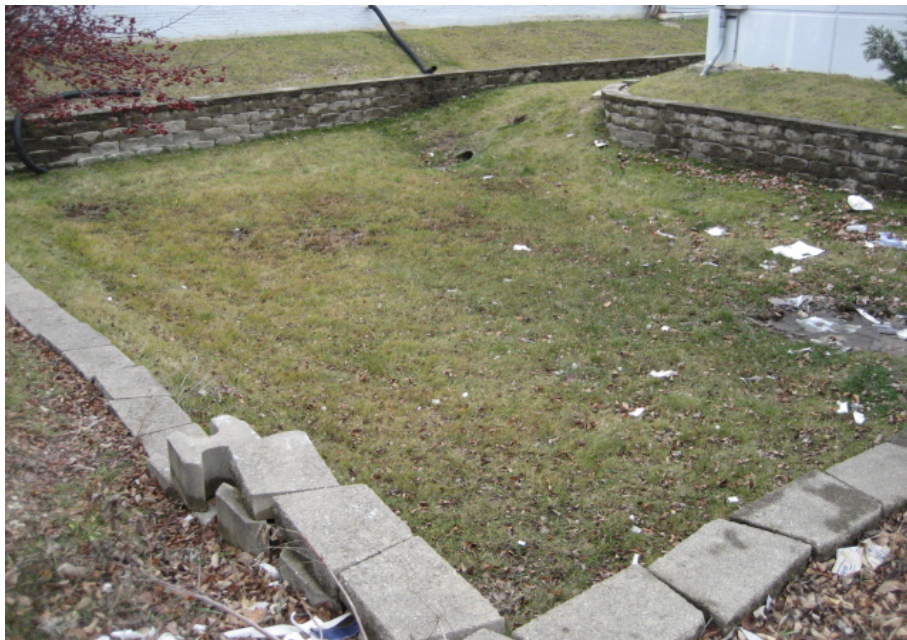
Photograph No. 8
Dry water detention area to the northeast of the Property.

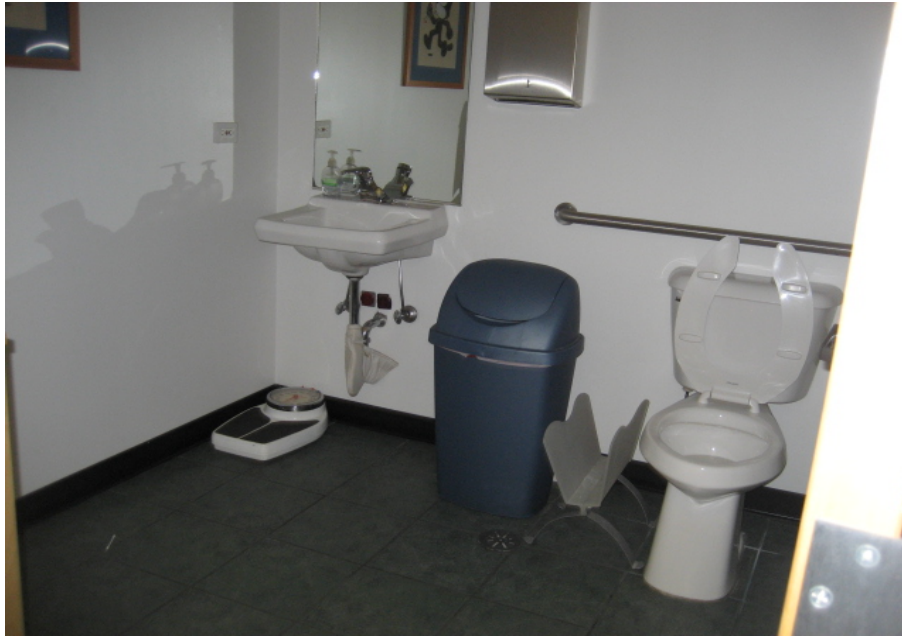
Observations: Bathrooms in the office portion of the building are provided with standard fixtures, porcelain enamel toilets with stalls and sink vanities. The fixtures observed by K-Plus were generally in good condition and no evidence of inadequate venting or water pressure was noted. Tempered water response time at fixtures and faucets in the building was also adequate.

Photograph No. 9
Existing restrooms

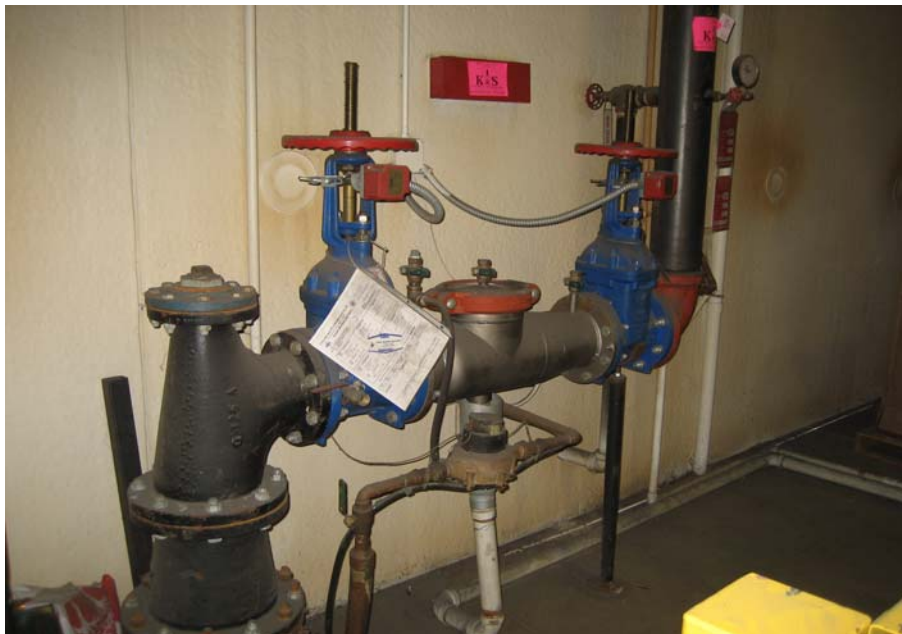
Photograph No. 10
Fire backflow system

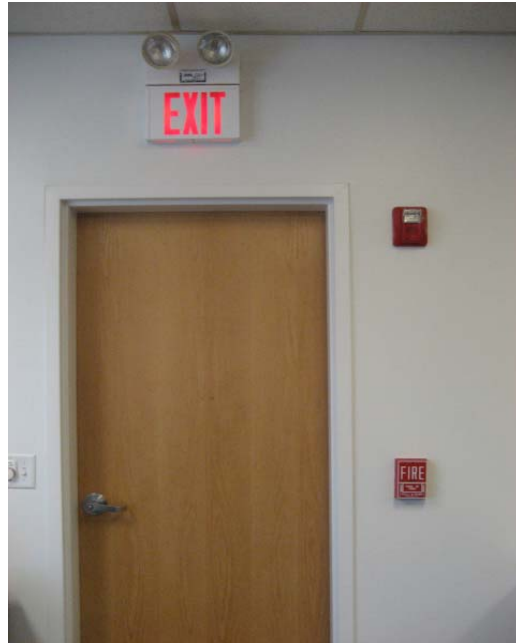
Photograph No. 11
Typical fire alarm and emergency exit.

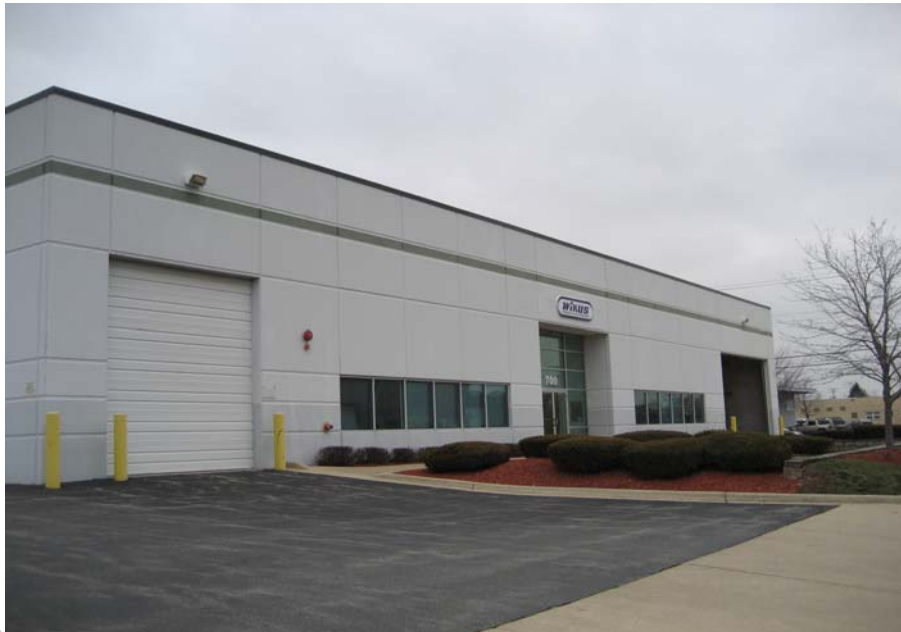
Photograph No. 12
Exterior view of the Property.

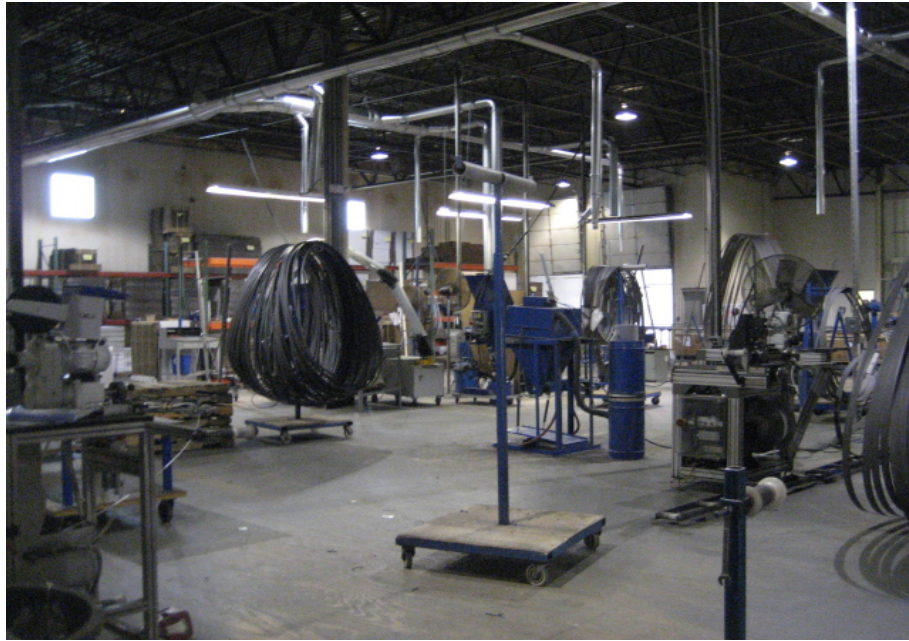
Photograph No. 13

Interior production / warehouse view of the Property.

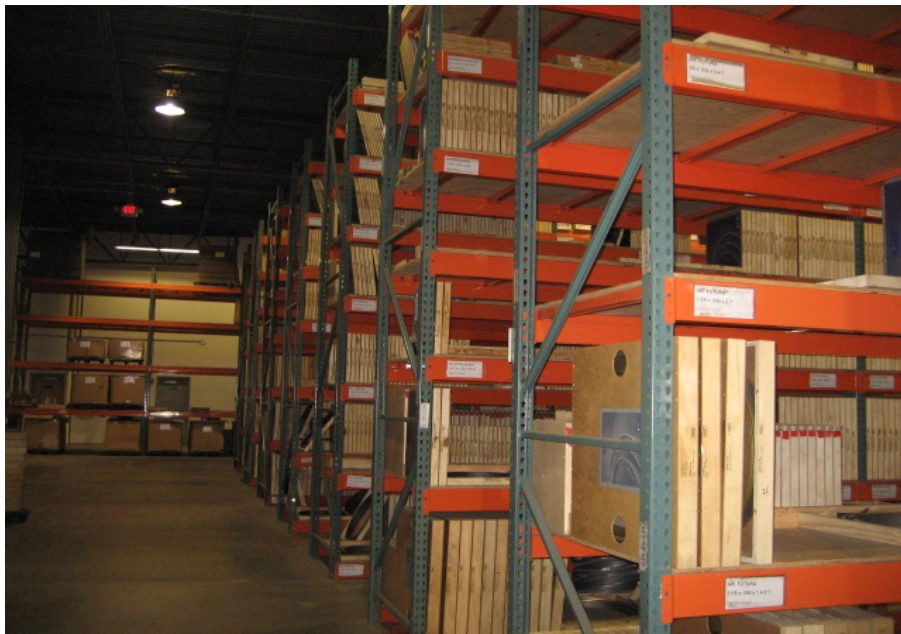
Photograph No. 14

Typical storage warehouse shelves at the Property.

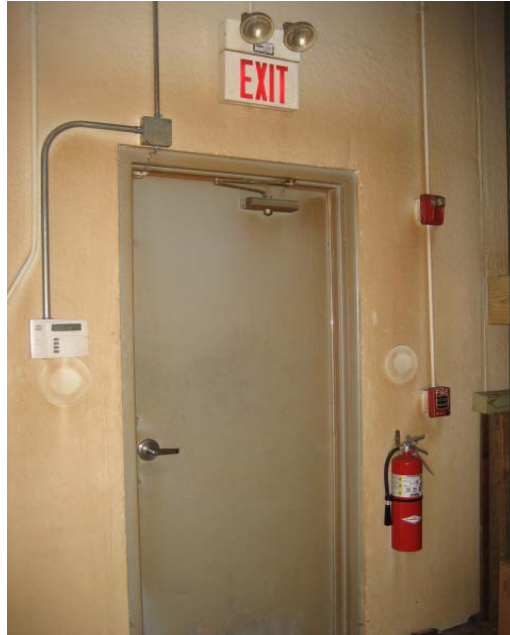
Photograph No. 15

Typical warehouse walls and emergency exit doors at the Property.

Comments and Recommendations: Tuck point repairs of the CMU as well as repainting should be completed as long term projects. K-Plus has included long term cost estimates.

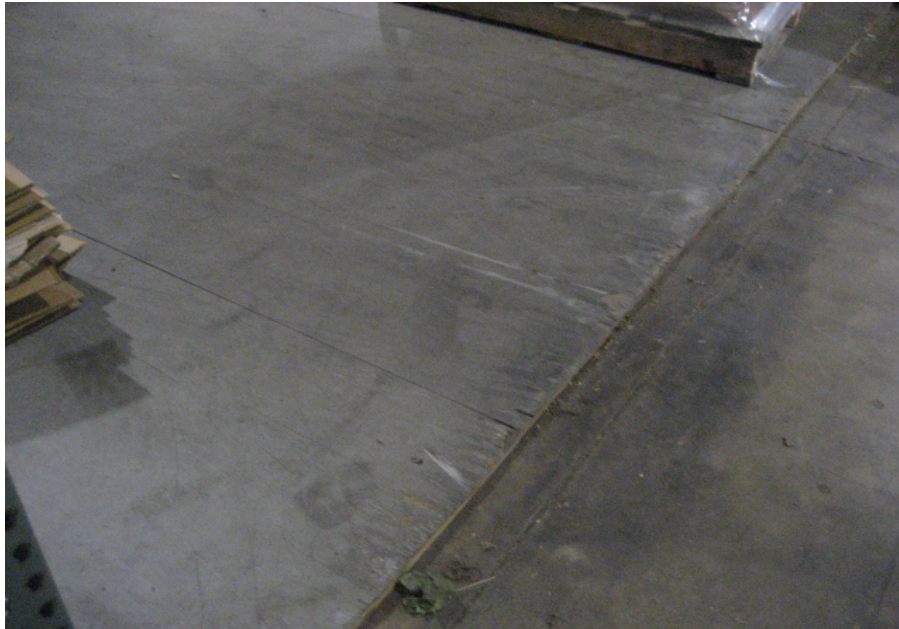
Photograph No. 16

Interior PCC slabs were observed in good condition. The observed interior slabs appeared to concrete floors with wood platform over production areas.

Typical concrete floors with wood overlay for production areas.

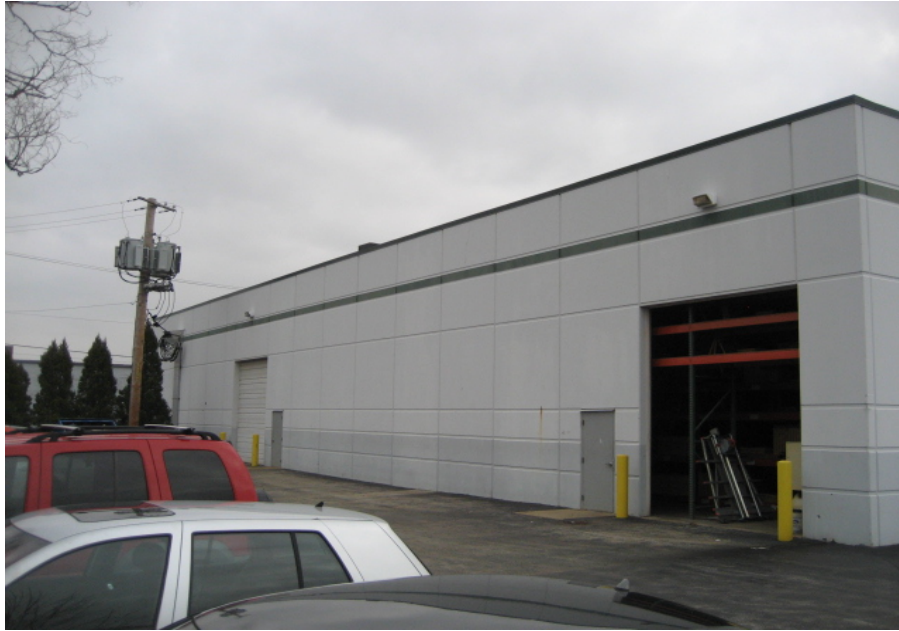
Photograph No. 17
South view of the Property.

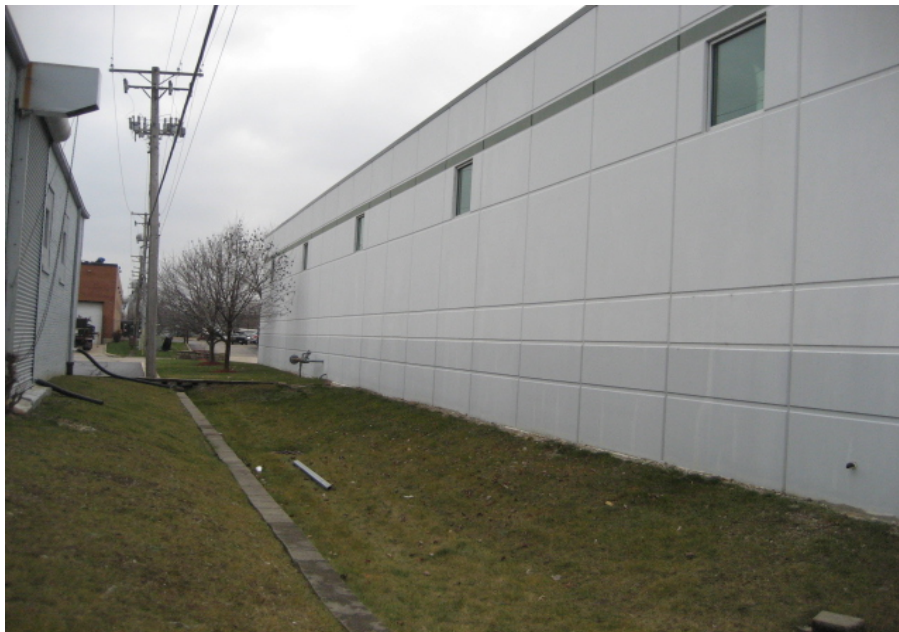
Photograph No. 18
East view of the Property.

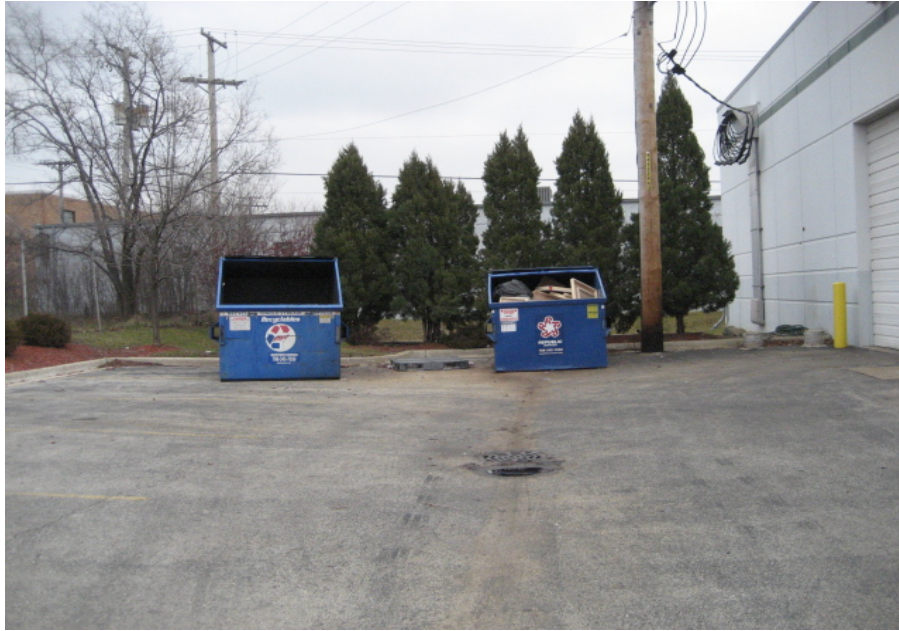
Photograph No. 19

West view of the Property - parking and dumpsters

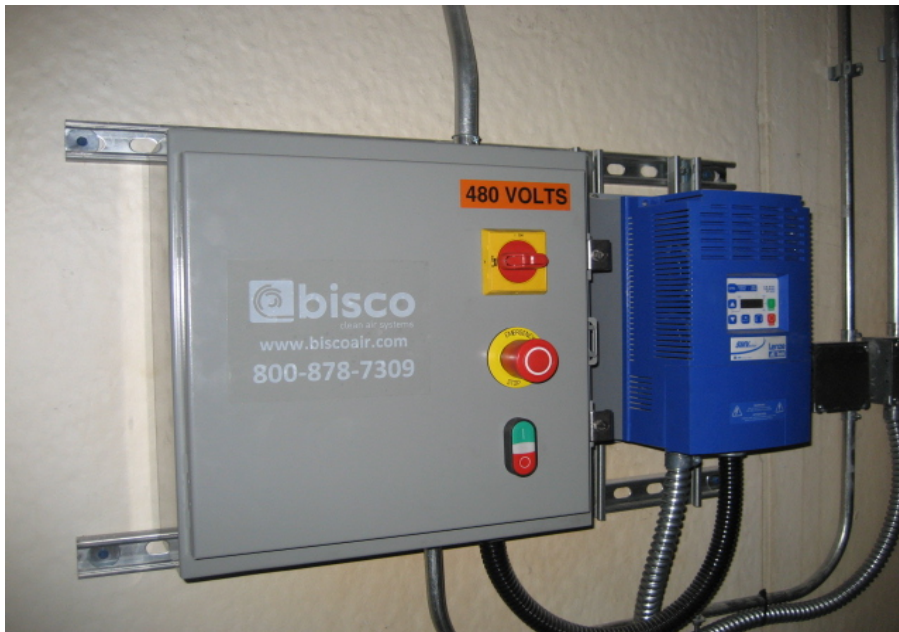
Photograph No. 20

Observations: ComEd supplies electric to the subject property. A utility-owned pad-mounted transformer was located near the northeast building exterior. In general, electrical distribution lines can be expected to provide 40 or more years of useful life, depending on the type and quality of materials and workmanship of the installation. Ms. Grengs reported that there have been no problems associated with the electrical distribution lines. The on-site electrical service mains were noted as 400 Amp. No emergency electricity generator was present.

Electrical panel at the Property.

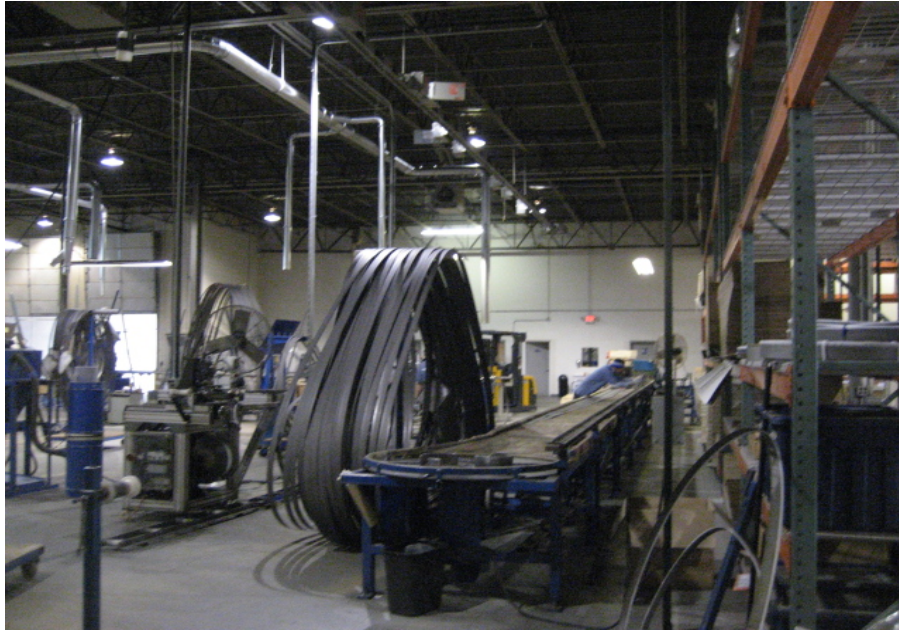
Photograph No. 21
Production area at the Property.

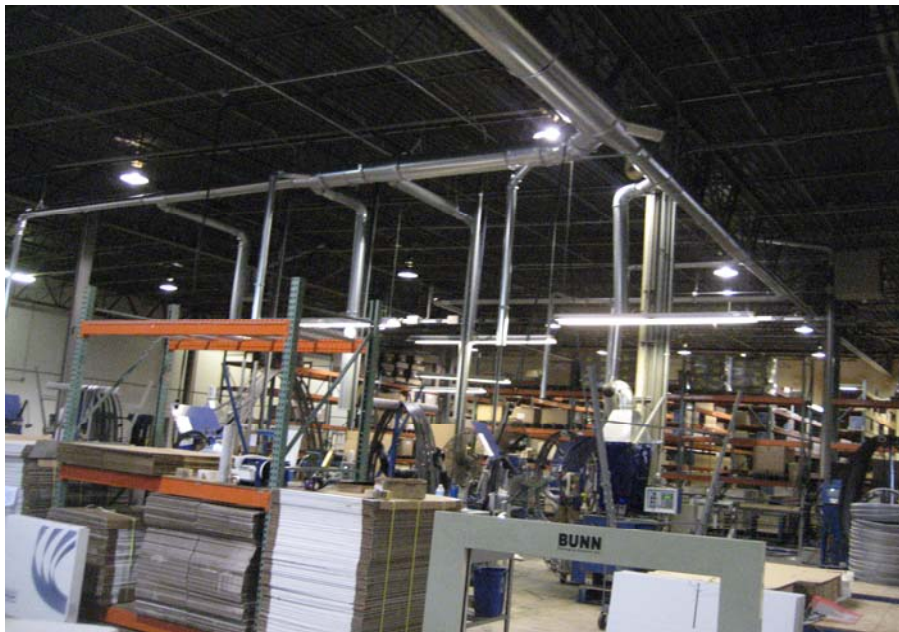
Photograph No. 22
Clean Air ventilation system at the Property.

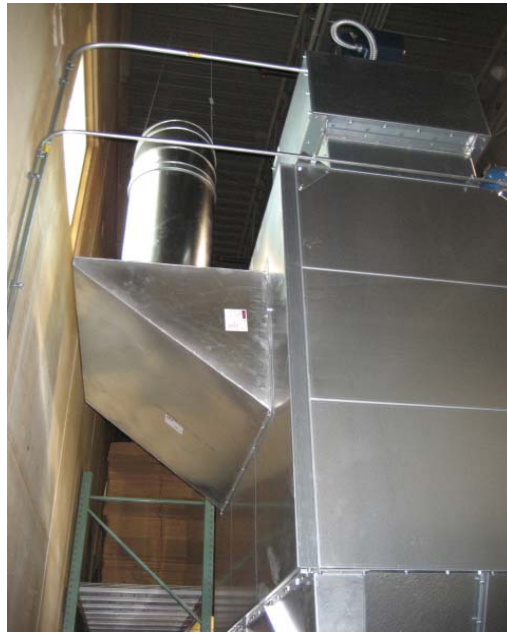
Photograph No. 23

Clean Air Filtrations System Installation in process to be completed Jan 2013
(approx. \$60,000)

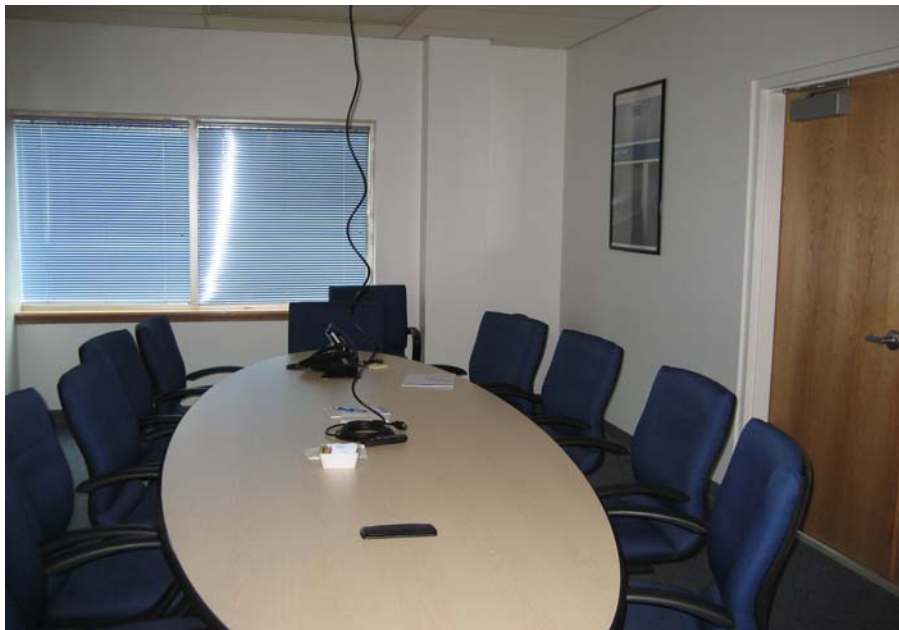
Photograph No. 24

Typical conference room at the Property.

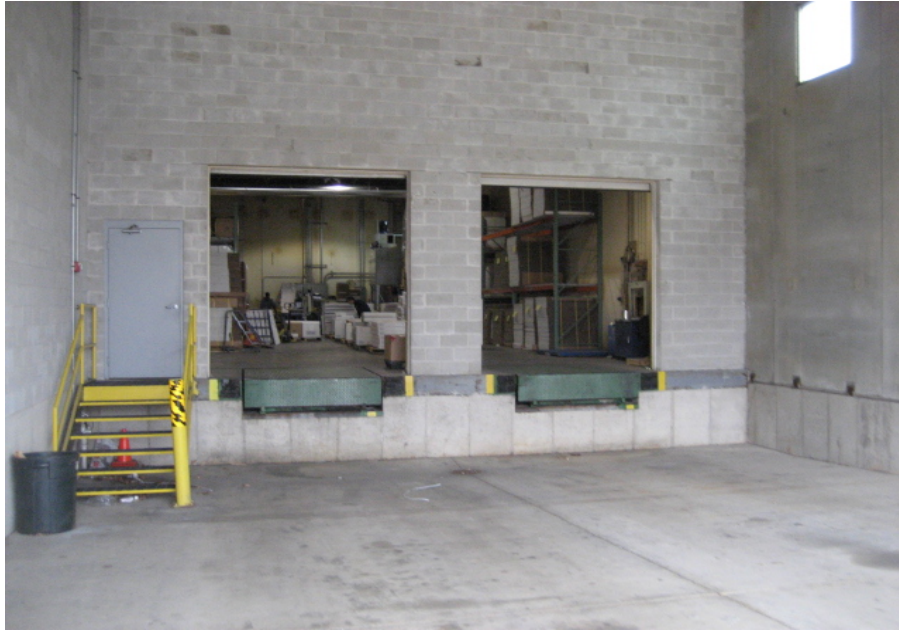
Photograph No. 25
Typical indoor receiving dock area.

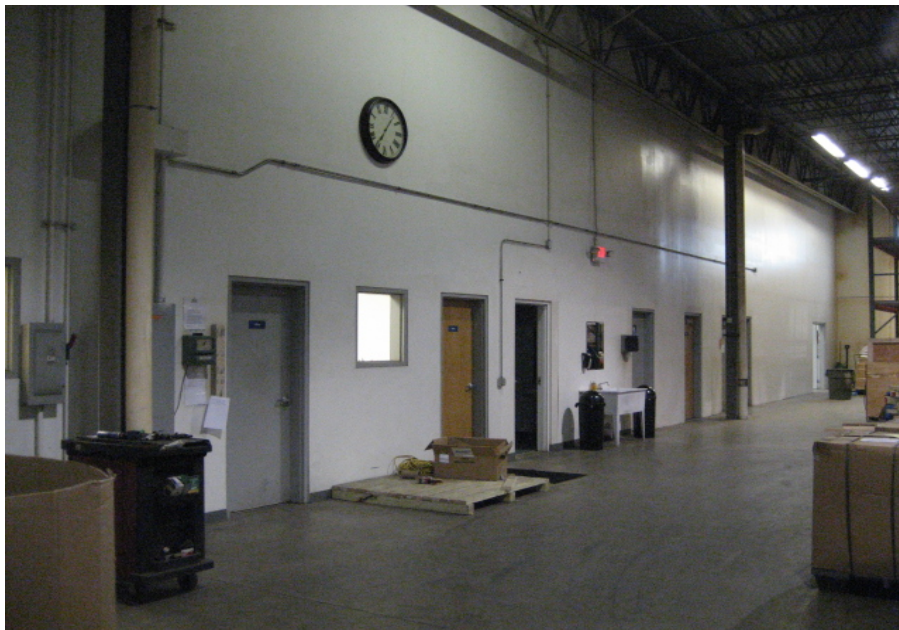
Photograph No. 26
Typical acces to office areas from production / warehouse facility.

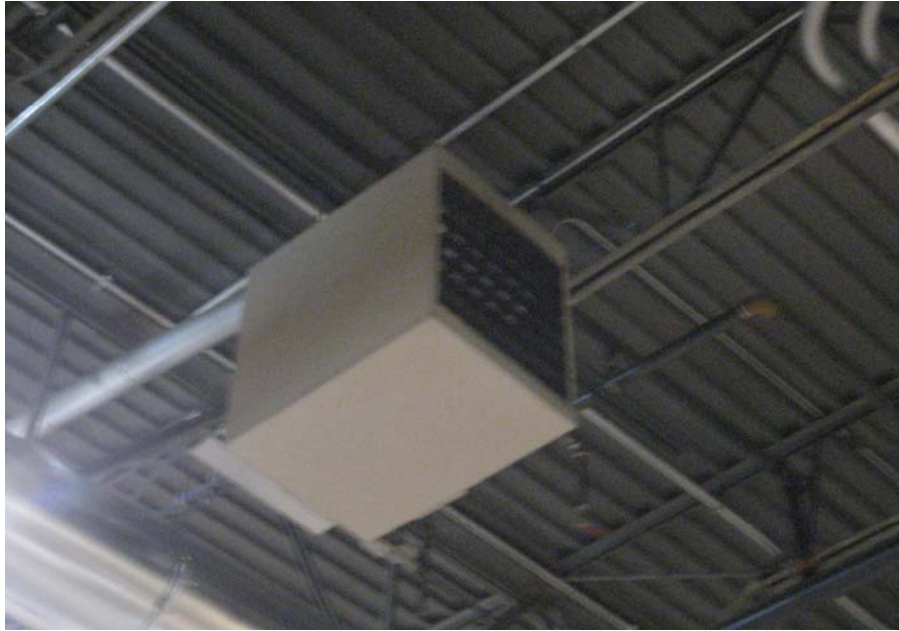
3.4.1 Plumbing Systems	■						
3.4.2 HVAC Systems	■				HVAC equipment is original; HVAC units can be expected to provide 15 to 20 years of useful life. Based on age of 11+ years K-Plus anticipates replacement over term.		\$5,000

Observations: Heating for the non-office portions of the office and maintenance building was provided by natural gas overhead radiant heat units. A roof-mounted package Lennox 5 ton unit was present over the office portion of the building. HVAC equipment is original and was also reported and noted to be well-maintained. In general, HVAC units can be expected to provide 15 to 20 years of useful life. As the unit is functional, replacement may not be necessary; however, a continued preventative maintenance program is necessary. Additionally K-Plus recommends replacement of the office HVAC during the term.

Photograph No. 27
Typical HVAC system at the Property.

Comments and Recommendations: No Immediate Repair Needs or Physical Needs over the Term were identified by K-Plus with the exception of replacement of the office HVAC package unit.
