**Three Woodfield Lake Office Building
900 National Parkway
Schaumburg, IL 60173**

PROPERTY CONDITION ASSESSMENT

FINAL REPORT

**REAL ESTATE ADVISORY
PROJECT # 065154**

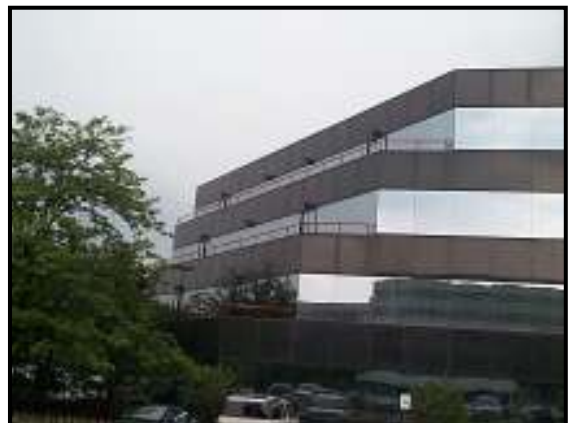
The Property features balconies located at both the west and east ends of the buildings. The balconies are located on floors 2-4 and have direct access from interior tenant suites. The balconies are accessed via sliding glass doors in anodized aluminum frames and have a rubber membrane surface with metal railings. One interior roof drain is located in each balcony. The balconies were noted to be in good condition. As the surface of the balconies is a rubber membrane, the rubber is susceptible to wear and tear from foot traffic. REA anticipates replacement over the term. Costs are included in the roof replacement number in the Replacement Reserve Worksheet.

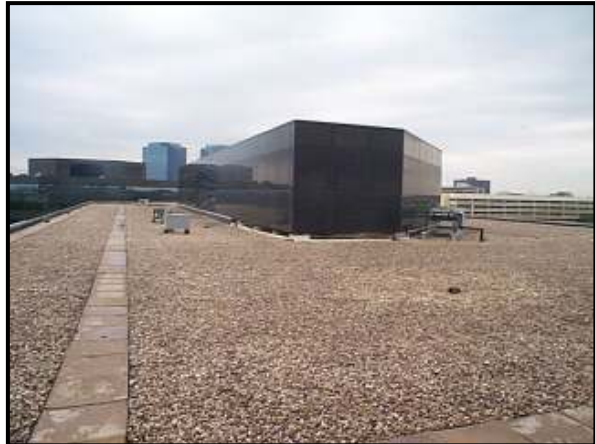
The roofing system at the Property consists of a flat roof with a rubber membrane and stone ballast. Property management reported that the roof was replaced in 1997 and is under warranty until September 26, 2007. No significant leaks or concerns were noted or reported. REA noted parapet walls with granite coping. The rubber membrane extends up the inside of the parapet wall and is mechanically fastened to the wall. Interior roof drains are used to remove stormwater from the roof. On the day of REA's inspection, it stormed with very heavy rain prior to REA's inspection of the roof. After the rain storm, REA did not note any standing water on the roof.

REA did not observe any tears or penetrations to the rubber membranes. Based on the age of the roof, REA anticipates replacement over the next 12 years. Costs are included in the Replacement Reserve Worksheet.

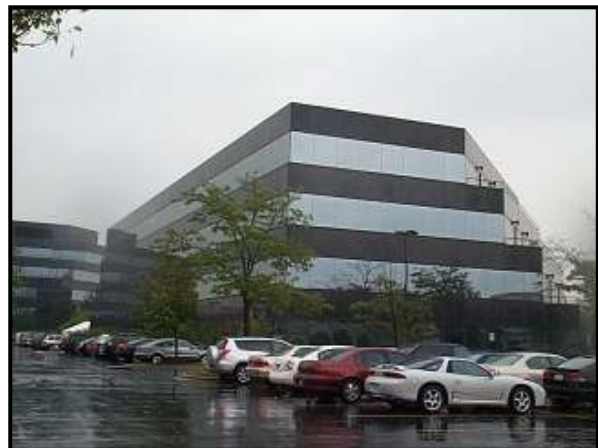
Building exteriors were noted to be in very good condition throughout the Property and have been well-maintained. No instances of significant damage were reported or observed. The building features a granite cladding with glass curtain walls. The windows are tinted, double-pane in anodized aluminum frames.

Entrance doors consist of anodized aluminum storefront types that were noted to be in good condition. There are two entries into the lobby of the building. Each entry features one turn-style door and two hinged doors, both equipped with ADA openers.

Caulking of the expansion joints is anticipated during the term as part of normal maintenance. Sealant and caulk joints at exterior window and door perimeter penetrations were noted to be in good condition with no instances of failure or damage noted. Normal exterior building envelope maintenance should include monitoring sealant joints at wall penetrations, material transitions, and windows. Costs for caulking of joints, windows, etc., are anticipated over the term and are included in the Replacement Reserve Table.

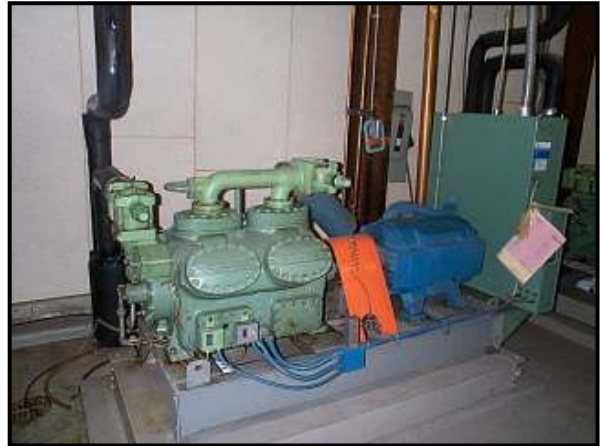
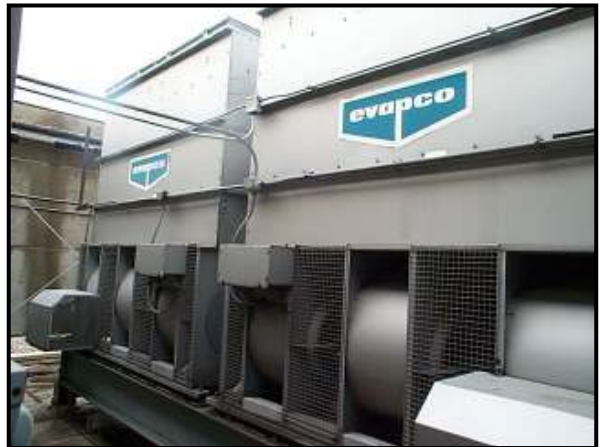
REA noted several rooftop AC condensers. However, the condensers are owned and maintained by individual tenants and not the responsibility of Property management. Therefore, REA has not attributed any replacement costs for these condensers.

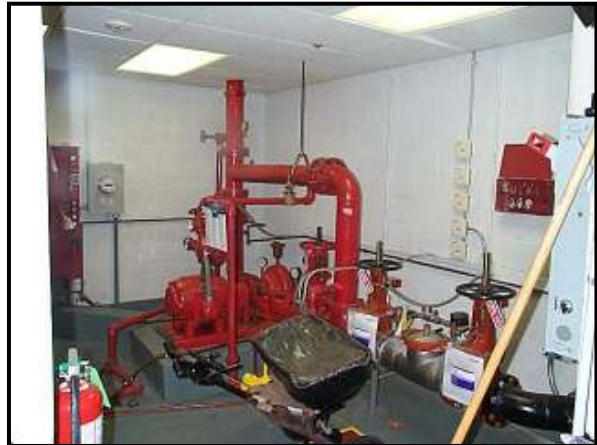
REA observed and Property management reported these systems to be in good working order. In addition, Property management routinely inspects, services, and maintains the fire and life safety systems. The sprinkler system at the building was inspected in 2006.

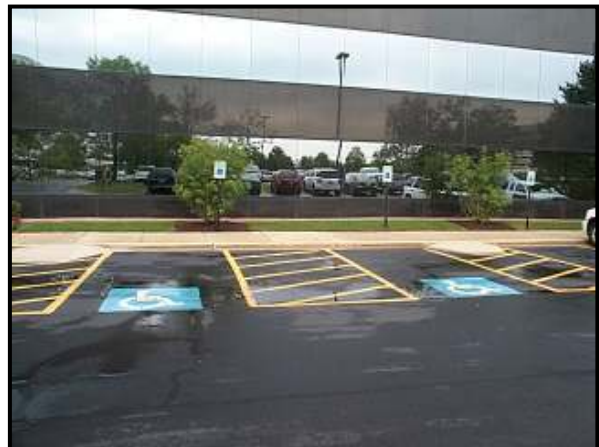
Reportedly, the Property has 355 total parking spaces. REA noted 8 handicap parking spaces located in close proximity to the main entry on the south side of the building. No concerns were noted.

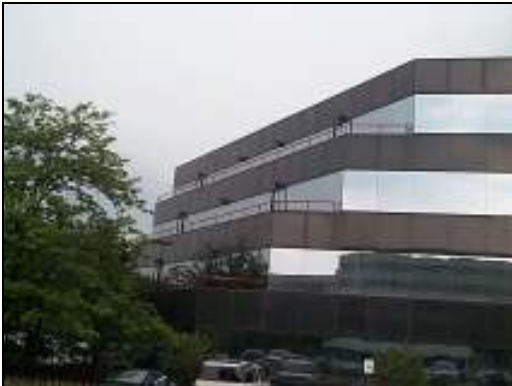
7. Balconies on both the west and east sides of the building (floors 2-4 only)

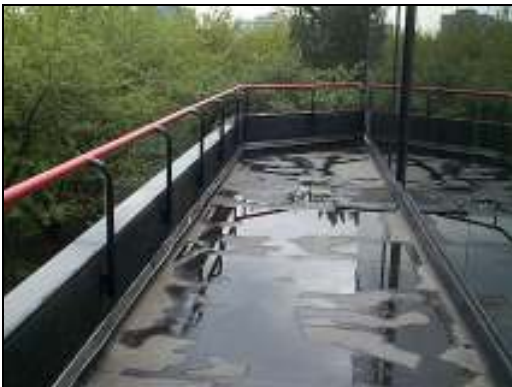
9. Balcony with rubber membrane

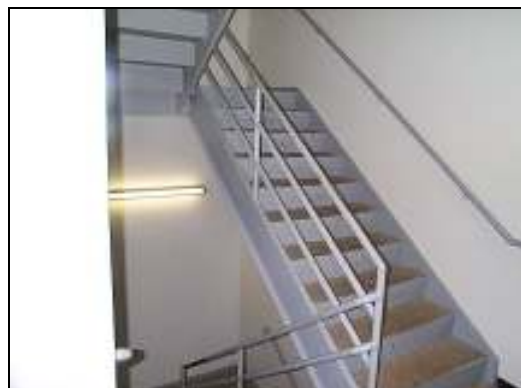
12. Typical stairwell – steel framed with concrete treads and landings

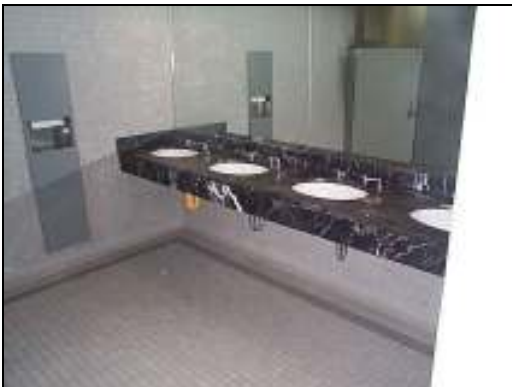
15. Common area bathroom sinks – 1 ADA compliant (yellow trap pad)

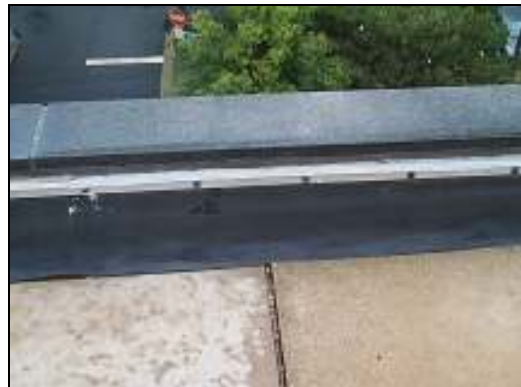
34. Rubber membrane with granite coping on parapet wall
