**Mountain Lodge Apartments
2501 Mountain Lodge Circle
Vestavia Hills, Alabama 35216**
PROPERTY CONDITION ASSESSMENT

**REAL ESTATE ADVISORY, LLC
PROJECT # 075535**

April 12, 2007

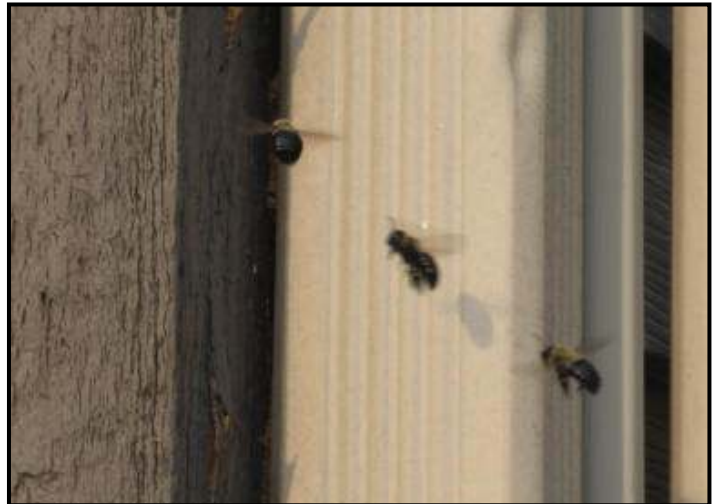
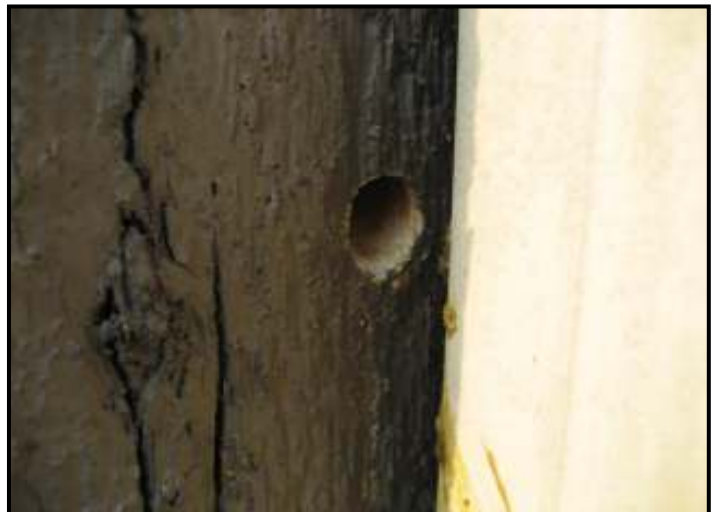
REA observed carpenter bees nesting in the wood beams and fascia boards. Carpenter bees nest in a wide range of softwoods and hardwoods, particularly if the wood is weathered. Carpenter bees create a nuisance by excavating round entry holes in wood (see bottom right picture) and depositing yellowish to brownish streaks of excrement and pollen on surfaces below entry holes. The bees can more easily tunnel through woods that are soft and that have a straight grain. In buildings, carpenter bees nest in bare wood near roof eaves and gables, fascia boards, porch ceilings, decks, railings, siding, shingles, shutters, and other weathered wood. These bees avoid wood that is well painted or covered with bark.

REA recommends the wood surfaces well painted with a polyurethane or oil-base paint to deter attack by carpenter bees. REA recommends periodic inspection on painted surfaces, to avoided coatings deterioration due to weathering. When dealing with carpenter bees, it is preferable to locate tunnel entrances during the daytime, but treat after dark on a cool evening when carpenter bees are less active. Wear protective clothing to avoid any stings during treatment.

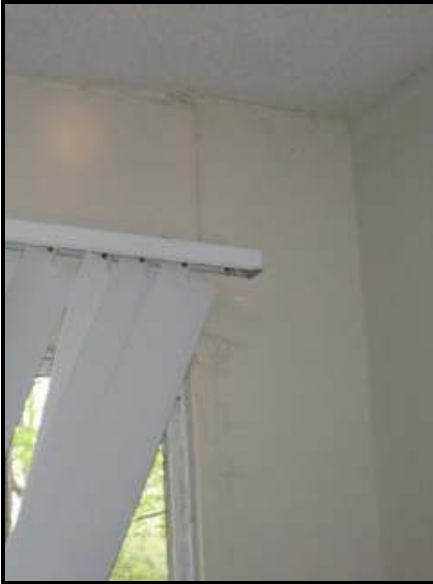
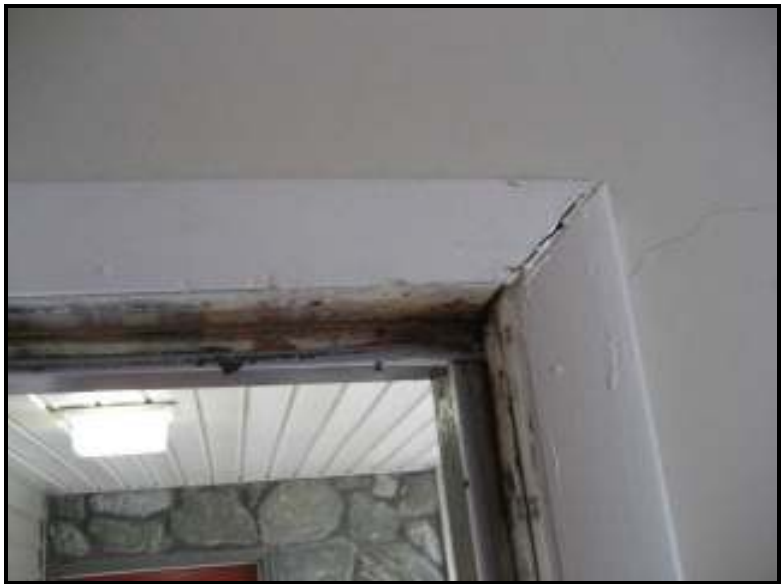
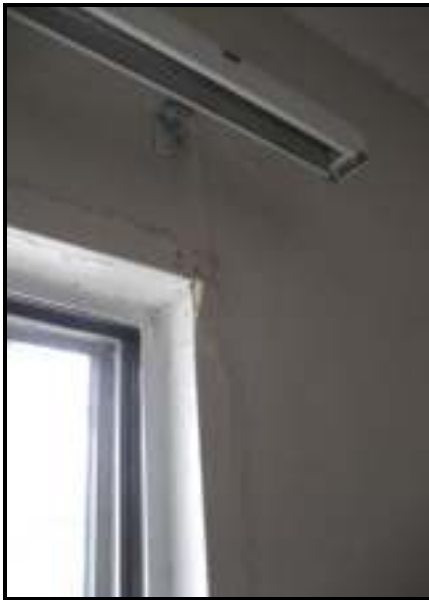
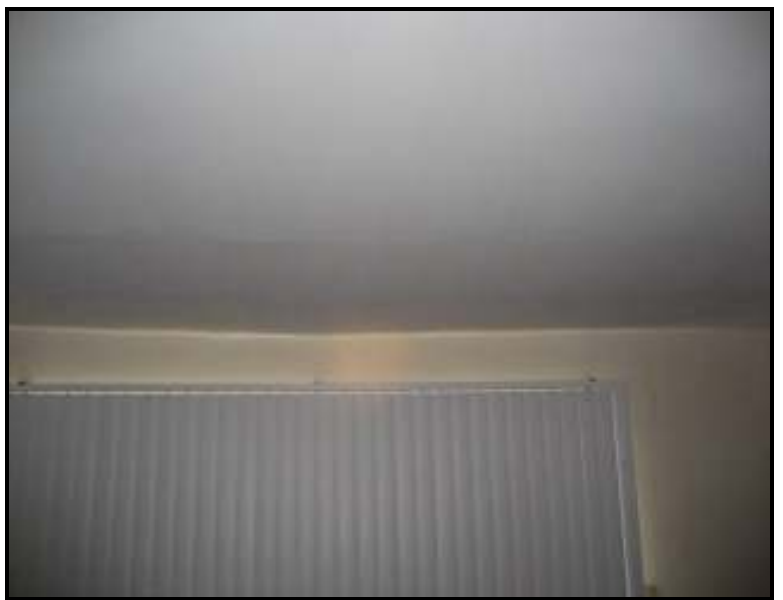
REA noted both the 10-mil layer polyethylene sheeting and blower fans installed in the crawl spaces of Buildings. Foundation in the crawl spaces appeared to be reinforced concrete supporting conventional wood stud framing and wood joists supporting plywood and gypcrete flooring.

In the observed cases, foundation movement has also resulted in interior drywall damage, poorly operating doors and windows, and uneven floors. It should be noted that structural integrity does not appear to be compromised in any of the areas of foundation settlement. Cracked brick veneer should be sealed as necessary and instances of significant settlement investigated by a foundation repair consultant. Estimated costs for additional investigation have been included in the Immediate Needs Table. Costs for potential needed repairs are to be determined after the additional investigation is completed.

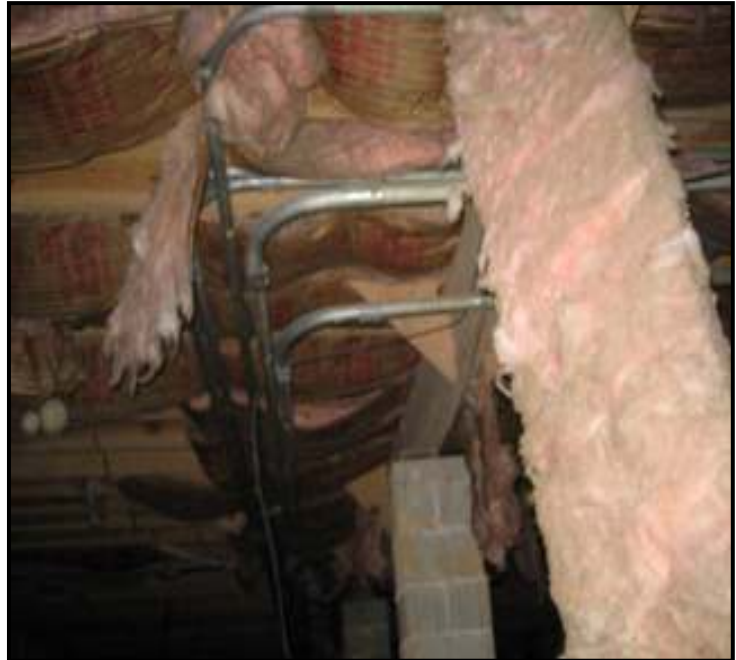
Floor insulation in the crawl spaces was observed to have fallen in many areas (typical condition shown at right). REA recommends that the insulation be replaced, and the costs have been accounted for in the Immediate Needs Table.

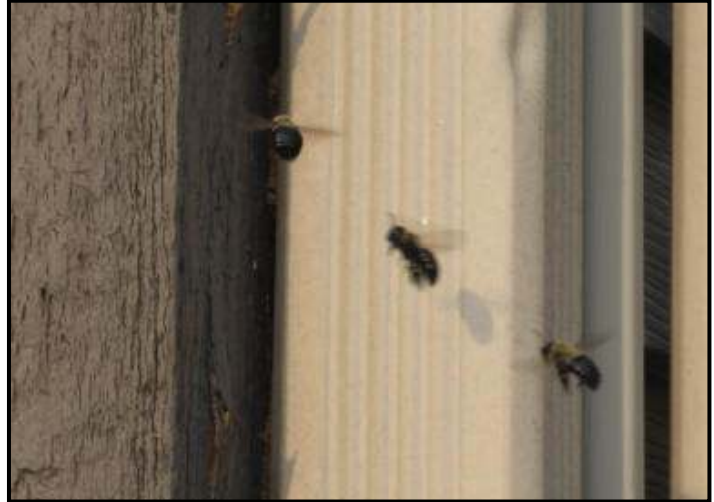
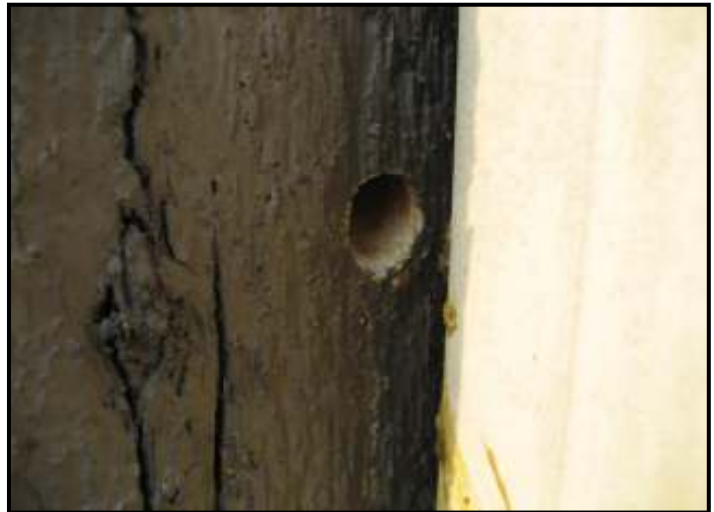
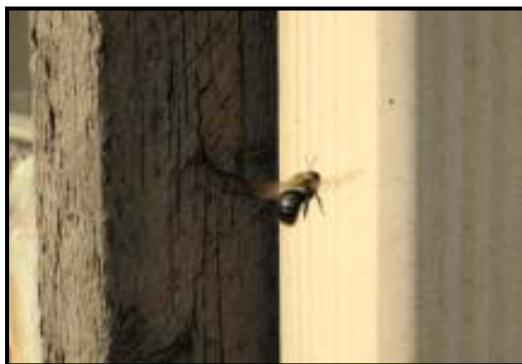
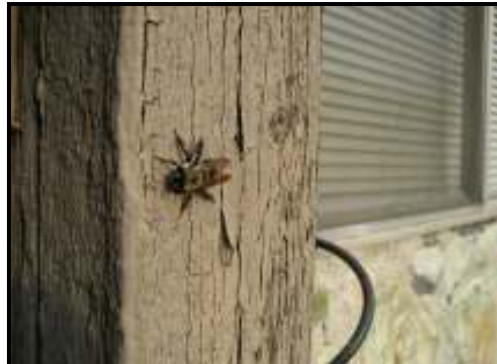
REA observed carpenter bees nesting in the wood beams and fascia boards. Carpenter bees nest in a wide range of softwoods and hardwoods, particularly if the wood is weathered. Carpenter bees create a nuisance by excavating round entry holes in wood (see bottom right picture) and depositing yellowish to brownish streaks of excrement and pollen on surfaces below entry holes. The bees can more easily tunnel through woods that are soft and that have a straight grain. In buildings, carpenter bees nest in bare wood near roof eaves and gables, fascia boards, porch ceilings, decks, railings, siding, shingles, shutters, and other weathered wood. These bees avoid wood that is well painted or covered with bark.

REA recommends the wood surfaces well painted with a polyurethane or oil-base paint to deter attack by carpenter bees. REA recommends periodic inspection on painted surfaces, to avoid coatings deterioration due to weathering. When dealing with carpenter bees, it is preferable to locate tunnel entrances during the daytime, but treat after dark on a cool evening when carpenter bees are less active. Wear protective clothing to avoid any stings during treatment.

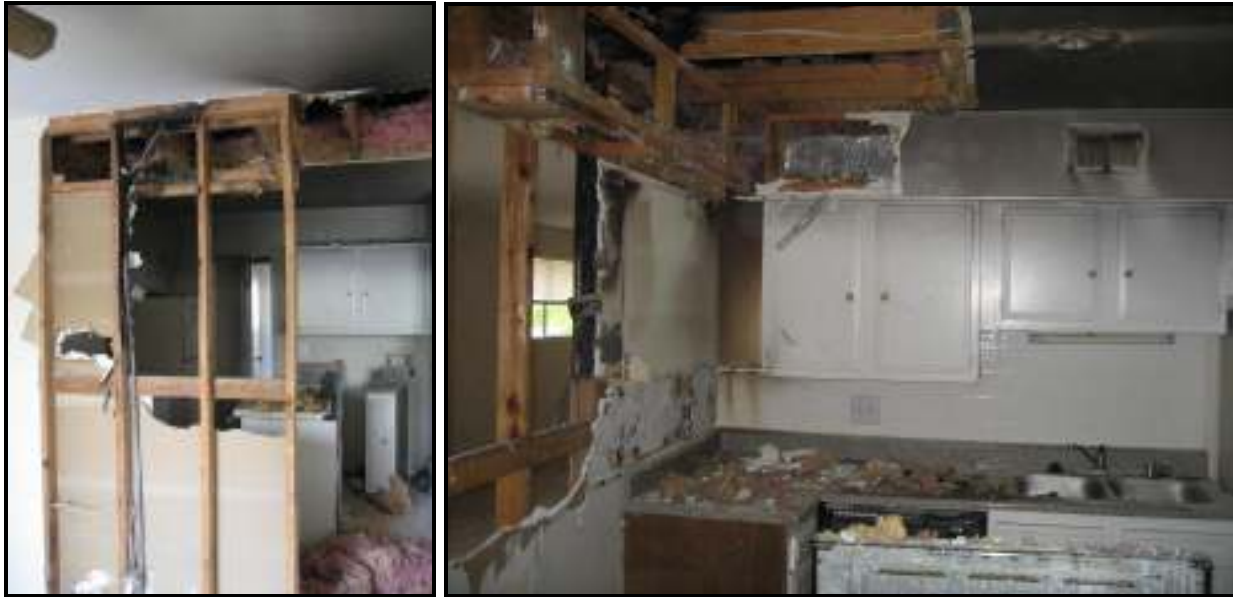
Two apartments and clubhouse were reported and observed to be down (i.e., unleaseable) at the time of the on-site assessment. Apartment 2535-C was down due to a kitchen fire in August 2006. The fire was reportedly caused in kitchen and was put out by the fire sergeant leaving next door before the fire department arrived to the Property.

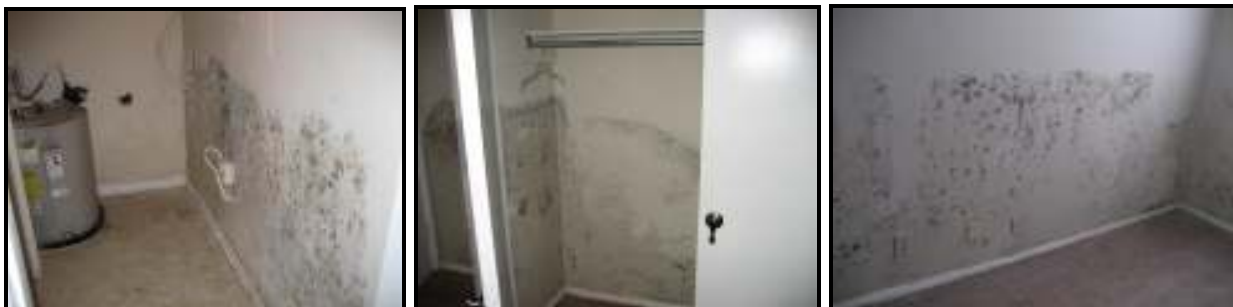
No reports of water infiltration or mold concerns were reported by the Property. However, REA did observe some mold buildup at Apartment 2557-A. This was a result of water leak from a water heater.

REA recommends this area be corrected.

Costs to repairs these items have been accounted for in the Immediate Needs Table.

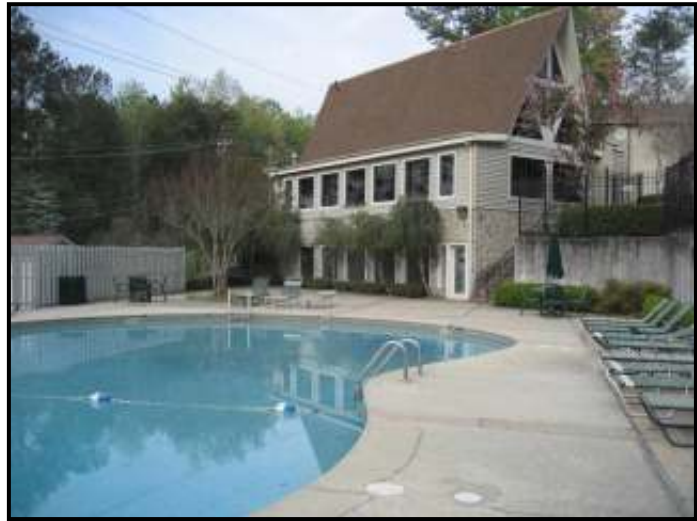
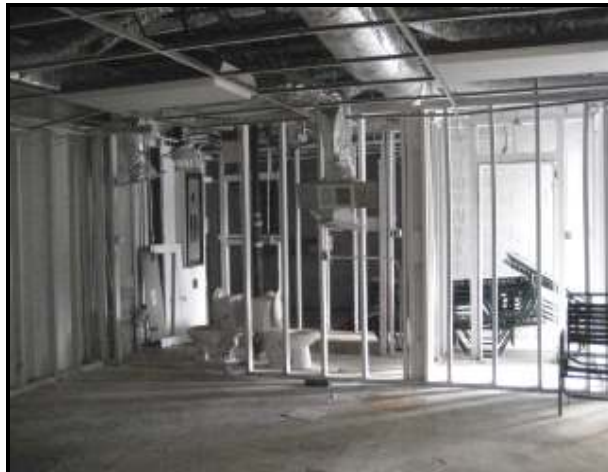
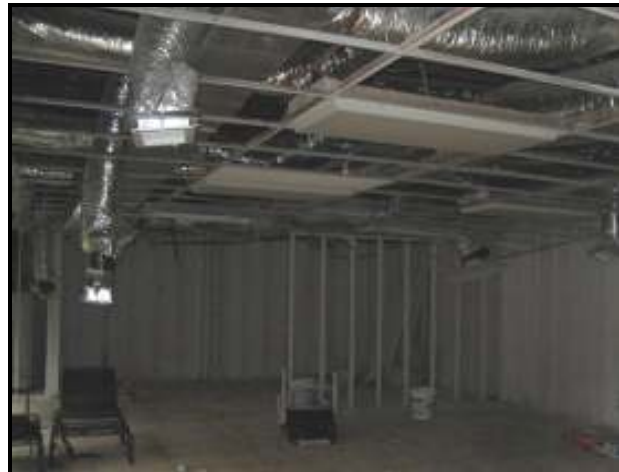
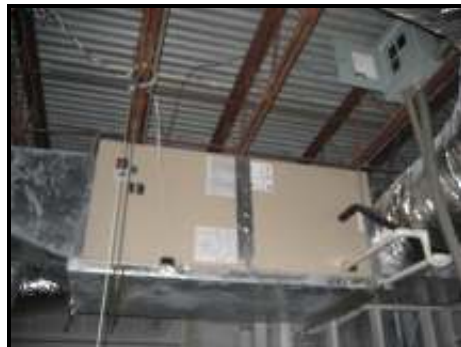
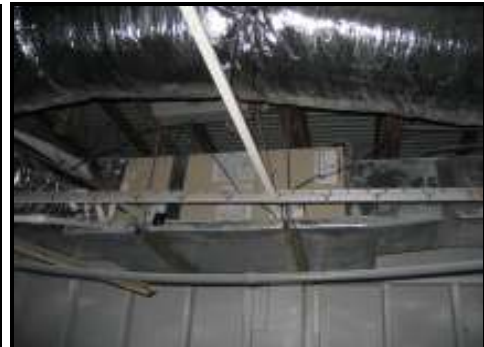
The clubhouse contains a fitness room, gathering area, laundry, storage and restrooms for tenant use. REA observed lower level of the clubhouse was gutted down to studs. Management reports that the lower level of the clubhouse had been closed down for some time. According to Mr. Tony Bird, Property maintenance supervisor, the water damage and mold growth was reportedly removed by a contractor. REA observed replacement ductwork installed in 2003, along with two and five ton HVAC units and 75 gallon water heater for the laundry room functioning at the time of inspection.

REA has attributed the cost to repair the lower level clubhouse in the Immediate Repair Needs. Except for the three units discussed above, interior finishes were noted to be in generally good condition. No other significant deficiencies were noted.

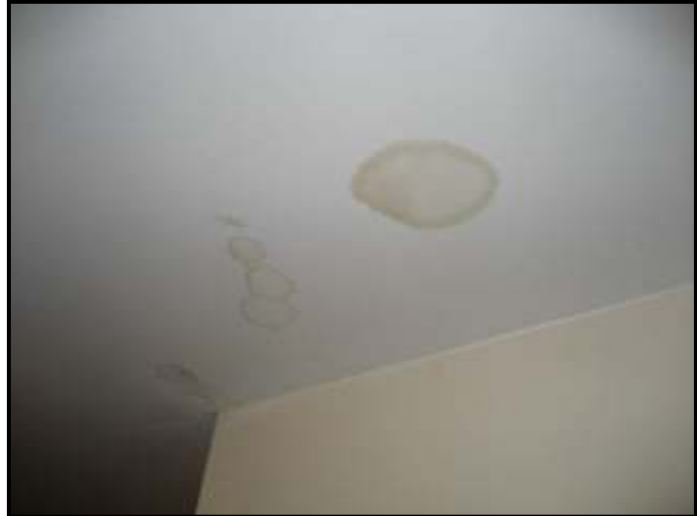
REA observed stained ceilings in some top-floor apartments and in some top-floor water heater closets (typical stain on apartment ceiling shown at right), reportedly resulting from formerly leaking roofs (no active leaks observed or reported). REA was informed by Mr. Tony Bird, Property Maintenance Supervisor, that roofs were repaired and re-singled throughout the Property in 2003. The leaking problem has since been corrected, and Mr. Bird reported no persistent roof leaks. Stained ceilings should be repaired/repainted as needed as part of routine maintenance or apartment turnover.

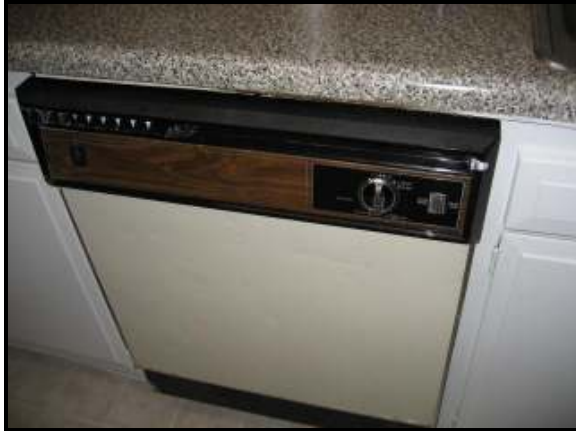
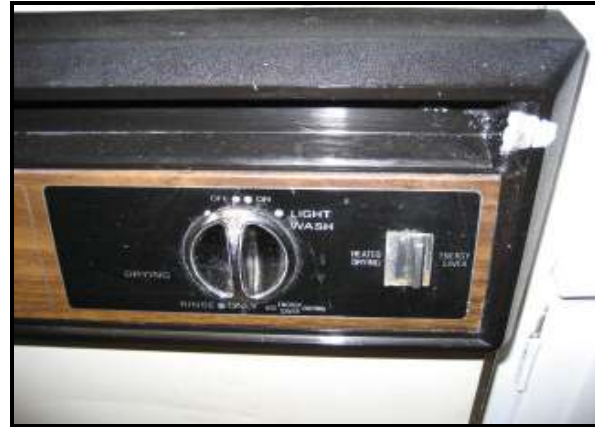
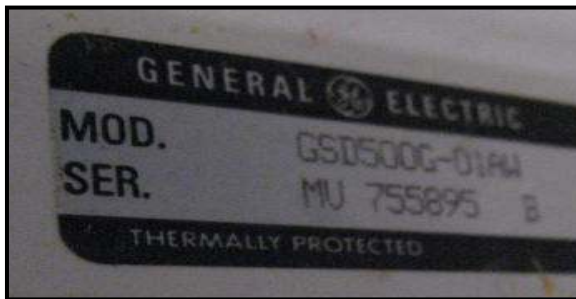
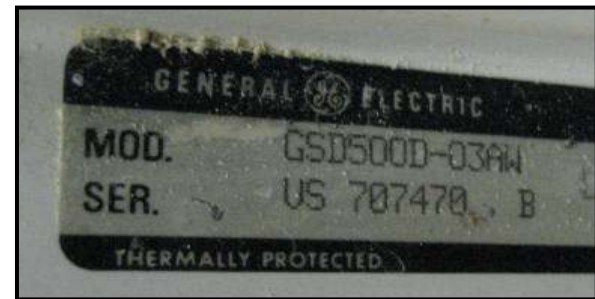
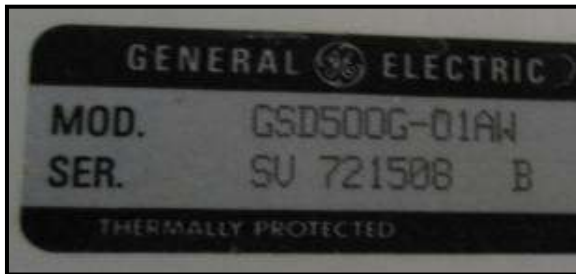
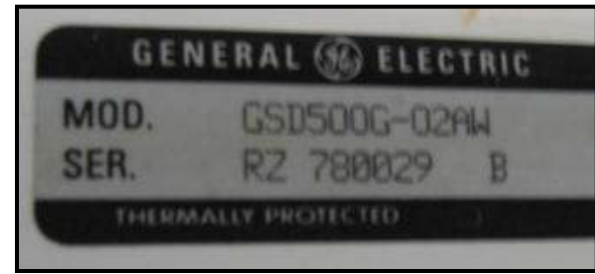
The appliances in the unit's inspected consist of a mix of original and new equipment and appear to be in good condition. In apartments inspected, REA noted GE and Hotpoint dishwashers in few units. A recall for defective slide switches was issued on these models. GE and Hotpoint brand dishwashers that have a slide switch can melt and ignite, presenting a fire hazard. GE manufactured 3.1 million of these dishwashers between 1983 and 1989. The GE and Hotpoint dishwashers involved are models beginning with GSD500D, GSD500G, GSD540, HDA467, HDA477, or DHA487 with serial number that has a second letter of A, M, R, S, T, V or Z (for example: MV755895, see below). REA recommends maintenance to inspect the affected parts on these dishwashers were replaced or repaired. Maintenance can also contact a GE-authorized technician to inspect and re-wire the slide switch for the dishwashers at no cost.

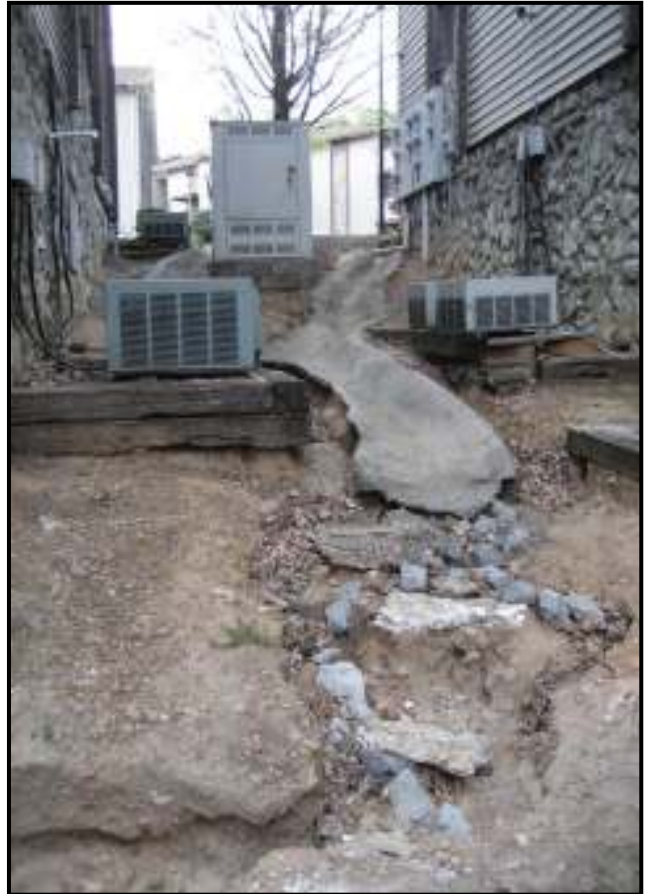
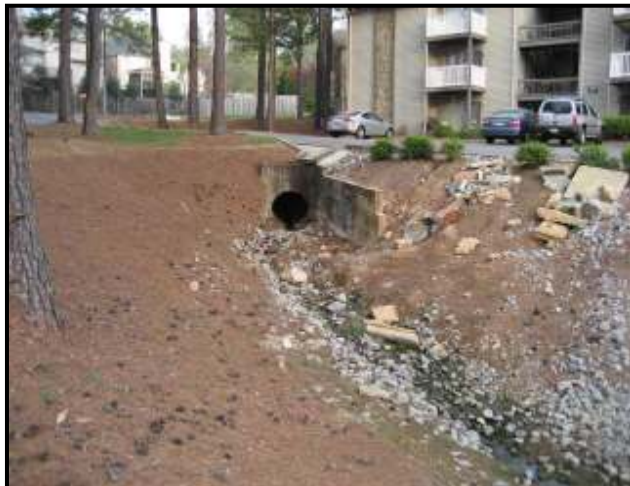
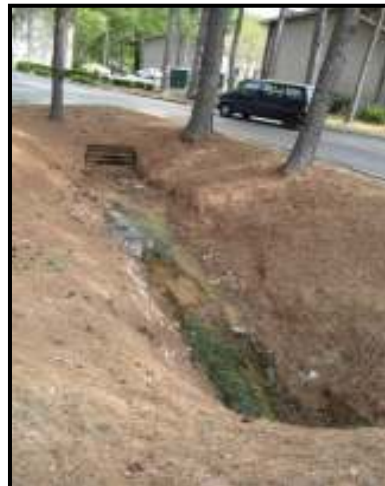
REA observed minor erosion between building 2573 and 2575. This is caused due to surface water from the lawn areas mostly flows overland via sheet flow to concrete drainage channels runs throughout the Property and carries stormwater to the southwest corner of the Property, where stormwater enters the municipal stormwater collection system.
