**Seabrook at Bear Brand  
56 Sea Terrace  
Dana Point, California 92629**

***PROPERTY CONDITION ASSESSMENT***

**REAL ESTATE ADVISORY, LLC  
PROJECT # 075663**

**July 19, 2007**

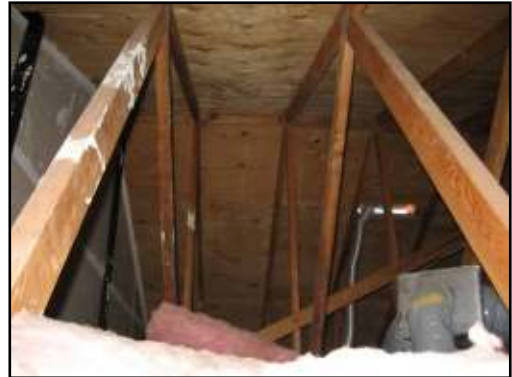
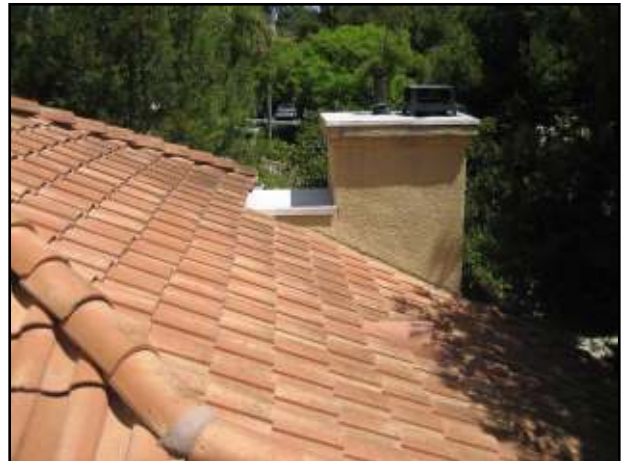
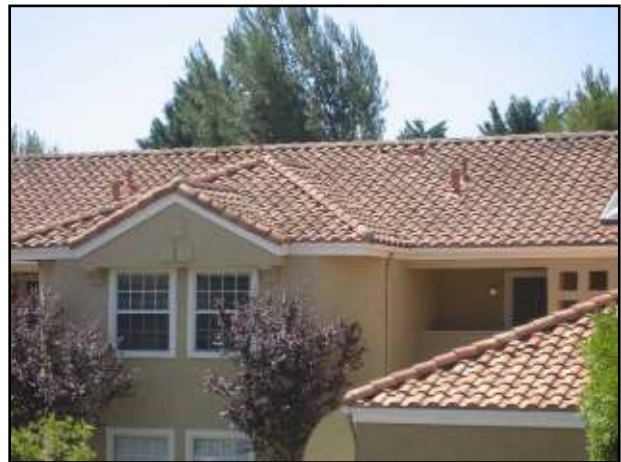
Roofing is original and was observed to be in good condition. Property management did not report any concerns regarding the roof.

REA did not observe any area of significant damage or signs of past repairs. The building flat roof systems feature modified bitumen roofing. The building flat roof system is constructed atop wood framing and decking. The roof membrane is penetrated by ventilation ducts and plumbing vents. REA inspected these penetrations (as possible) and found them to be in good condition. The roof is designed to drain to gutters and downspouts. No replacement of the concrete tile roofing is anticipated based on its 40+ year estimated useful life. In addition, based on the observed good condition and the mild climate, no significant replacement of the modified bitumen roofing is anticipated.

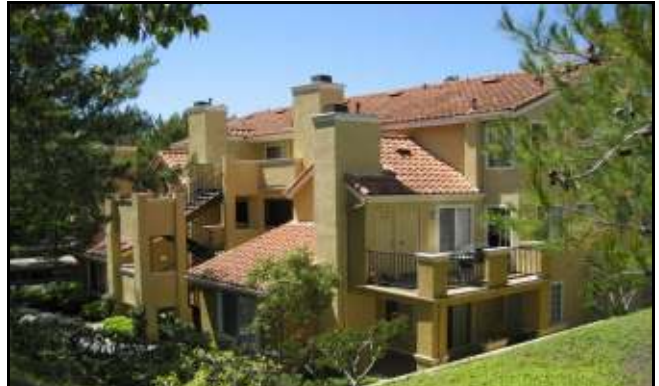
1. View of typical front elevation apartment building.

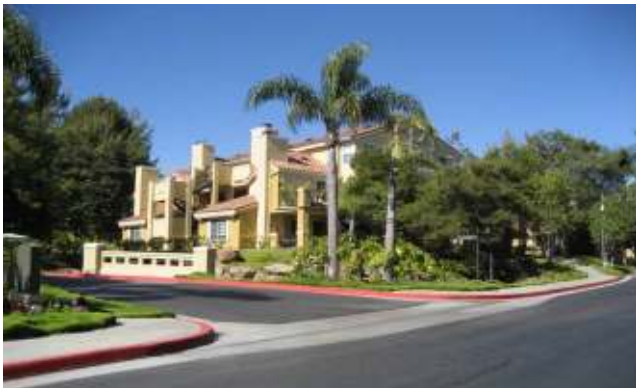
2. View of typical rear elevation apartment building.

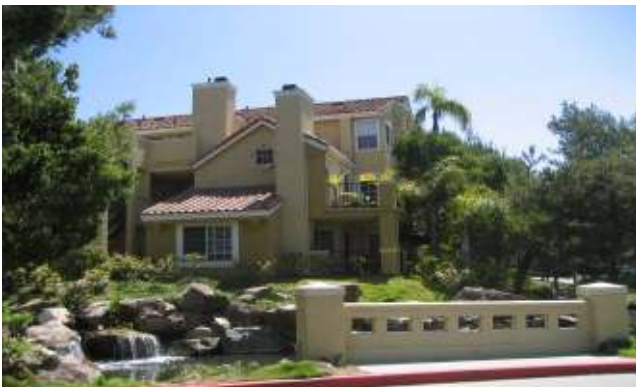
4. View of typical front/side elevation apartment building.

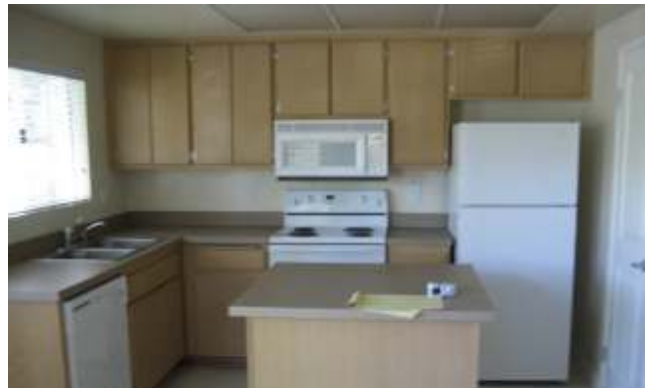
7. View of typical kitchen area.

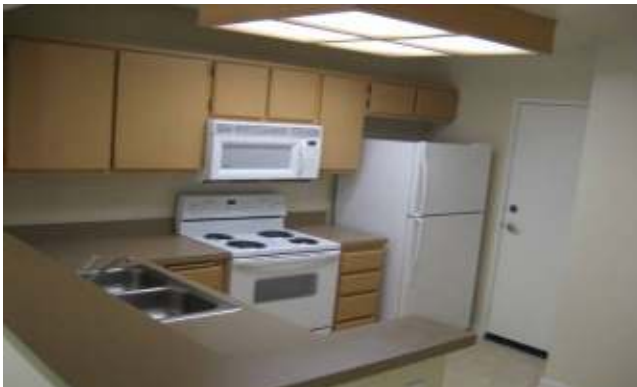
8. View of typical kitchen area.
