**Villas at Huffmeister Apartments
15050 Copper Grove Boulevard
Houston, Texas 77095**

PROPERTY CONDITION ASSESSMENT

**REAL ESTATE ADVISORY
PROJECT # 096751**

February 11, 2009

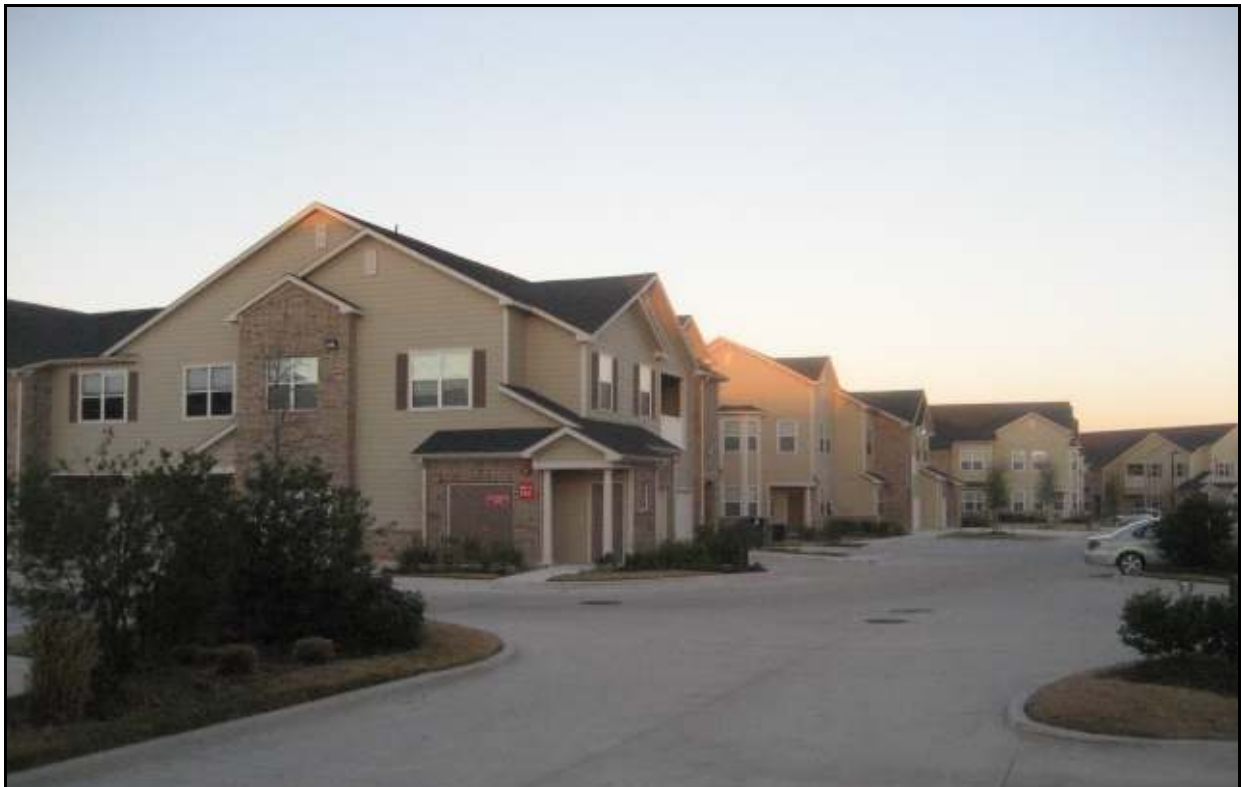
REA noted no significant deficiencies with respect to foundations at the Property, and no significant foundation concerns were reported by property management personnel. During the term considered, REA does not anticipate substantial capital expenditures regarding foundations.

Foundation systems for the apartment buildings at the Property consist of reinforced concrete footings with post-tensioned concrete slabs at grade. Proper drainage should be maintained around building perimeters to maintain positive drainage away from foundations.

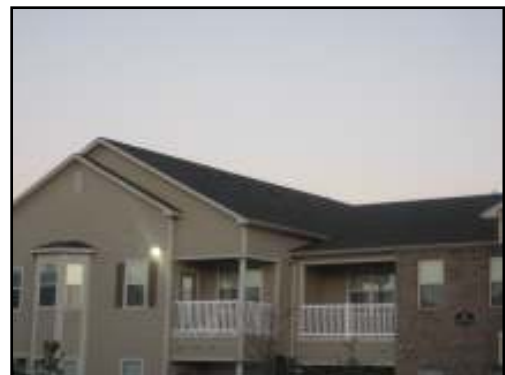
The roofing systems at the Property consist of gabled roofs with asphalt composition shingles installed over plywood decking, which is supported by wood framing. Attic ventilation appeared to be adequate and is provided by intermittently spaced soffit vents. Fascias and soffits at roof perimeters feature perforated fiber-cement material. Typically, the buildings have gutters around roof perimeters. The gutters direct water to downspouts that discharge to splash blocks or concrete surfaces at grade. No evidence of fire retardant roof sheathing was observed or reported at the Property.

Because the roofs are approximately one year old and were observed to be in very good condition, no significant expenditures are anticipated for roof replacement during the term considered. In addition, the Property management personnel did not report concerns with the roofing.

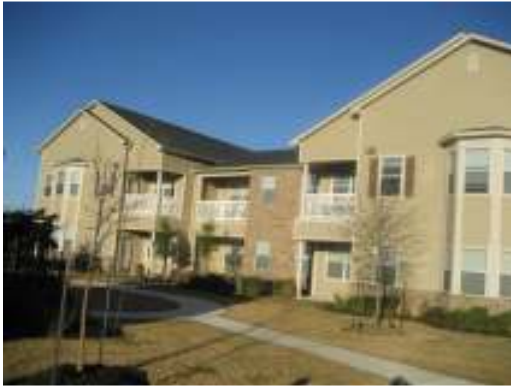
1. TYPICAL BUILDING EXTERIORS

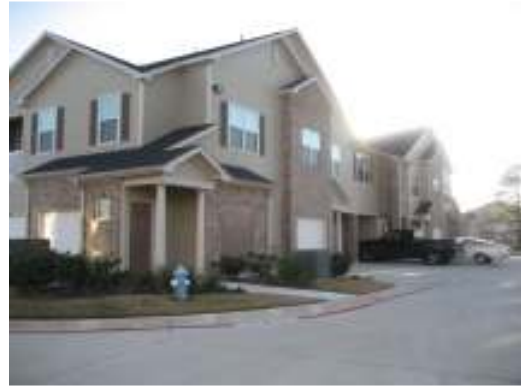
2. CONCRETE DRIVES AND PARKING AREAS

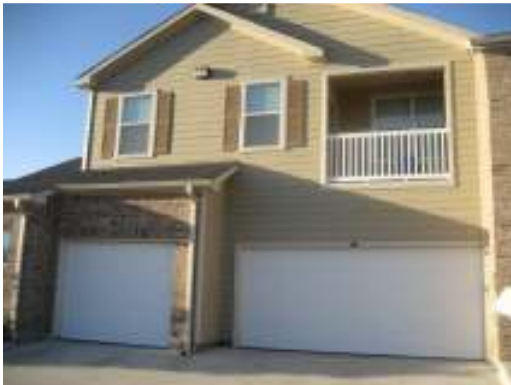
3. TYPICAL VIEW OF GARAGES

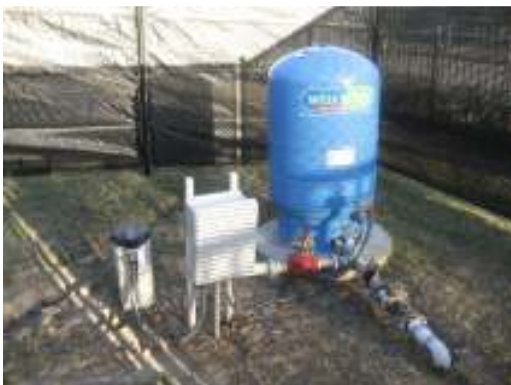
5. LANDSCAPE IRRIGATION SYSTEM/
STORAG TANK

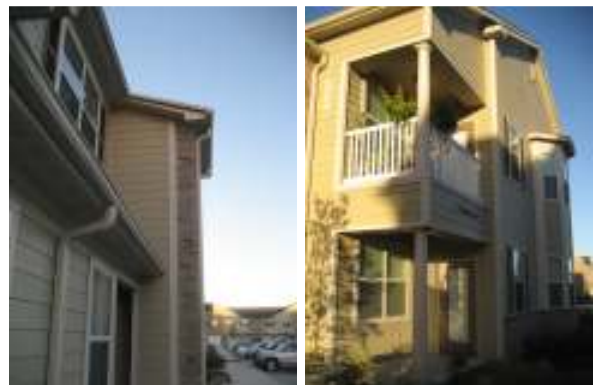
6. CLOSE-UP VIEW OF TYPICAL EXTERIOR
MATERIALS

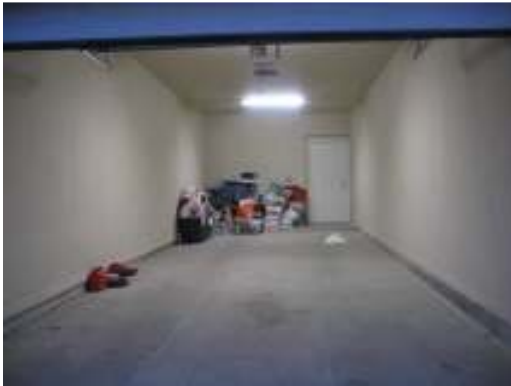
7. TYPICAL GARAGE FINISHES. NOTE AUTOMATIC GARAGE DOOR OPENER

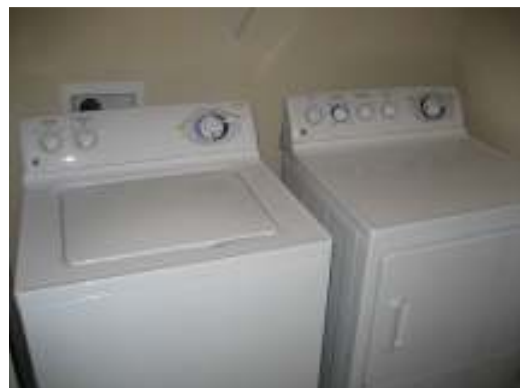
12. LAUNDRY EQUIPMENT IN EACH UNIT

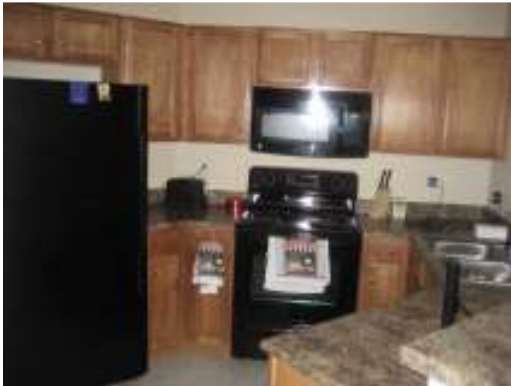
13. VIEW OF A TYPICAL APARTMENT KITCHEN

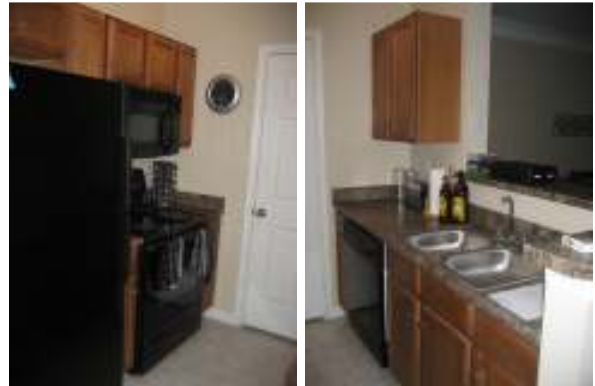
14. MICROWAVE VENT HOODS AND ELECTRIC RANGES IN KITCHENS

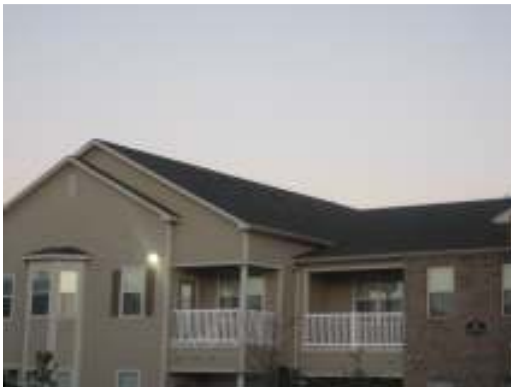
21. ASPHALT SHINGLE ROOFING
