**The Pointe Office/ Retail
1427 & 1429 West Saginaw Street
East Lansing, Michigan 48823**

PHASE I ENVIRONMENTAL ASSESSMENT

**REAL ESTATE ADVISORY
PROJECT # 096775**

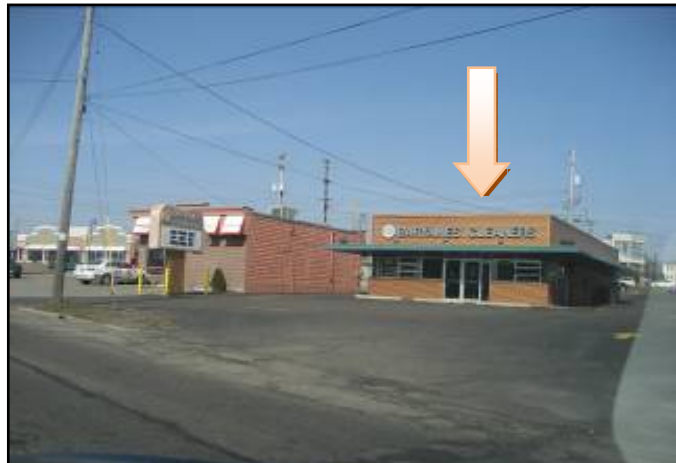
- Baryames Cleaners is located at 1518 West Grand River, west of the Property across Coolidge Road. The present of adjoining dry cleaners Baryames Dry Cleaners has been in operation since 1970's. The identified site is listed as small quantity generator (SQG), between 100 and 1000 kg/month. REA performed a visual reconnaissance and interviews with on-site personnel to identify dry cleaner operations that would pose an environmental concern to the Property.

At the time of REA's site inspection, this dry cleaning facility was being used for pick-up and drop-off service only. On-site dry cleaning operations ceased in 2004. While Baryames Dry Cleaners have discontinued operations, it is possible that former operations impacted the Property. However, based on the results of Phase II ESA prepared by PME on December 12, 2002, no evidence of releases from the dry cleaner or known impacts to the area were identified. Therefore, significant impact to the Property from the former dry cleaning operations at this site is not anticipated.

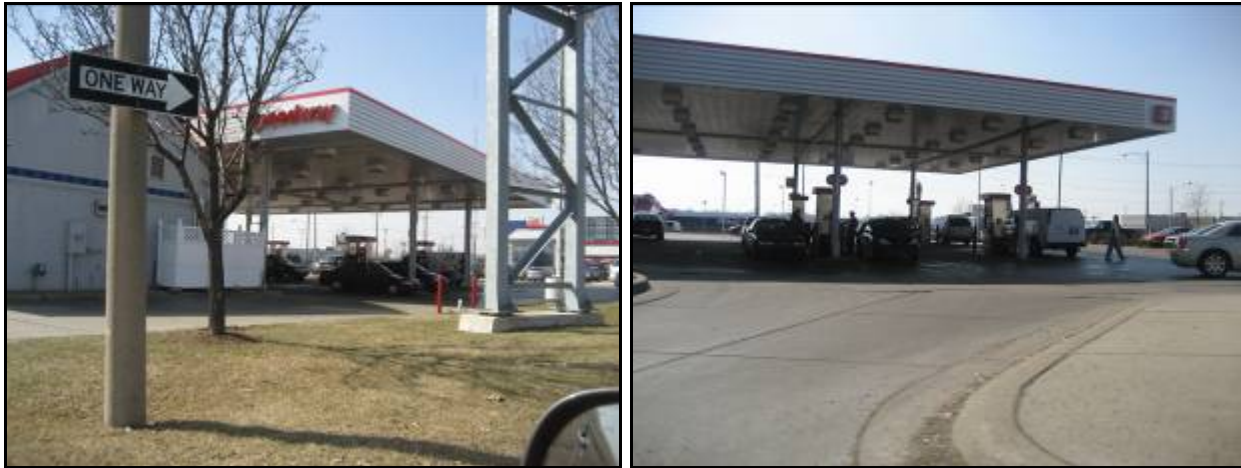
Five UST/AST sites were identified within the approximate one-mile study radius. The closest identified listings are as follows:

- Speedway 8785 (listed twice) located 3201 E. Saginaw Street, 0.19-mile southwest of the Property. Two gasoline USTs, including one (1) 15,000-gallon tank and one (1) 12,000-gallon tank, are currently in use at the Property. The tanks were installed in August, 1993 with automatic line leak detectors and composite (steel with fiberglass) double walled construction material. As noted in section 4.1.1; one open LUST incident is listed for this site. However, based on distance and gradient, impact to the Property from this site is not anticipated.

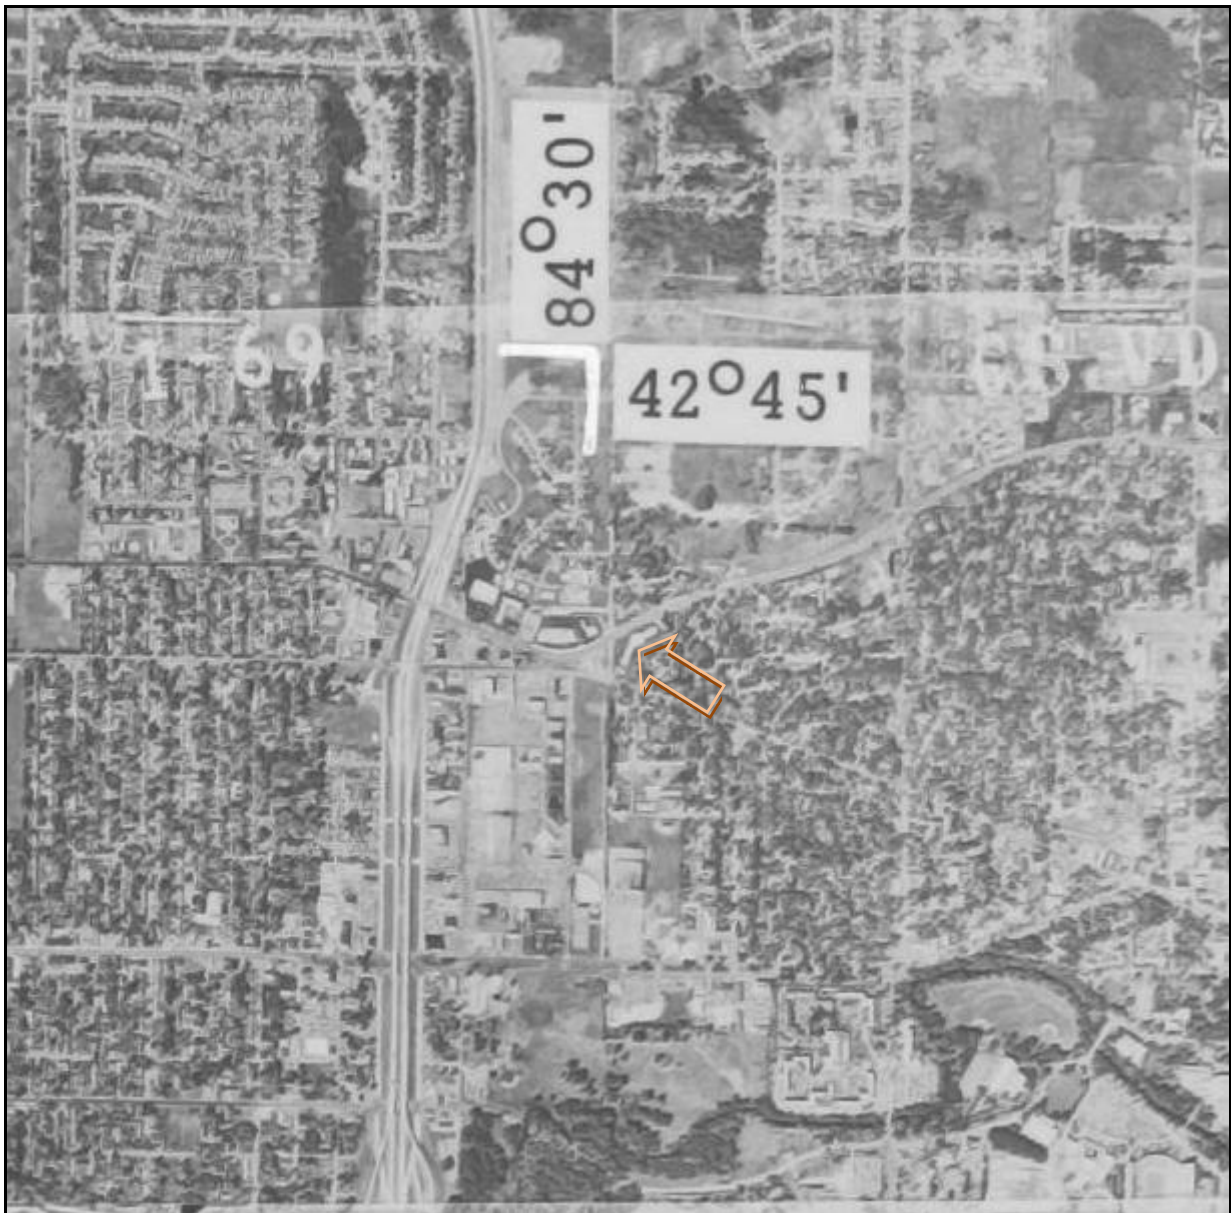
The 1973 (below) aerial photograph depicts the following:

Property	Developed with Motel
North	Single-family Residential
South	Single-family Residential
East	Single-family Residential
West	Commercial Development

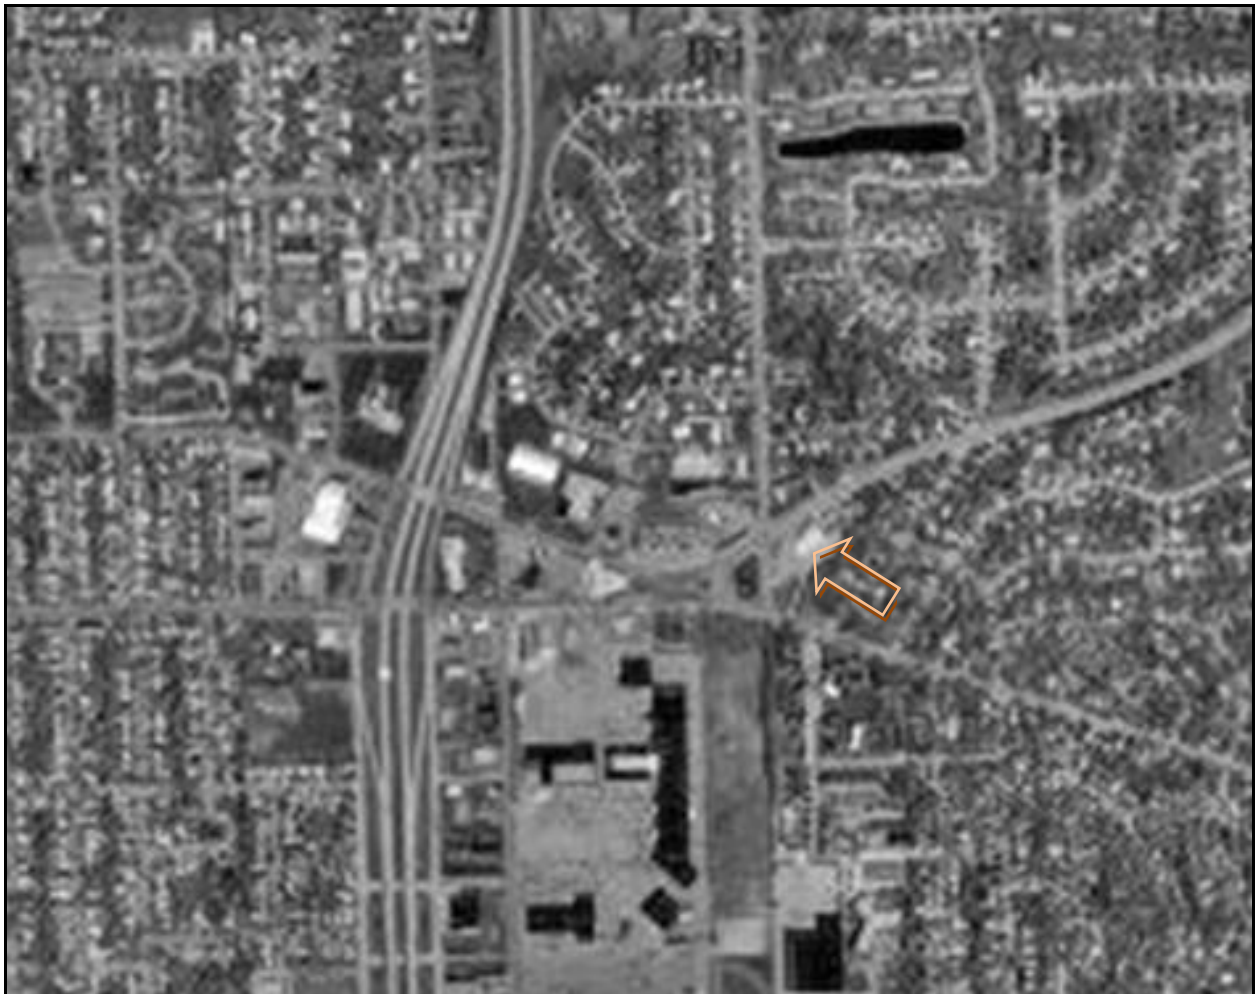
The 1994 (below) aerial photographs depict the following:

Property	Developed with Motel / Office Building
North	Single-family Residential
South	Single-family Residential
East	Single-family Residential
West	Commercial Development

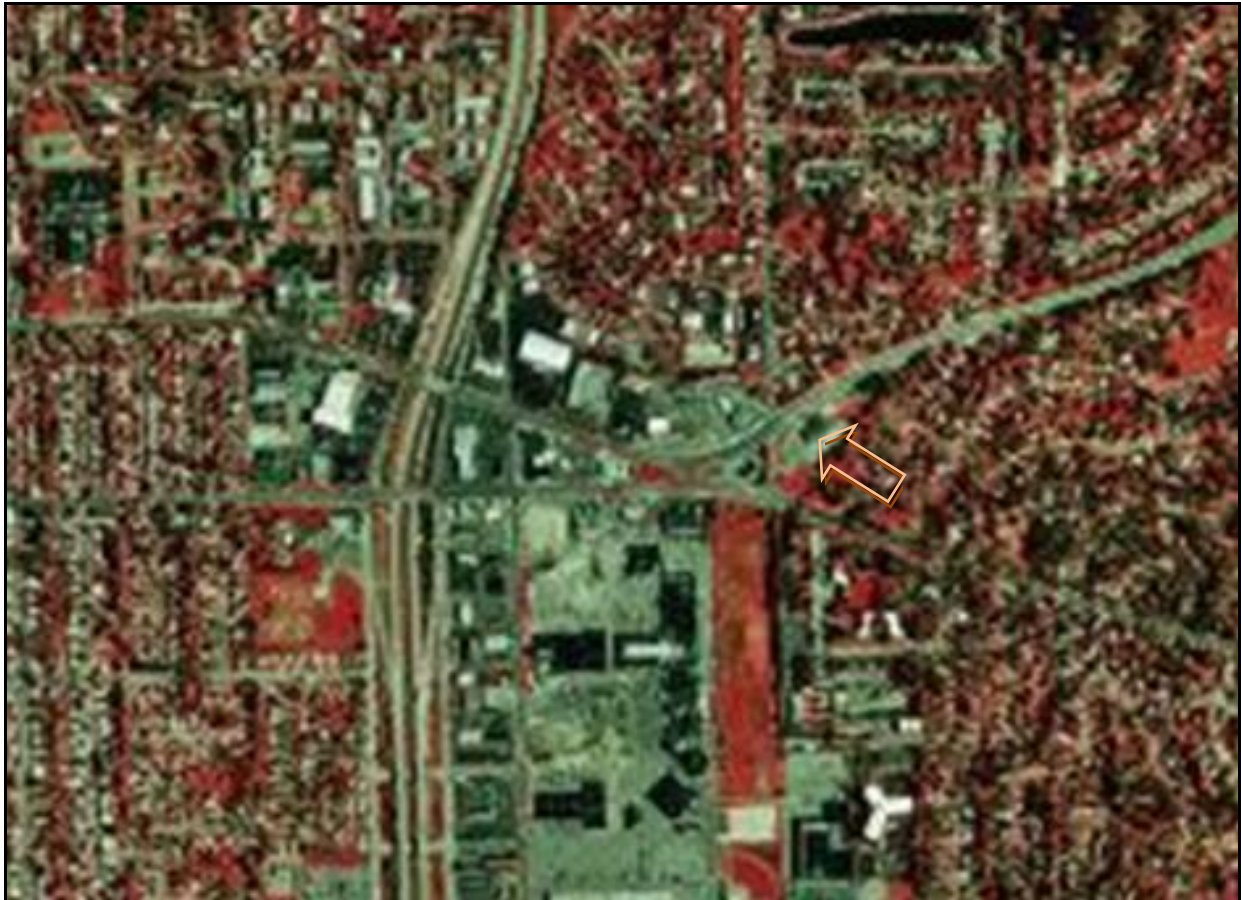
The 1998 (below) aerial photograph depicts the following:

Property	Developed with Motel/ Office Building
North	Single-family Residential
South	Single-family Residential
East	Single-family Residential
West	Commercial Development

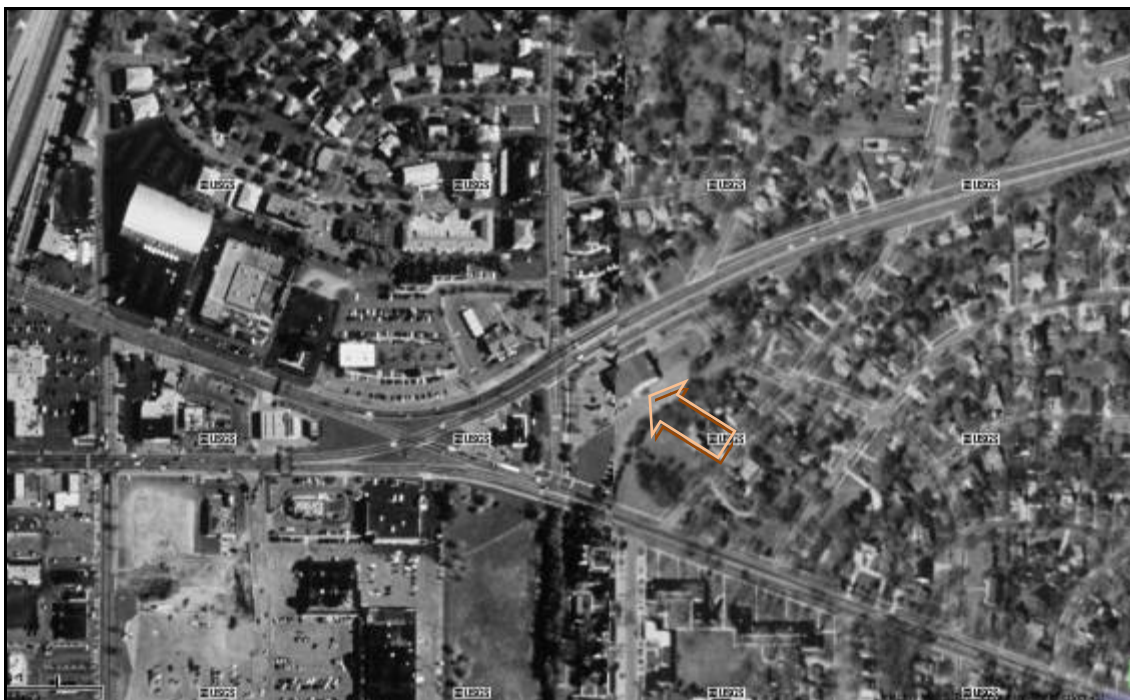
The 1999 (below) aerial photograph depicts the following:

Property	Developed with Motel / Office Building
North	Single-family Residential
South	Single-family Residential
East	Single-family Residential
West	Commercial Development

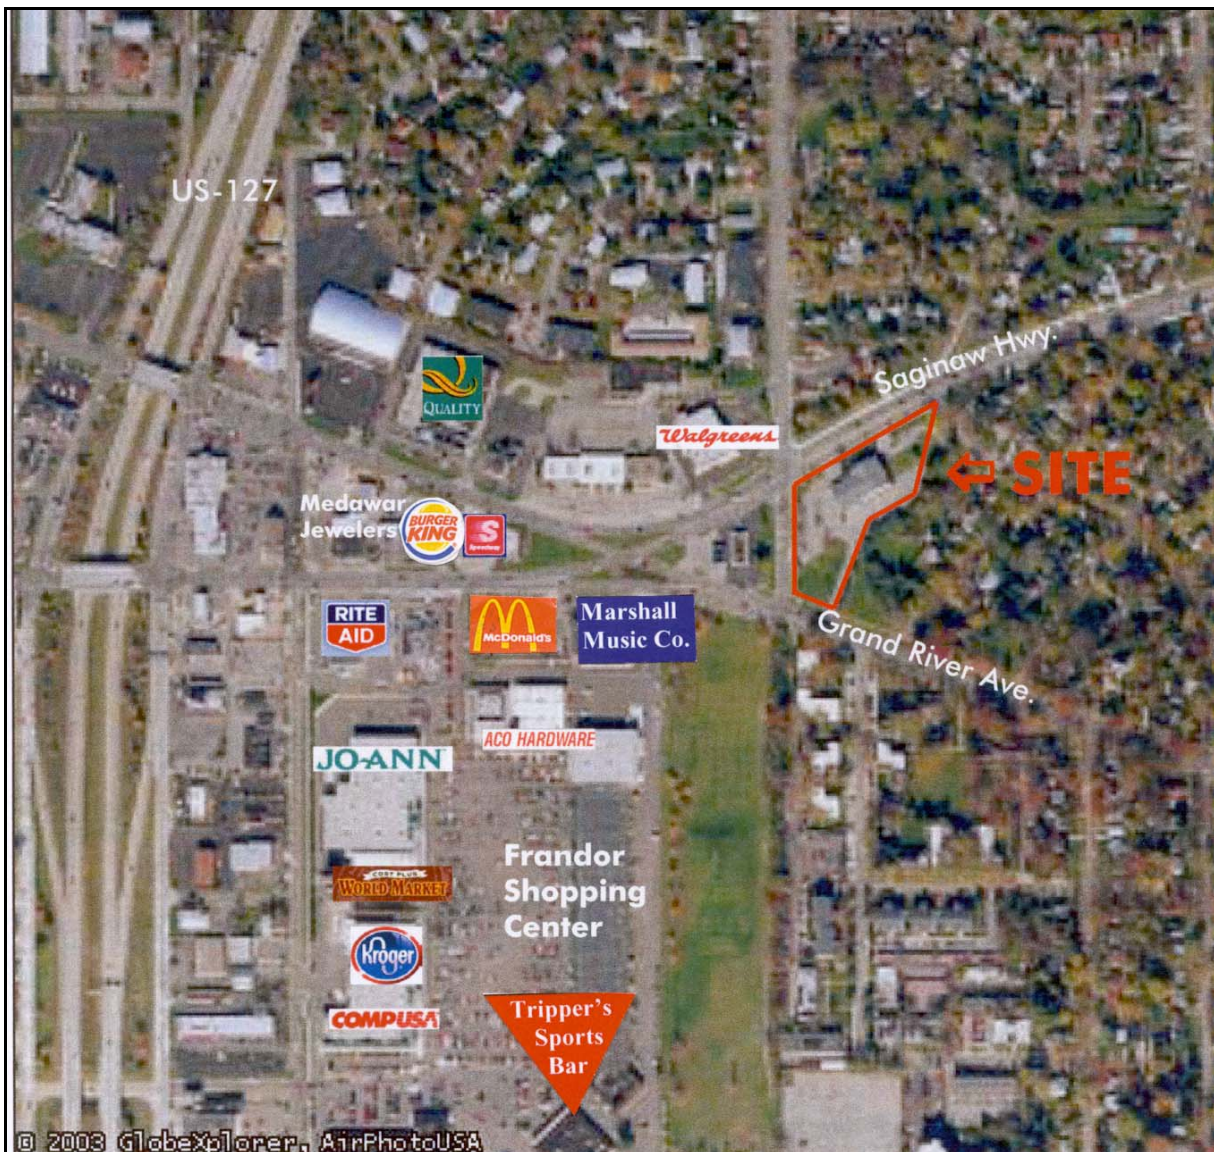
The 2003 (below) aerial photograph depicts the following:

Property	Developed with Motel / Office Building
North	Single-family Residential
South	Single-family Residential
East	Single-family Residential
West	Commercial Development

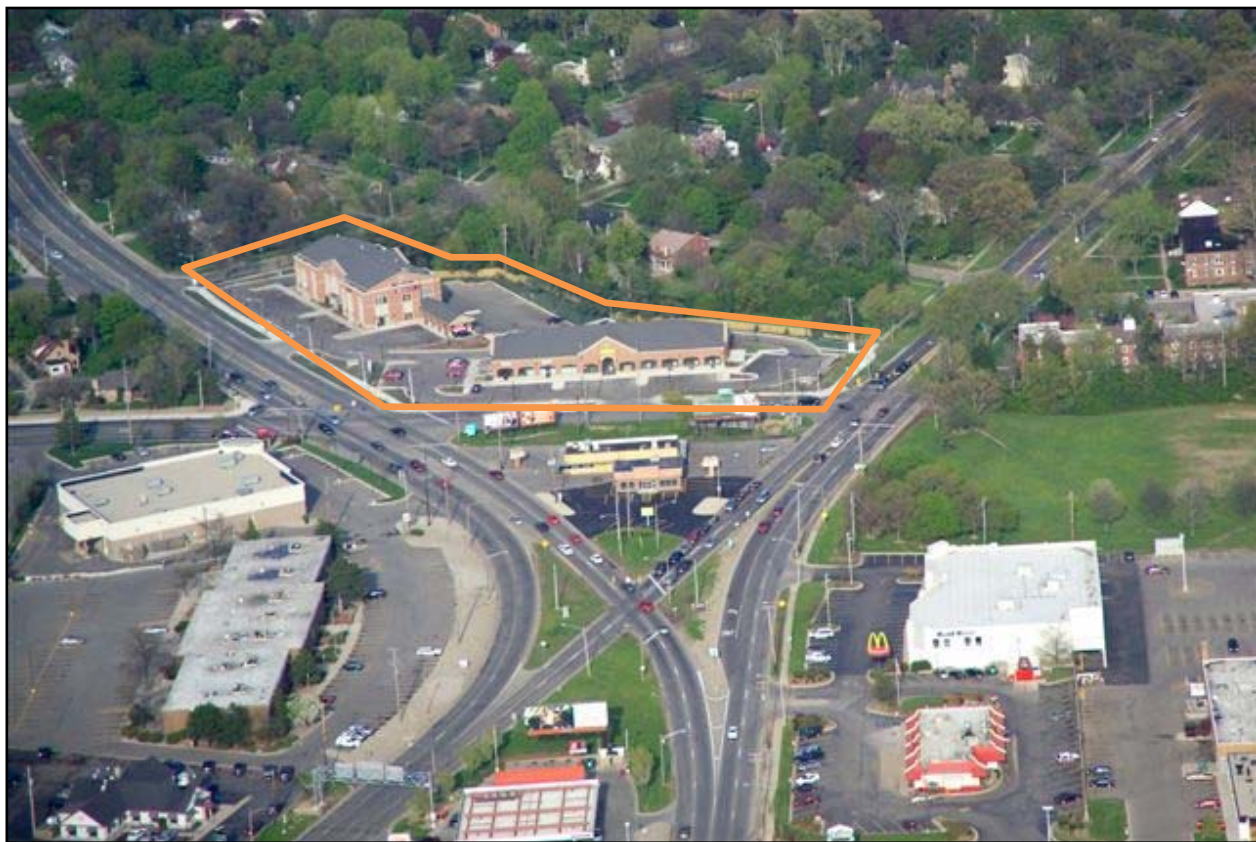
The 2004 (below – 3D south view) aerial photograph depicts the following:

Property	Developed with current retail/office buildings
North	Single-family Residential
South	Single-family Residential
East	Single-family Residential
West	Commercial Development

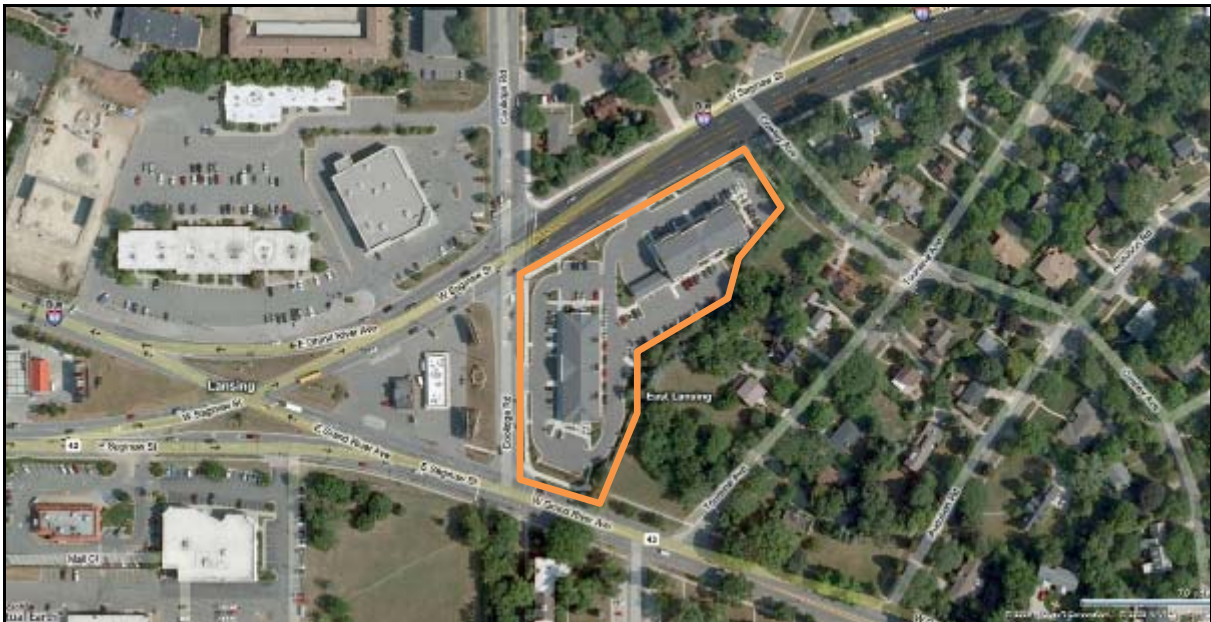
The 2008 (below) aerial photograph depicts the following:

Property	Developed with current retail/office buildings
North	Single-family Residential
South	Single-family Residential
East	Single-family Residential
West	Commercial Development

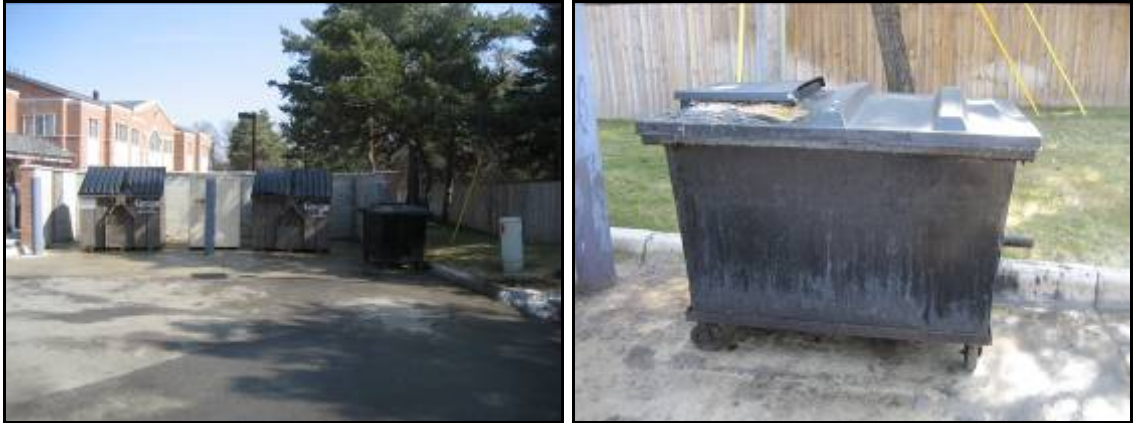
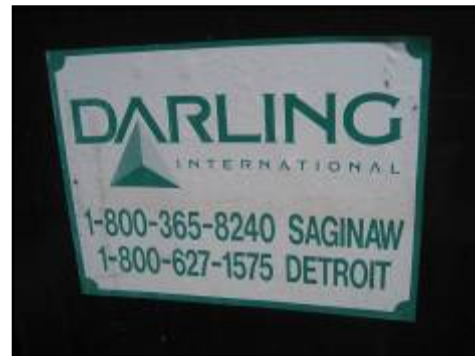
Solid waste is stored in trash dumpsters located about the Property. The waste is periodically removed by Granger Trash. In addition, Darling International a private vendor, is used to collect cooking oil produced by restaurant (Lou & Harry's), stored in a locked container by the waste disposal dumpsters. The storage and collection appeared to be adequate, and no significant concerns were identified.

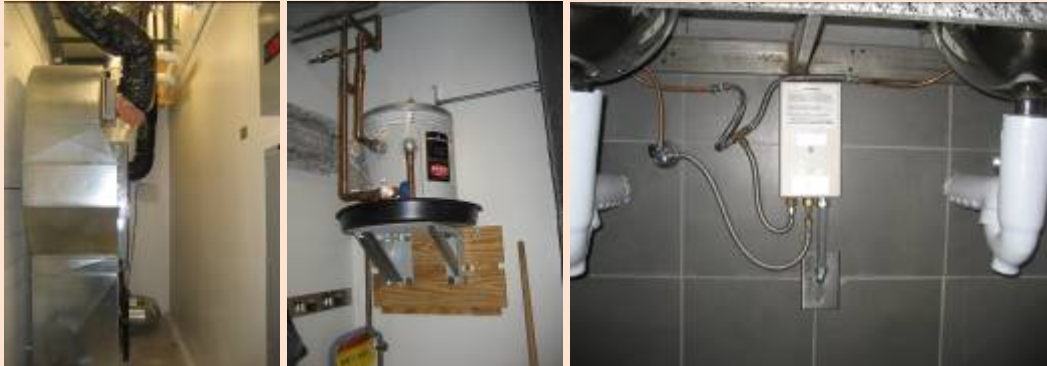
HVAC System and Water Heaters at the Property

REA also inspected representative common areas, office areas, both storage and warehouse areas. No concerns were noted or reported by Property management. Heating and cooling is provided to each unit by wall mounted HVAC system. Hot water is supplied by individual 15 gallon electric water heaters or individual electric under the sink systems. Leaks in tenant space should be repaired and instances of mold if any should be addressed aggressively.

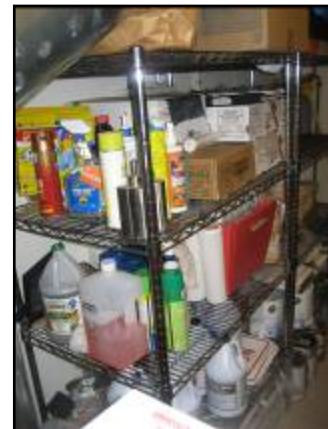
The Property does not store, generate or dispose of significant quantities of hazardous materials. Maintenance chemicals and paint were observed to be stored in a responsible manner in the maintenance shop. No significant concerns were identified.

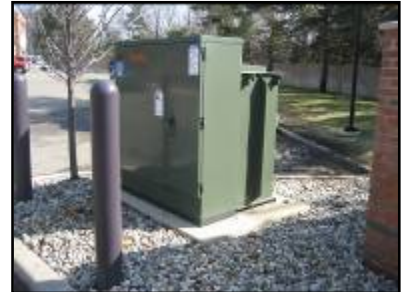
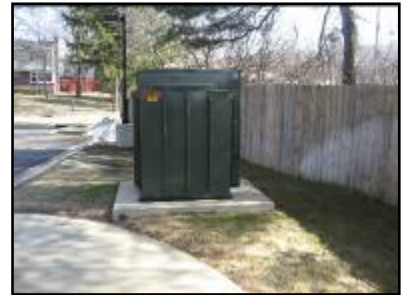
The Property is served with electricity via two pad-mounted, utility-owned transformers. The transformers did not have yellow and black warning stickers affixed to them. Such a sticker is required under federal law if the transformer is considered PCB-contaminated. The electrical equipment was observed to be in good condition with no evidence of leakage noted. Since the transformers are owned by Consumers Energy, the responsibility for the maintenance of the equipment, including any potential for contamination, belongs to Consumers Energy.

REA is of the opinion that the transformers identified on the Property do not represent significant environmental concerns to the Property. No other equipment was identified on the Property that is suspected of containing significant quantities of PCBs.

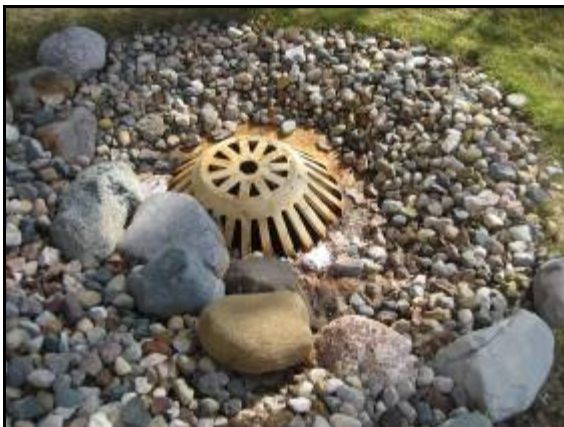
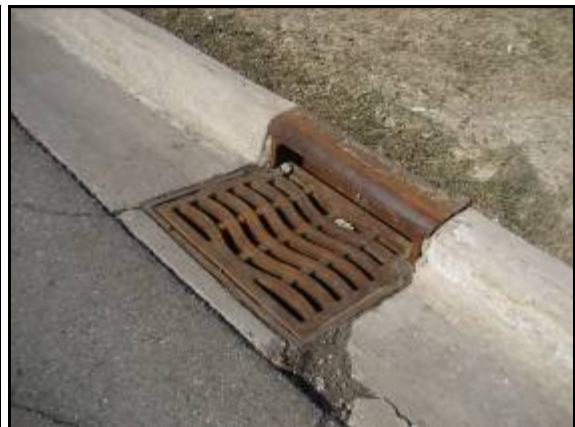
Storm water on the Property drains to various storm drainage inlets located in parking areas and lawns. Underground piping then directs storm water to the municipal storm water system. No evidence of pits, lagoons and sumps was noted at the Property, and no concerns were reported by property management.

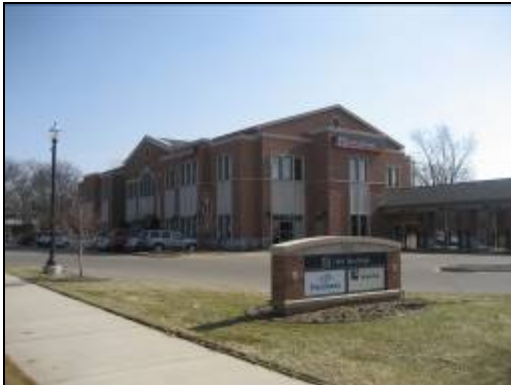
1. Typical tenant space at the Property

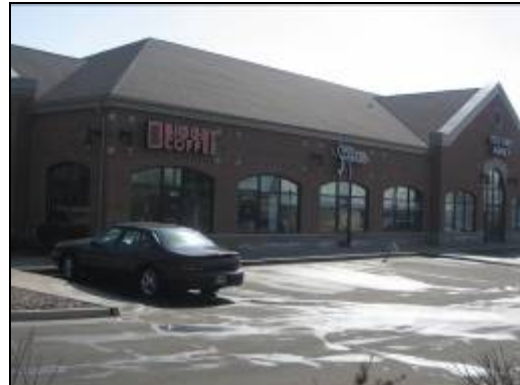
2. Typical tenant space at the Property

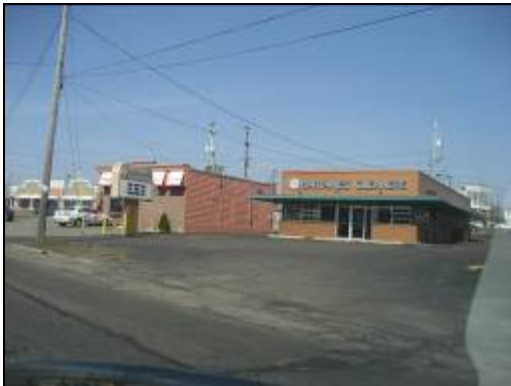
3. Adjacent Dry Cleaners to the west of the Property
