**One Financial Plaza  
120 South Sixth Street  
Minneapolis, Minnesota 55402**

***PHASE I ENVIRONMENTAL ASSESSMENT***

***REAL ESTATE ADVISORY, L.L.C.***  
**PROJECT 107759**

**August 4, 2010**

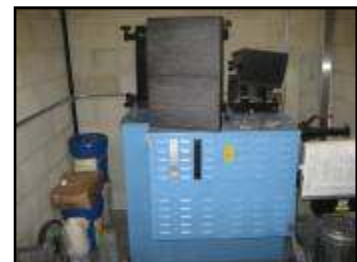
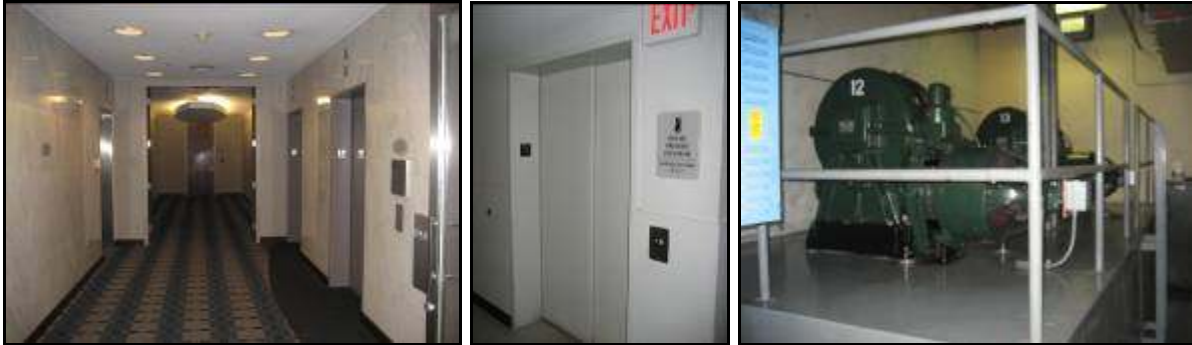
The Property features a one hydraulic and six traction (cable-driven) elevator systems. According to Property Manager at the time of REA's inspection the Department of Industrial Relations, Division of Occupational Safety and Health of State of Minnesota had recently inspected the elevators. No concerns were noted.

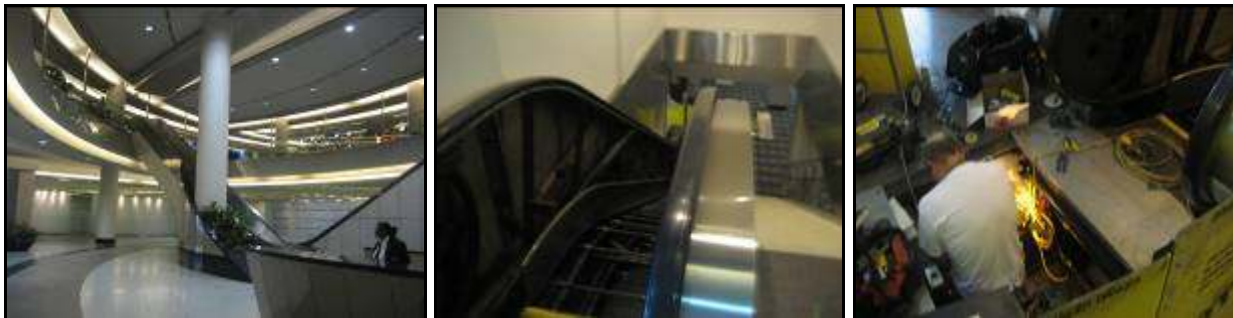
In addition 3 escalators are provided for tenants and customers convenience. At the time of REA's inspection one escalator was temporarily out of service for maintenance.

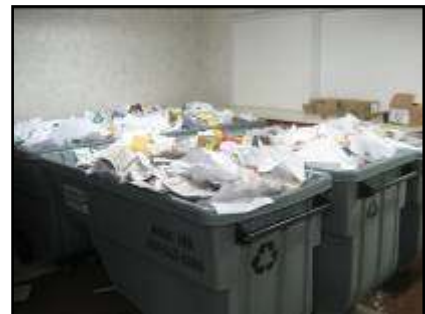
Solid waste is stored in trash dumpsters located about the Property and is reportedly periodically removed by Waste Management. The storage, handling and collection appeared to be adequate and no significant concerns noted.

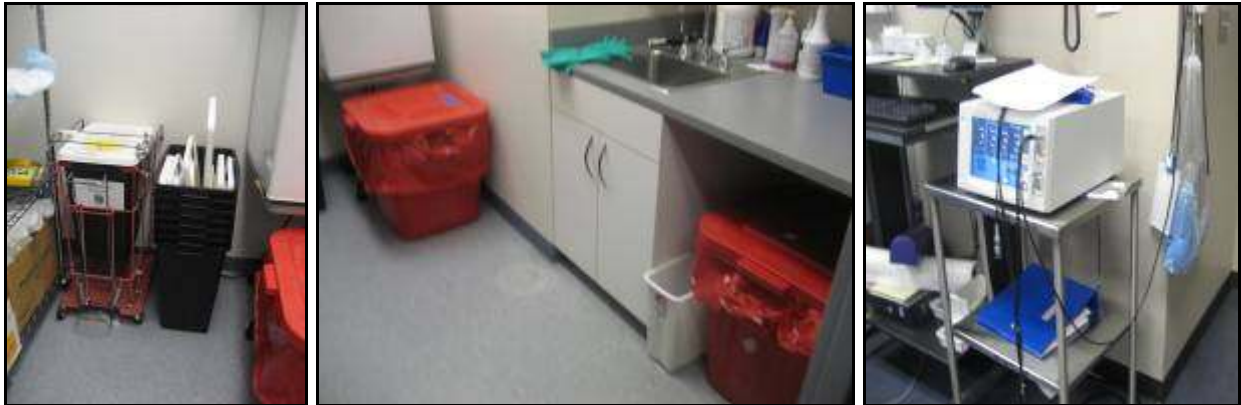
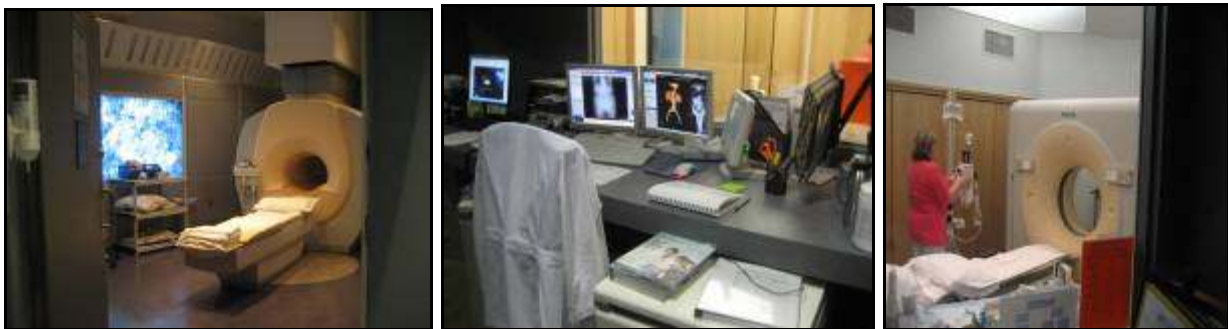
The Property does not store, use, generate or dispose of significant quantities of hazardous materials. In addition, a doctor's office (suite 155) was noted to be in excellent condition, with material safety data sheets (MSDS) in binders and medical/hazardous waste containers appropriately labeled. No significant concerns were identified.

In addition the doctor's office consists of CT/MRI, CAT scan, CARM / X-Ray used for fluoroscopy and ultrasound. No use of chemicals were noted / reported to for the X-Ray development. X-Rays are scanned and digitalized on disks.

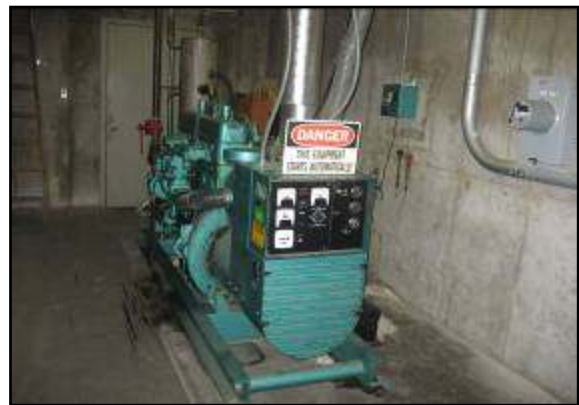
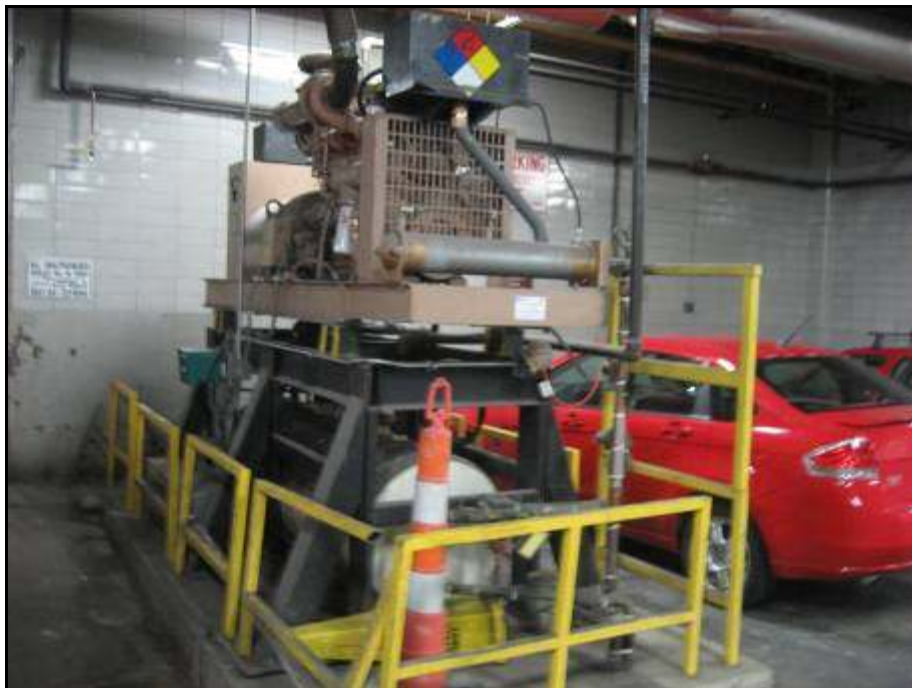
The Property is equipped with one diesel-powered emergency electric generator and one natural gas emergency electric generator. The diesel powered generator is manufactured by Kohler with rate capacity of 500 kVA. The generator is located on ground floor of the parking garage. A 500-gallon diesel fuel tank mounts beneath the generator. REA did not note any secondary containment in the form of double-walled steel or curbing. However, according to the Property manager, the fuel level is manually measured and the generator is auto programmed to run every month for self test. No concerns such as leakage was observed or reported.
