**Talon Hill Apartments
1640 Peregrine Vista Heights
Colorado Springs, Colorado 80921**

PROPERTY CONDITION ASSESSMENT

**REAL ESTATE ADVISORY, LLC
PROJECT # 075562**

April 26, 2007

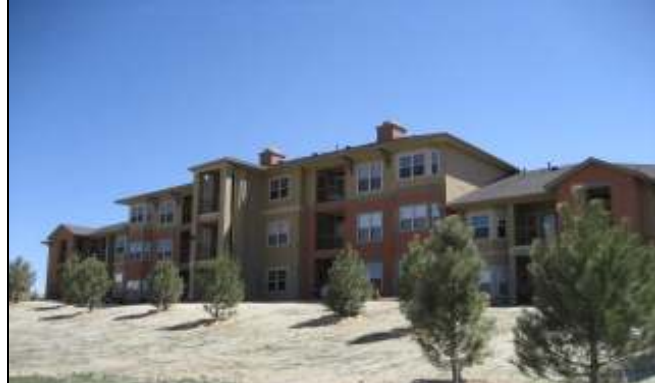
2. View of typical rear elevation apartment building.

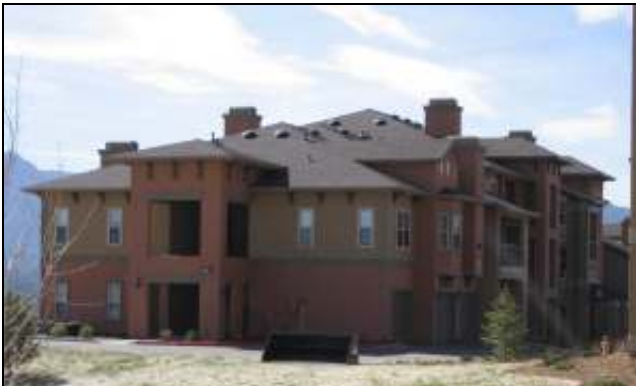
3. View of typical front/side elevation apartment building.

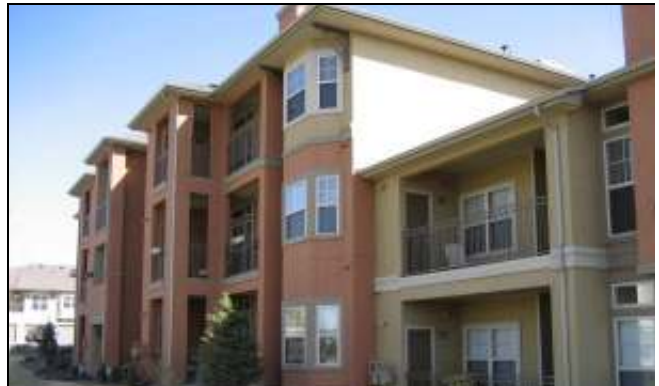
4. View of typical front/side elevation apartment building.

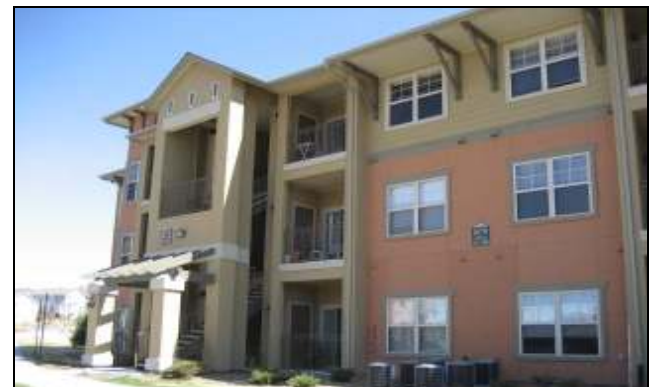
6. View of typical front/side elevation apartment building.

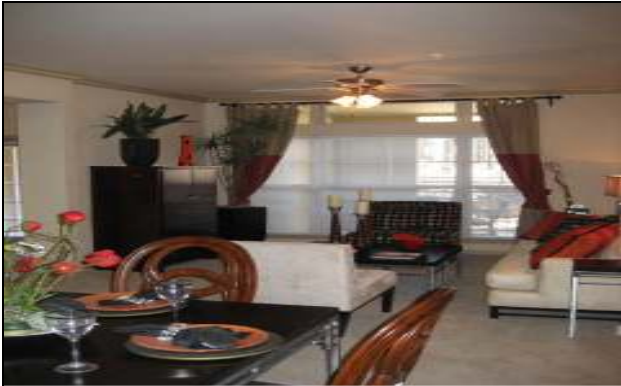
19. View of typical living room area.

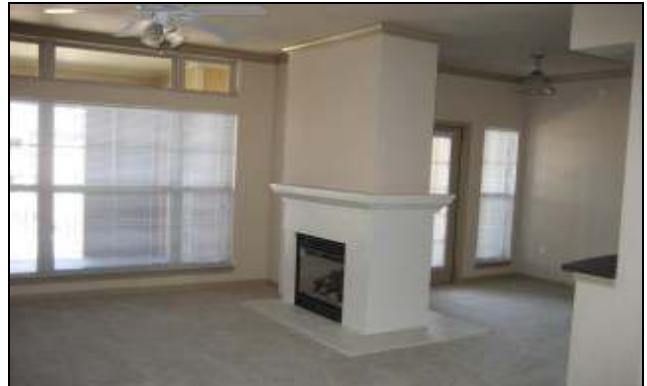
20. View of typical fireplace.

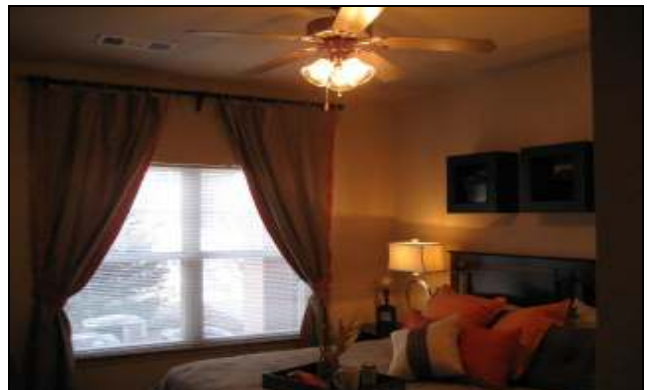
22. View of typical bedroom area.

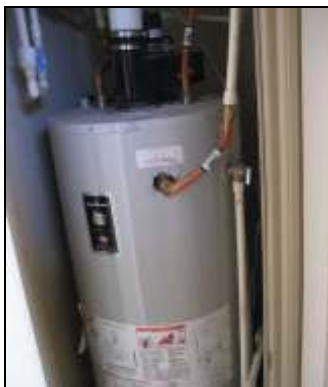
23. View of typical water heater in the water heater closet.
