**Mountain Lodge Apartments
2501 Mountain Lodge Circle
Vestavia Hills, Alabama 35216**
PROPERTY CONDITION ASSESSMENT

**REAL ESTATE ADVISORY, LLC
PROJECT # 075535**

April 12, 2007

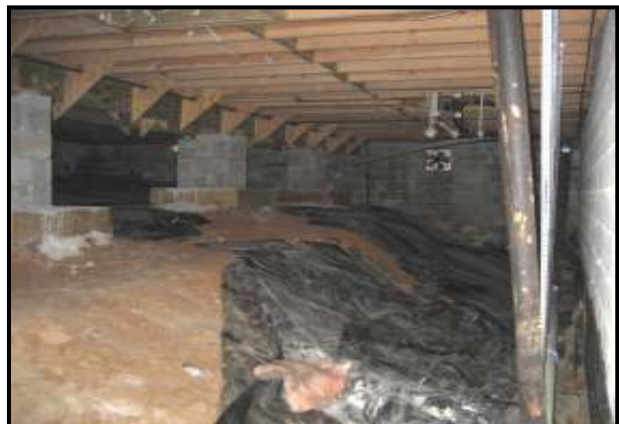
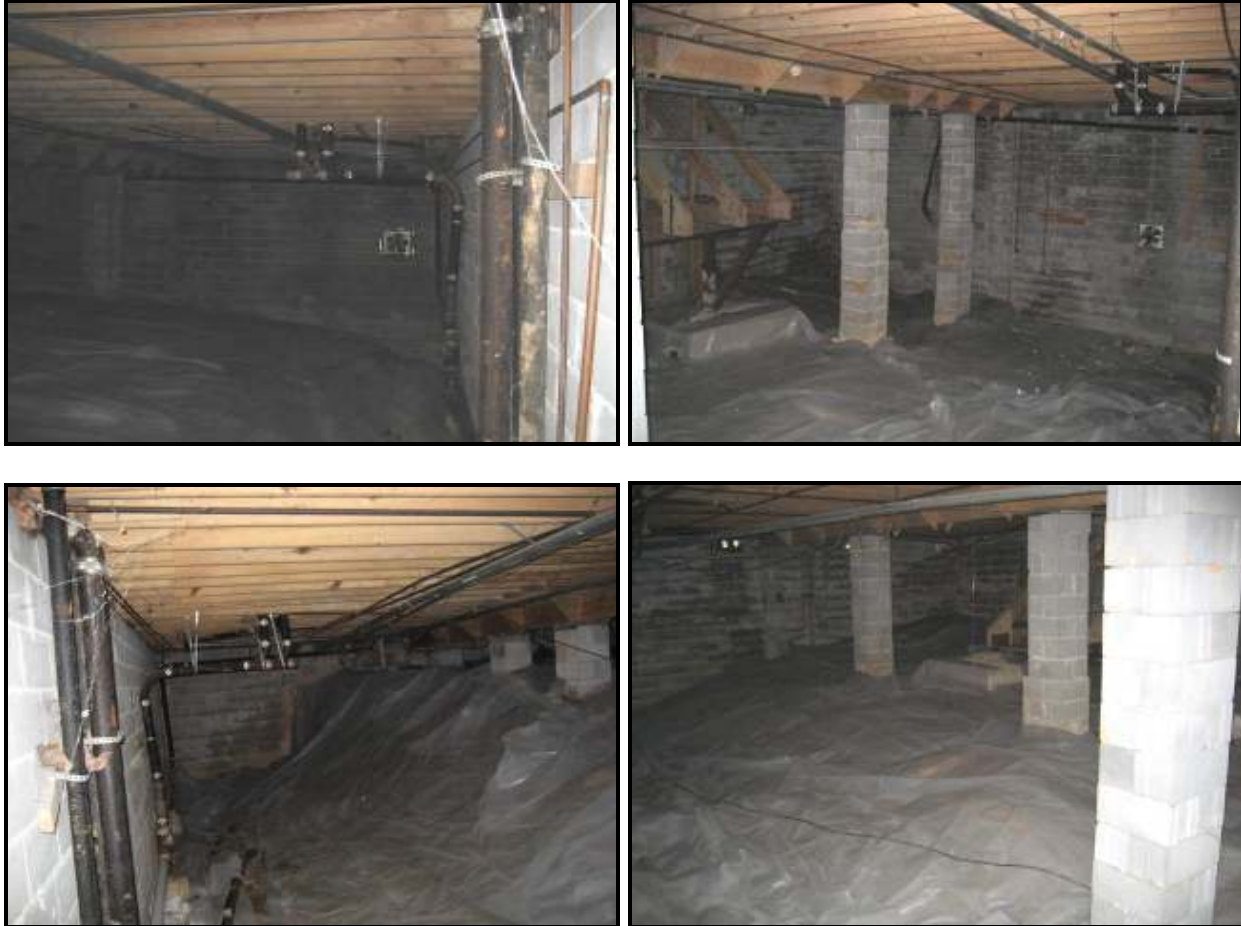
- Of the 37 buildings observed, five buildings (2563, 2565, 2567, 2569 and 2571) had visual evidence of foundation settlement at several units (cracked drywall, masonry, sloping floors). These buildings should be investigated further to determine the extent of settlement and recommend required repairs. REA recommends hiring a structural engineer to examine these buildings. Locations of units impacted by significant foundation settlement have been included in the Appendix 3 (List of apartments inspected).
- According to Ms. Jean Fryman, the Property Manager, there were no recent cracks reported (during her 2 year tenure).

REA noted both the 10-mil layer polyethylene sheeting and blower fans installed in the crawl spaces of Buildings. Foundation in the crawl spaces appeared to be reinforced concrete supporting conventional wood stud framing and wood joists supporting plywood and gypcrete flooring.

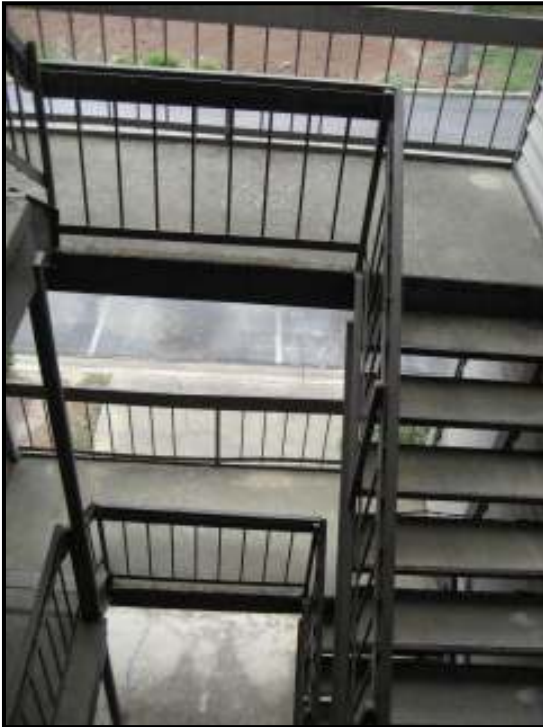
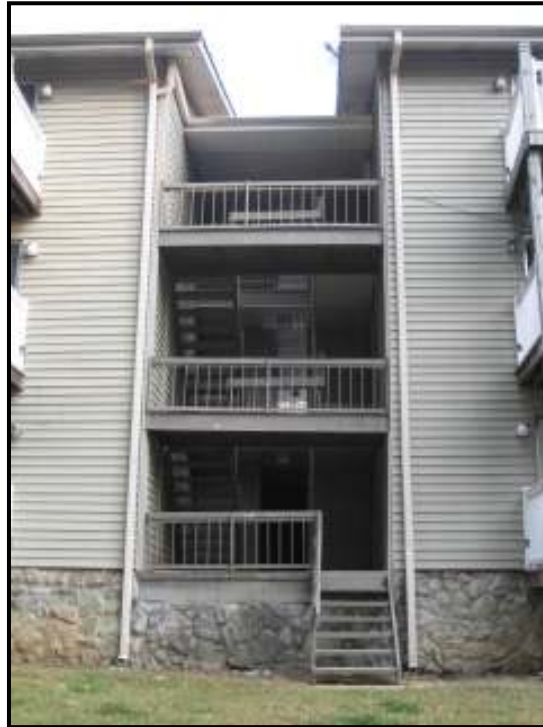
The breezeways/common entryway walks of Property mostly have steel-framed, concrete-filled metal pan landings at all levels. Building with crawl spaces has concrete slab landings at grade level. REA notice that the Property handrails (33 inches high) and pickets (5½ inches spacing) do not meet current building and life safety codes. This condition was also noted in the Terracon Property Condition Report, dated October 2003. REA recommends replacing or modifying the railings as a safety precaution. Estimated costs are included in the Immediate Needs Table.

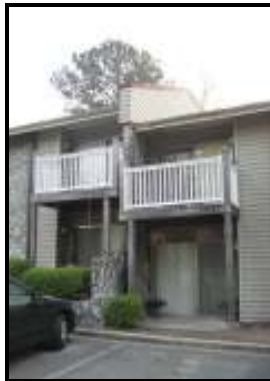
Stairways consist of metal stringers with concrete filled metal pan stairs treads with open risers and metal handrails. REA noted significant rusting on the metal undersides of the stairs treads.

REA has accounted for stairwell and landing repairs with costs included in the Immediate Needs Table. REA anticipates continued maintenance/repairs to the metal framed stairwells over the term with costs included in the Replacement Reserve Worksheet.

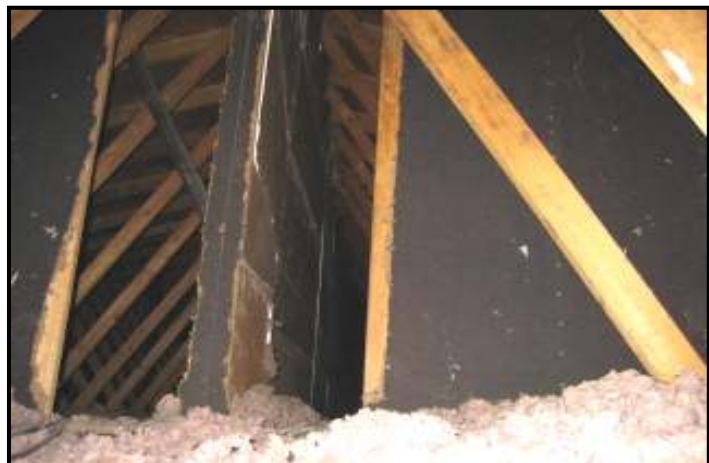
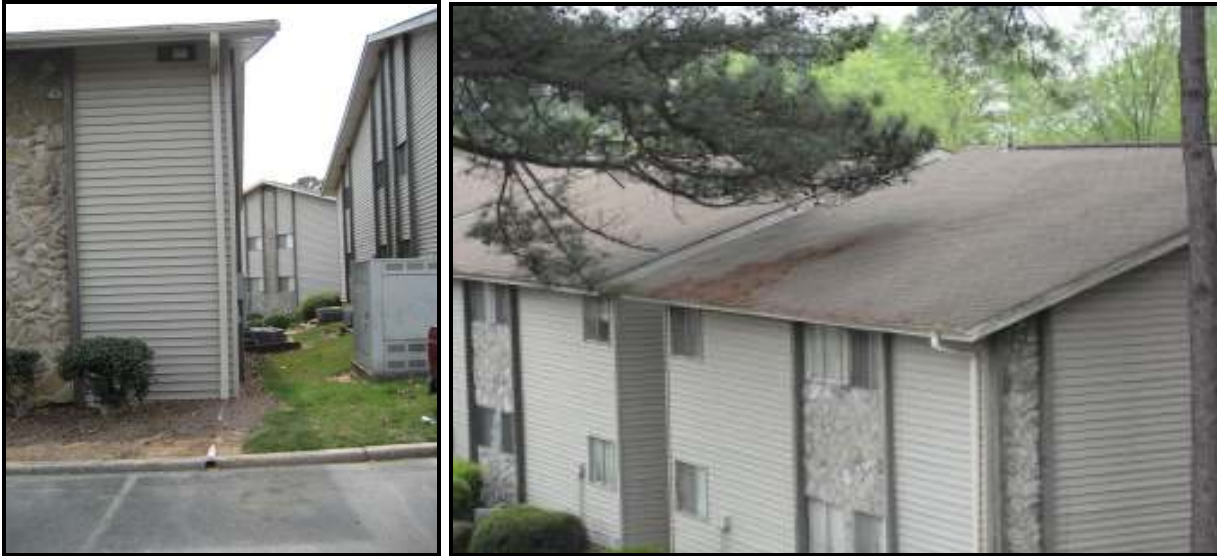
Aluminum gutter and downspout systems are present at horizontal roof lines. The gutters direct stormwater to downspouts, which in turn discharge mostly to underground or aboveground piping via sheet flow to concrete drainage channels that runs throughout the Property. REA observed areas of damaged (e.g., bent) gutters. REA recommends gutter deficiencies are to be corrected. In addition roof drainage appeared to be adequate; however, property maintenance reported that most gutters and downspouts were blocked by an accumulation of pine straw. REA recommends management to consider gutter protection system to reduce the continuing labor intensive problem of managing pine straw removal from the gutters and downspout system.

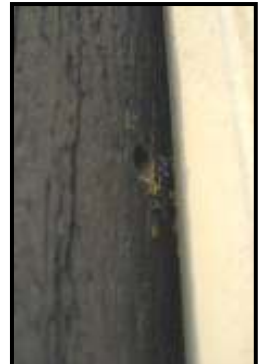
REA observed carpenter bees nesting in the wood beams and fascia boards. Carpenter bees nest in a wide range of softwoods and hardwoods, particularly if the wood is weathered. Carpenter bees create a nuisance by excavating round entry holes in wood (see bottom right picture) and depositing yellowish to brownish streaks of excrement and pollen on surfaces below entry holes. The bees can more easily tunnel through woods that are soft and that have a straight grain. In buildings, carpenter bees nest in bare wood near roof eaves and gables, fascia boards, porch ceilings, decks, railings, siding, shingles, shutters, and other weathered wood. These bees avoid wood that is well painted or covered with bark.

REA recommends the wood surfaces well painted with a polyurethane or oil-base paint to deter attack by carpenter bees. REA recommends periodic inspection on painted surfaces, to avoid coatings deterioration due to weathering. When dealing with carpenter bees, it is preferable to locate tunnel entrances during the daytime, but treat after dark on a cool evening when carpenter bees are less active. Wear protective clothing to avoid any stings during treatment.

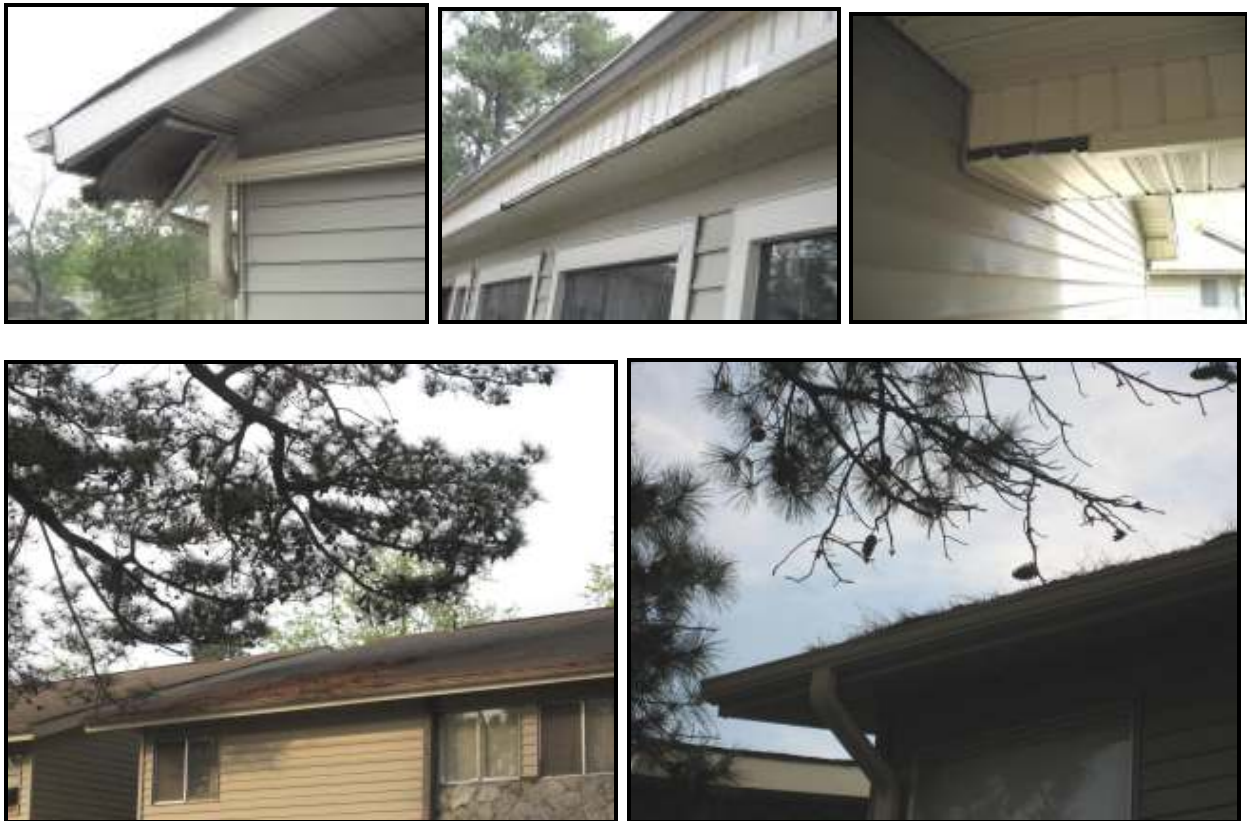
REA observed minor damaged fascias, soffits and gutters. REA has included repair costs in the Immediate Needs Table.

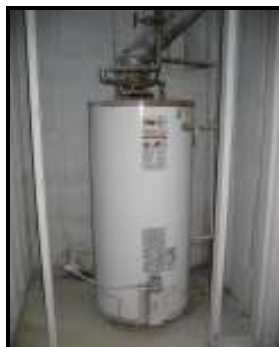
The clubhouse contains a fitness room, gathering area, laundry, storage and restrooms for tenant use. REA observed lower level of the clubhouse was gutted down to studs. Management reports that the lower level of the clubhouse had been closed down for some time. According to Mr. Tony Bird, Property maintenance supervisor, the water damage and mold growth was reportedly removed by a contractor. REA observed replacement ductwork installed in 2003, along with two and five ton HVAC units and 75 gallon water heater for the laundry room functioning at the time of inspection.

REA has attributed the cost to repair the lower level clubhouse in the Immediate Repair Needs. Except for the three units discussed above, interior finishes were noted to be in generally good condition. No other significant deficiencies were noted.

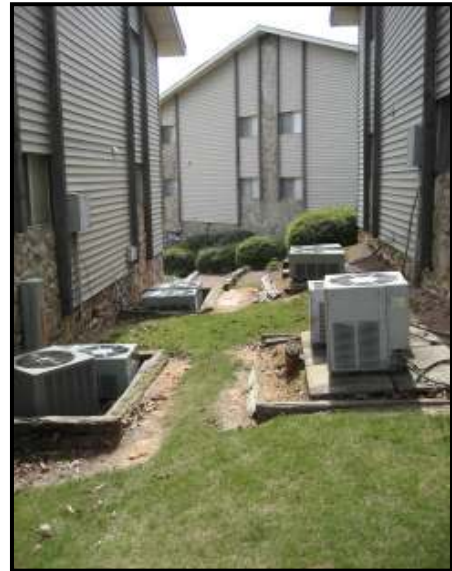
HVAC equipment was noted to be in fair to good to serviceable condition with no significant tenant complaints reported by Property management personnel. Heating and cooling in the units are provided by individual split system with electric coils in the air handling units and exterior pad-mounted condensing units. The ceiling-hung fan coil units are located in the laundry room within each apartment unit. Fan coil units are mostly original (i.e., approximately 34 years old in thirty three percent of the Property). These units are replaced as needed at a cost of \$400 per unit. The cooling capacity of the air conditioning units ranges from 2 to 2½ tons depending on the unit size. Air conditioning condensing units have been replaced on as-needed basis; REA noted approximately 1/3 of original condensing units remain. The remaining condensing units are in the range of 1-15 years old. The original condensing units and fan coil units observed were mostly in poor condition. REA anticipates some capital expenditures during the term for HVAC equipment replacement and costs are accounted for in the Replacement Reserve Worksheet.

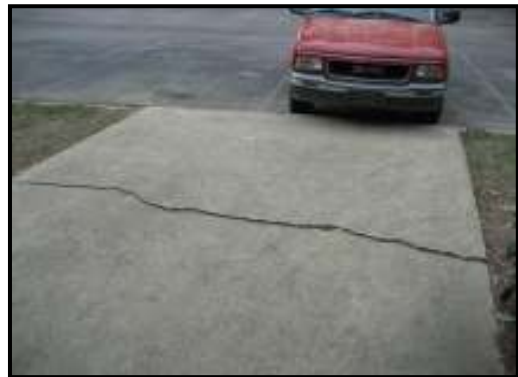
Concrete sidewalks and concrete steps are located throughout the Property. The sidewalks and steps are located at the ends of the buildings and provide access from the asphalt paved parking areas to the building exterior landings and stairwells. REA noted cracked and damaged sidewalk, landings at Building 2561. This is considered a trip hazard. Associated repair costs are included in the Immediate Needs Table.

8.	Repair concrete sectional breezeway entrance Building 2561 (Net)	\$1,000
9.	Paint wooden beams and wood surfaces with a polyurethane or oil-base paint to deter attack by carpenter bees. (Net)	\$5,000

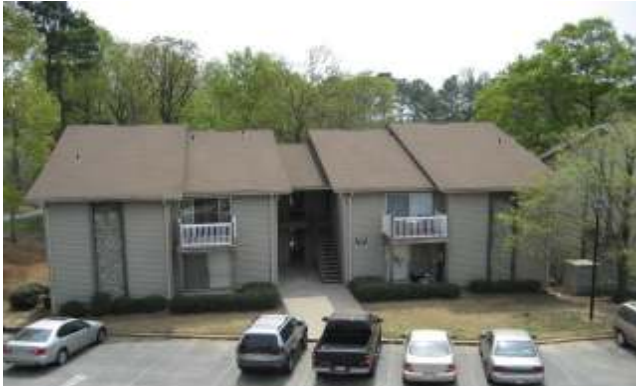
1. View of typical front elevation apartment building.

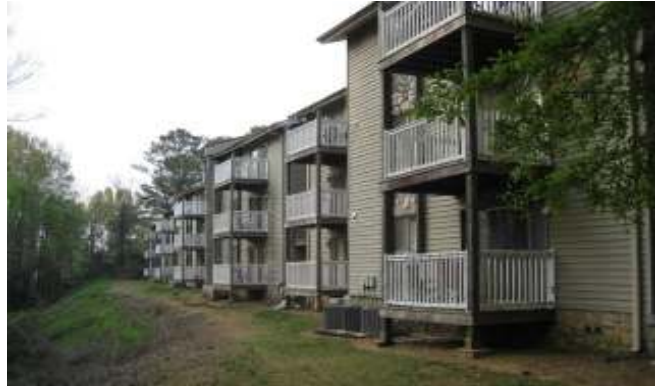
2. View of typical rear elevation apartment building.

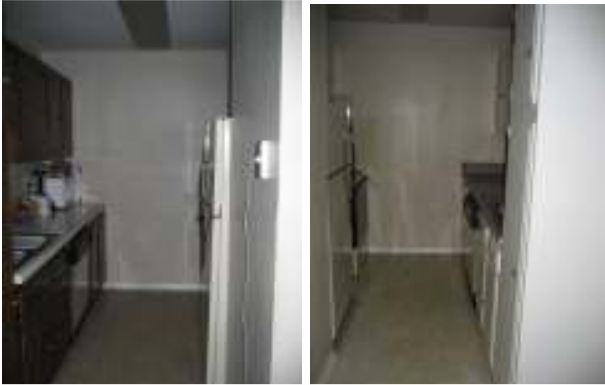
7. View of typical kitchen area.

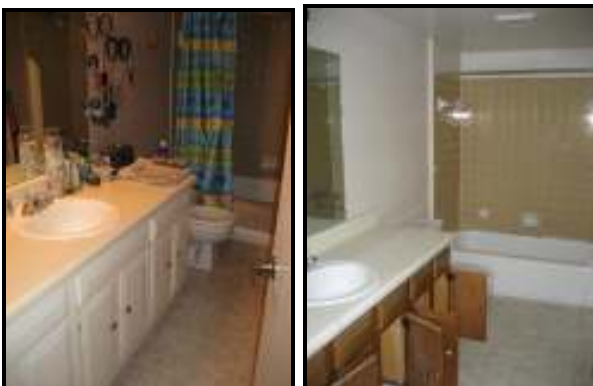
11. View of typical bathroom area.
