**Seabrook at Bear Brand  
56 Sea Terrace  
Dana Point, California 92629**

***PROPERTY CONDITION ASSESSMENT***

**REAL ESTATE ADVISORY, LLC  
PROJECT # 075663**

**July 19, 2007**

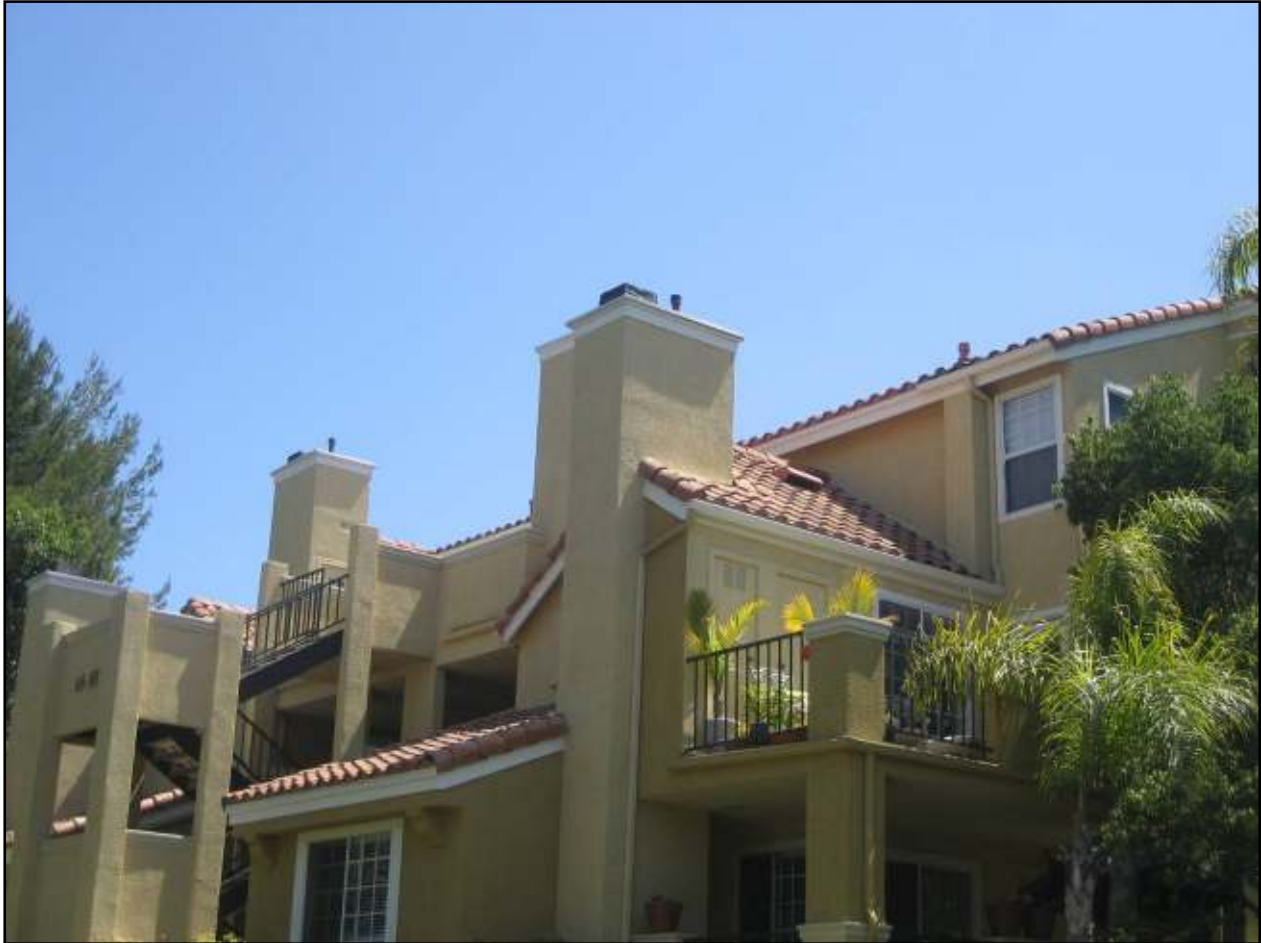
The balconies, patios, stairways, landings and hallways were noted to be in good condition. REA anticipates repainting and some floor finish replacement in the term. Associated costs are included in the Replacement Reserve Worksheet.

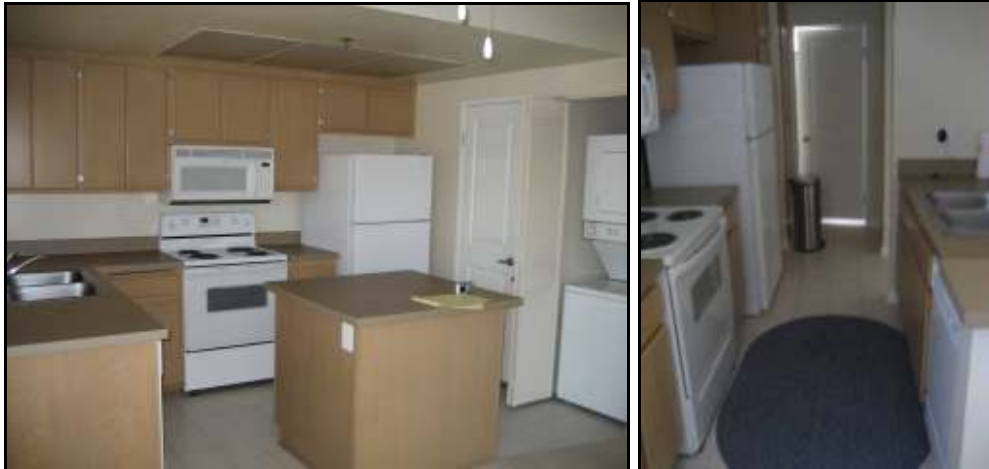
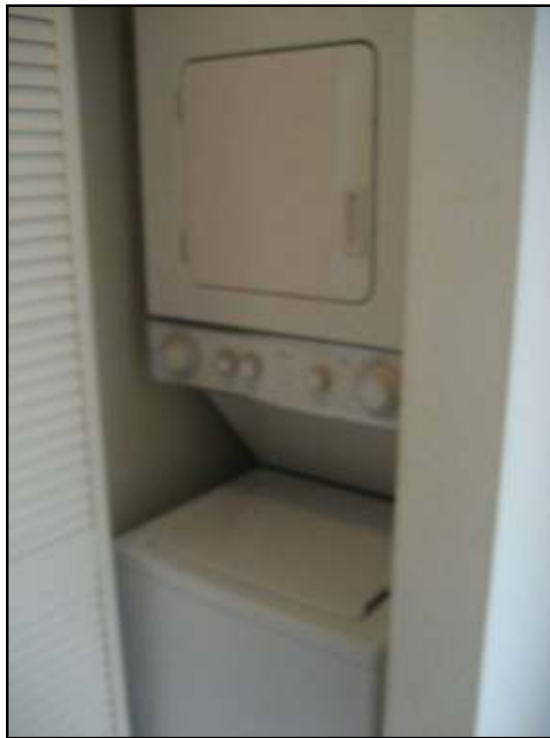
Interior finishes were noted to be in good condition (typical apartment kitchen and stackable washer and dryer shown at below).

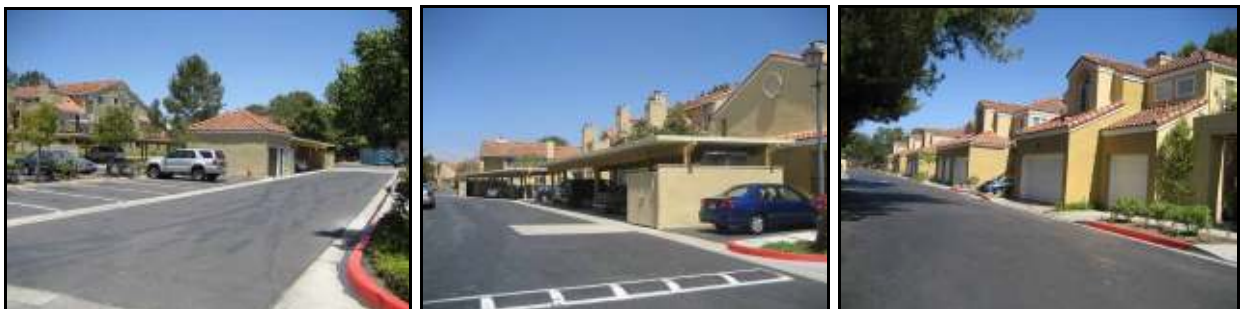
REA noted no deficiencies regarding driveways, parking lots or sidewalks (typical asphalt paving and curbing shown at right). During the term considered, REA anticipates periodic sealing and striping of the asphalt. No other significant capital expenditures are anticipated during the term. Costs for sealing and striping are accounted for in the Replacement Reserve Worksheet.

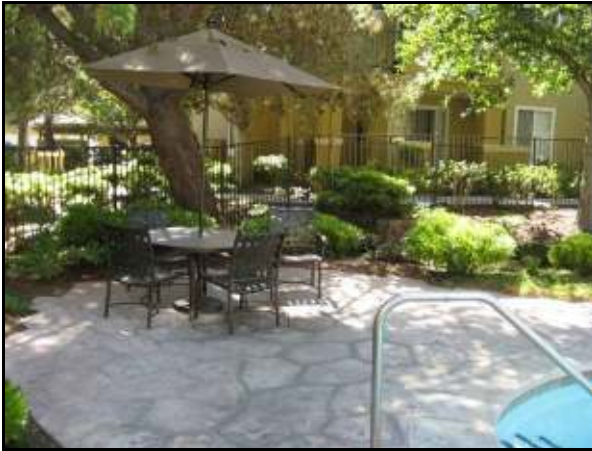
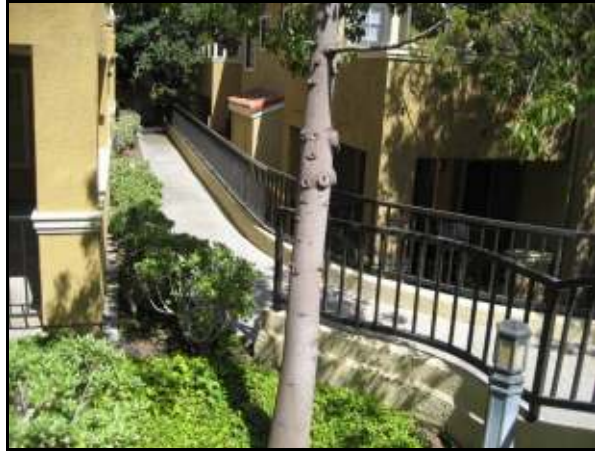
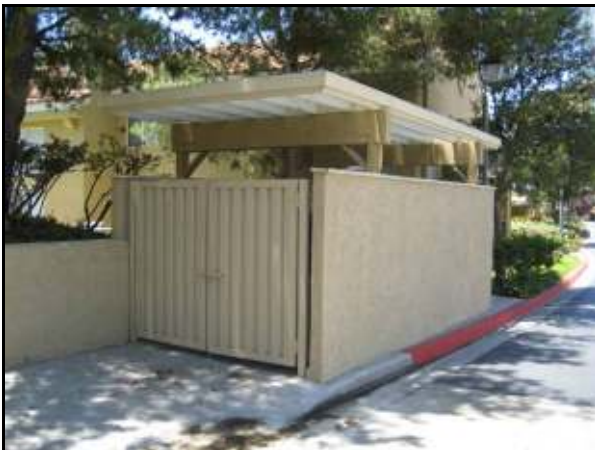
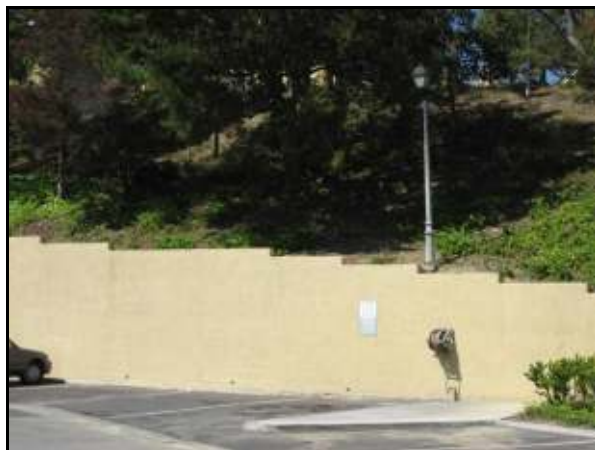
REA noted no significant deficiencies regarding fencing, and REA does not anticipate significant capital expenditures during the term regarding fencing.

- Approximately 5-foot tall painted metal grate fencing with metal posts surrounds the swimming pool.
- Approximately 4-foot tall painted metal grate fencing on metal posts is located atop most retaining walls to prevent falls.
- A 5-foot tall concrete with stucco finish fence around the solid waste areas.
- A 5-20 foot tall concrete with stucco finish fence around Property boundary.

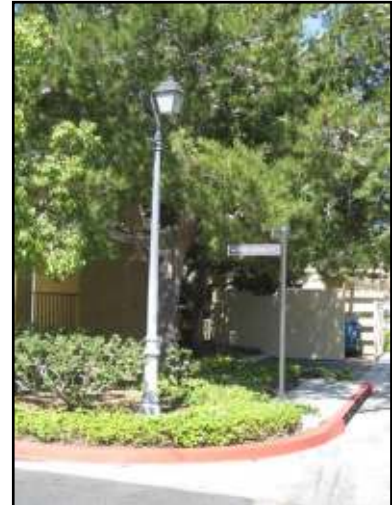
Exterior pole-mounted high intensity lighting was observed throughout the complex and was noted to be in good condition. Light fixtures are located atop the metal posts that surround the swimming pool. Ceiling-mounted incandescent or fluorescent lights are located in the building breezeways. Exterior lighting is operated by photo-cell sensors. The lighting appeared to be adequate, although the lights were not observed at night.

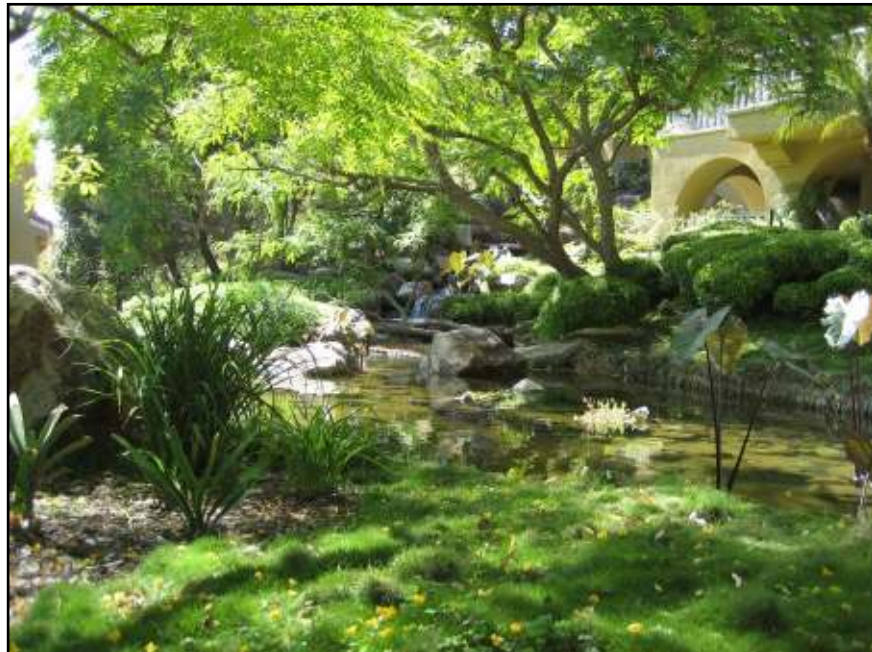
Landscaped common areas contain professionally maintained landscaping with a tranquil streams pond, waterscapes, fountains, and street frontages. The Property is landscaped with grass, ornamental trees, flowers and shrubs at building elevations throughout the Property. REA noted the landscaping at the Property to be in very good condition.

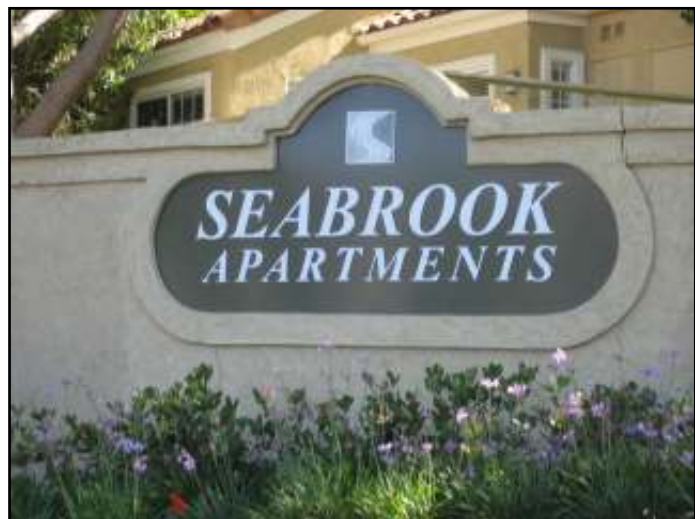
The Property is marked with a stucco and metal monument along Golden Lantern Drive. The building is also marked with lettering which identifies the Property address. Each apartment unit is marked with lettering mounted on the entry door. Signage was clearly visible and observed to be in good condition. No significant deficiencies were noted.

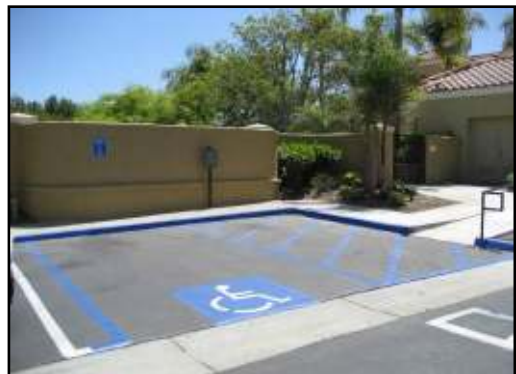
Less than 25 parking spaces are provided at the leasing office/clubhouse. One space is properly designated with pole-mounted signs and pavement markings. In addition, designated handicapped parking spaces were noted throughout the Property.

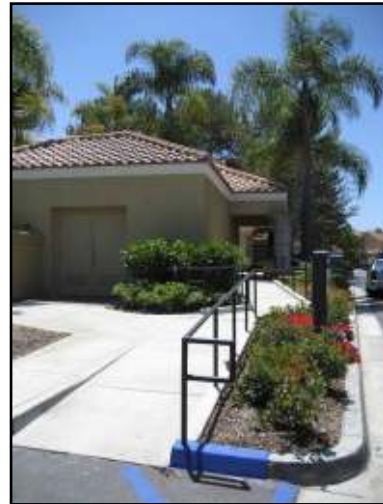
Accessible exterior routes were noted leading to the leasing office/clubhouse, swimming pool, mail facility and apartment building breezeways.

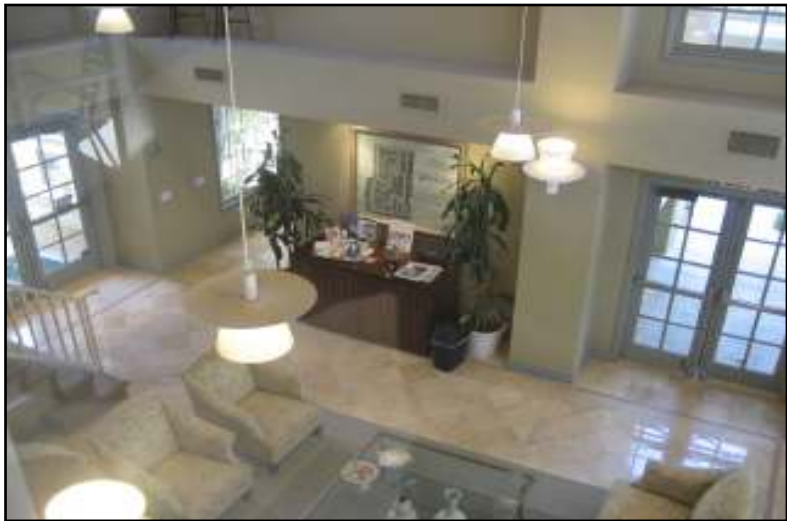
The leasing office/clubhouse is configured to accommodate persons with disabilities. Walk-in level apartments appear to be accessible per Fair Housing Act requirements.

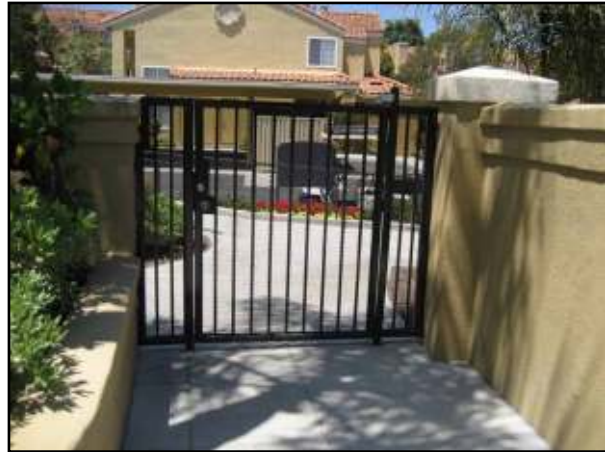
The swimming pool area is accessible from a parking lot near the leasing office/clubhouse. The pool has two sets of steps with rails and one wall-mounted ladder to allow access to the pool interior.

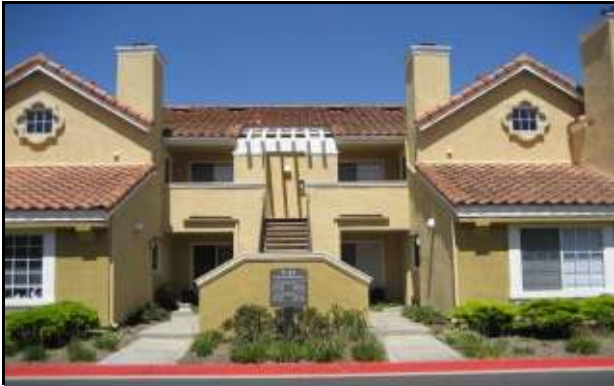
1. View of typical front elevation apartment building.

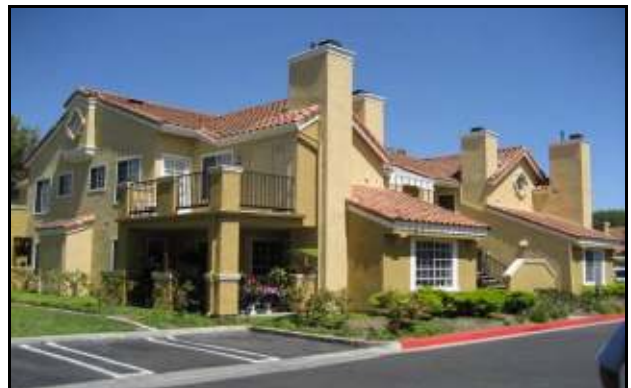
4. View of typical front/side elevation apartment building.

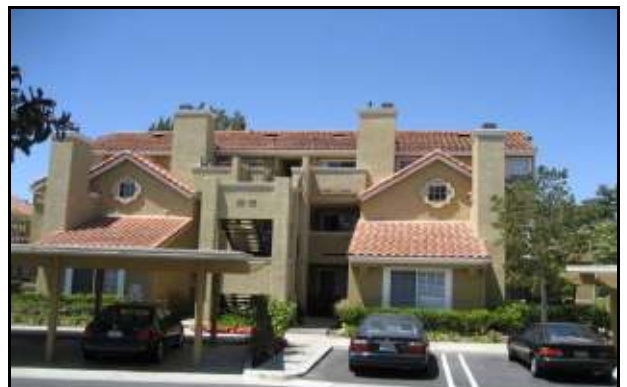
6. View of typical front/side elevation apartment building.

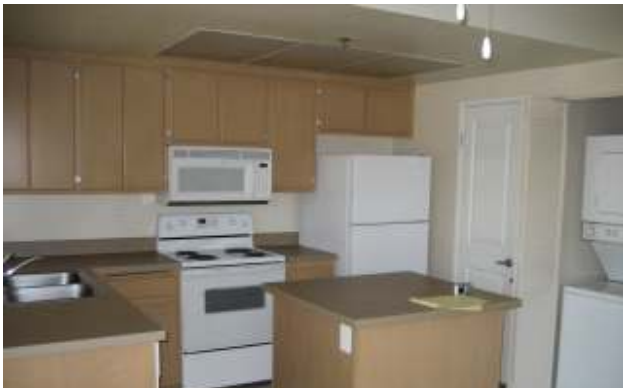
7. View of typical kitchen area.

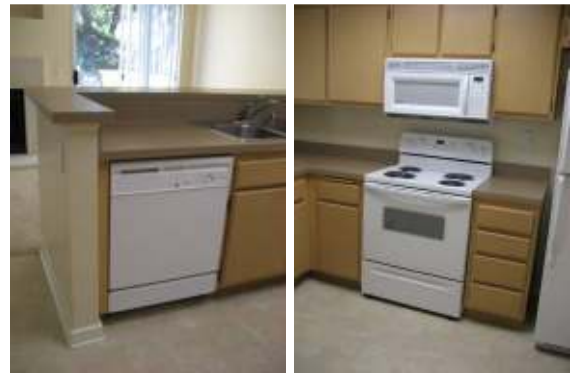
10. View of typical kitchen area.

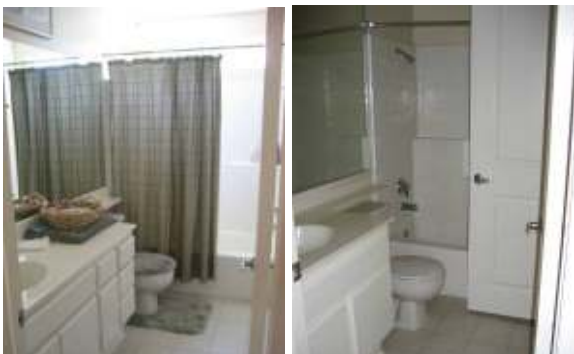
11. View of typical bathroom area.

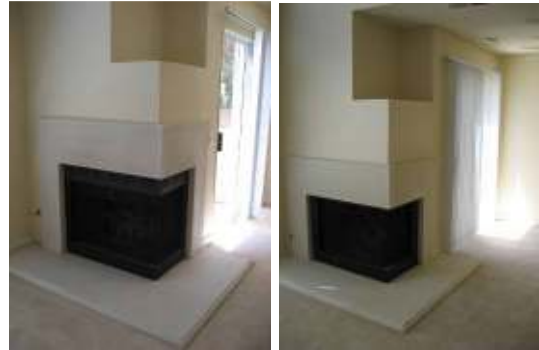
19. View of typical living room area.
