**Villas at Huffmeister Apartments
15050 Copper Grove Boulevard
Houston, Texas 77095**

PROPERTY CONDITION ASSESSMENT

**REAL ESTATE ADVISORY
PROJECT # 096751**

February 11, 2009

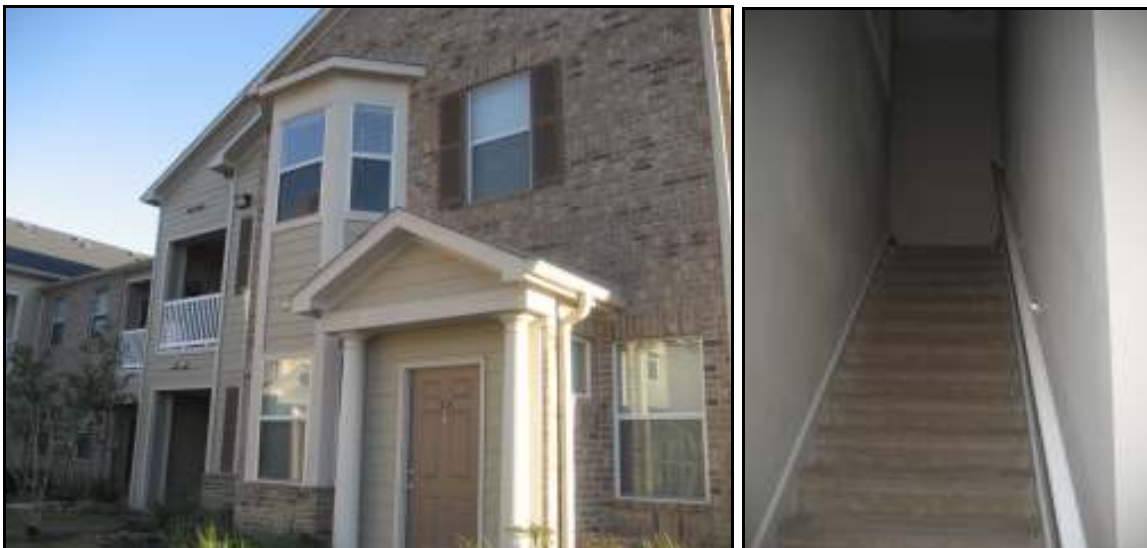
REA did not observe significant damage or deficiencies pertaining to stairways or landings. All apartments feature first floor individual entrances. Second floor apartments feature individual wooden stair cases with carpeted treads and risers. Wooden handrails are present at all stair locations.

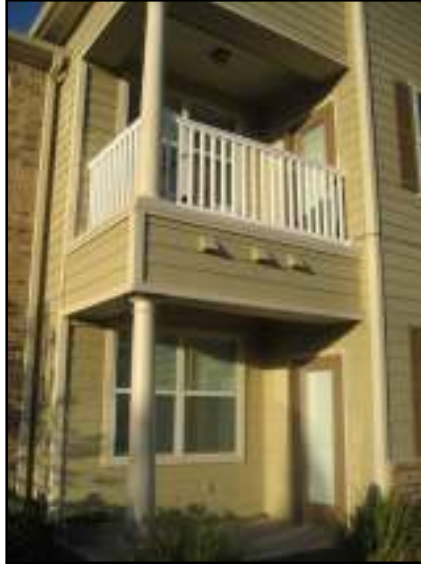
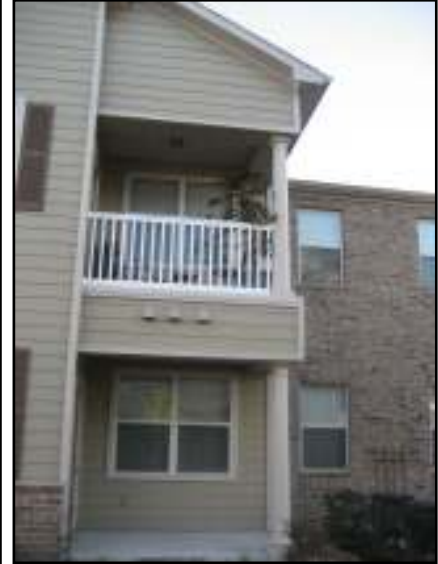
Apartment units feature private patios with PVC railing at upper level units. Ground floor patios do not feature railings or enclosures. Patios are accessed via swinging hollow-metal doors and are constructed with wood framing and lightweight concrete at upper levels.

Painted gypsum soffits are present beneath roof overhangs, upper level entrance patios, and balconies. The soffits

were observed to be in good condition. REA anticipates normal painting of exterior components over the term. Costs have been included in the Reserve Table.

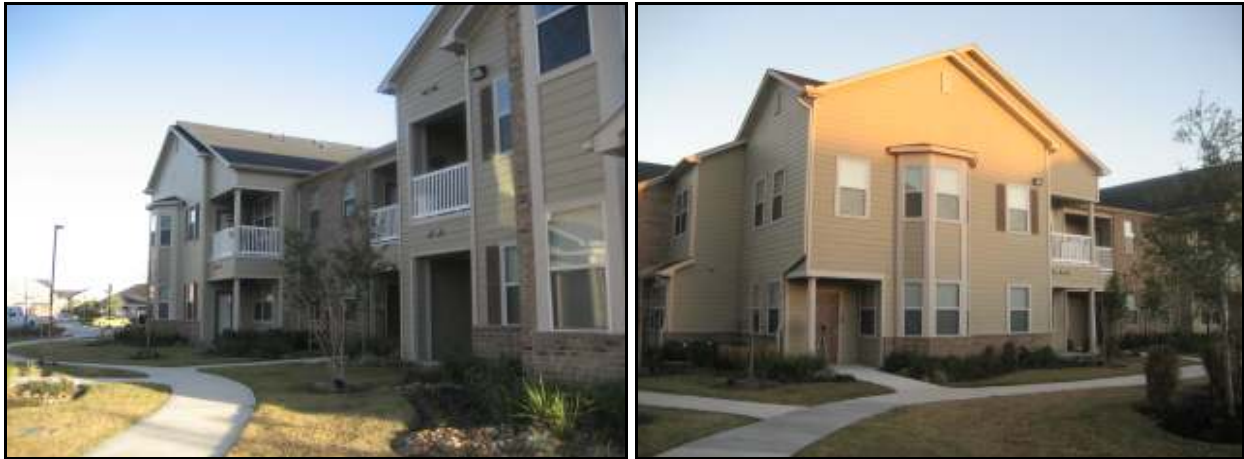
Facades were noted to be in generally good condition throughout the Property. REA does not anticipate significant expenditures for facade maintenance over the term of this assessment. Building exteriors are primarily brick veneer with areas of fiber-cement siding and wood trim. Buildings feature fiber-cement roof eaves, fascia, and gypsum patio soffits and were in good condition. It should be noted that no reports or evidence of water infiltration was noted at the apartment interiors. Costs for normal repaint of building exteriors over the term are included in the Reserve Table.

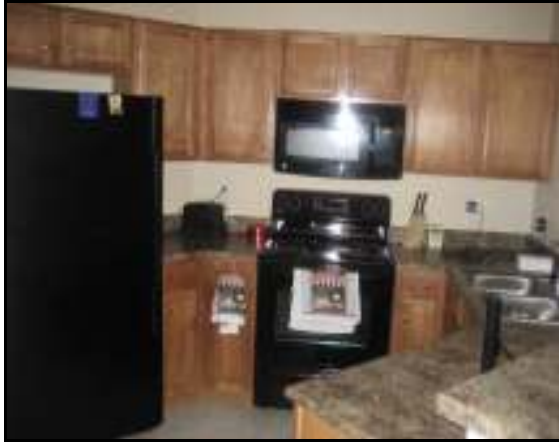
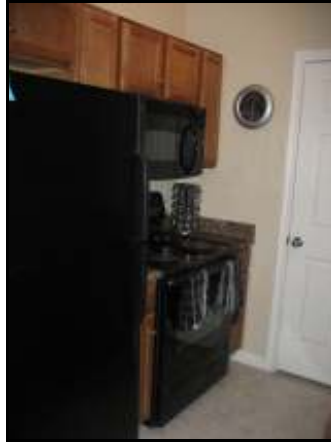
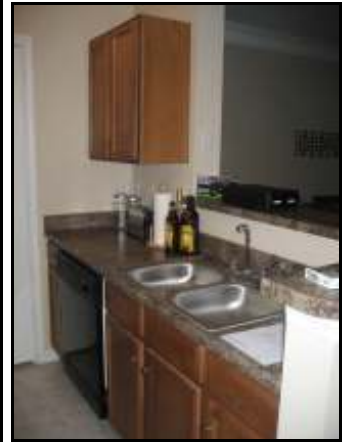
Kitchens at the Property were noted to be in generally good condition. Some countertop refinishing and cabinet door and drawer front replacement will likely be required during the term considered. However, the costs are considered to be part of routine apartment turnover, and no costs have been accounted for in the Replacement Reserve Worksheet regarding cabinet doors and/or drawer fronts.

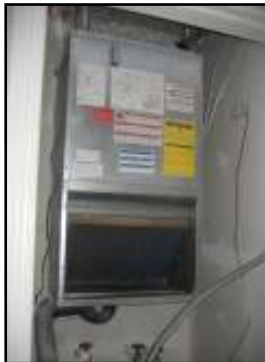
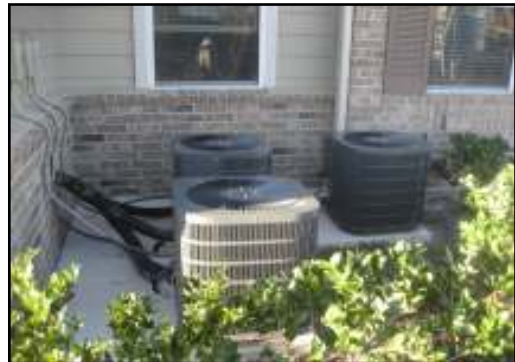
HVAC equipment was noted to be in good condition with no significant tenant complaints reported by property management or maintenance staff. According to property management, equipment will be replaced as needed.

Costs for replacing some HVAC equipment during the 12-year term are accounted for in the Replacement Reserve Worksheet.

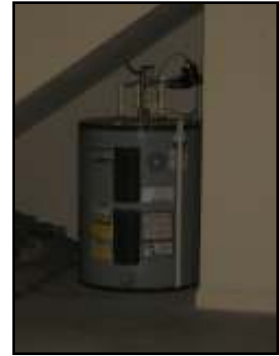
REA noted the water heaters to be in good working condition.

REA anticipates periodic replacement of the individual water heaters over the term of the loan. Costs are included in the Replacement Reserve Worksheet.

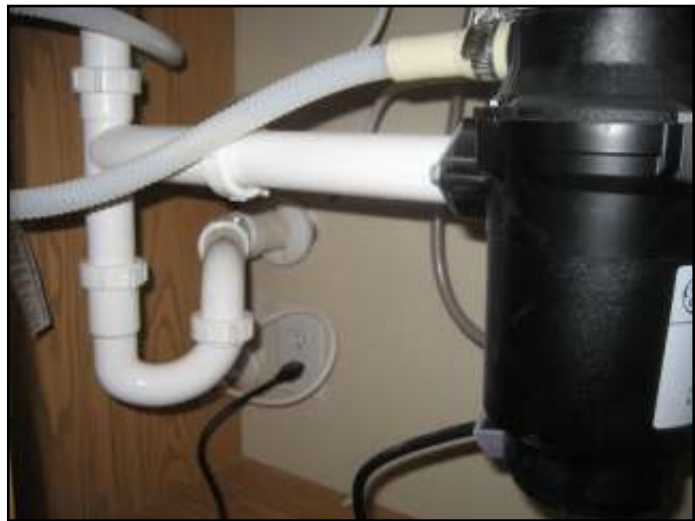
REA noted no significant deficiencies regarding plumbing at the Property, and no significant capital expenditures are anticipated during the term.

No polybutylene piping was observed, and none was reported to be present by property management.

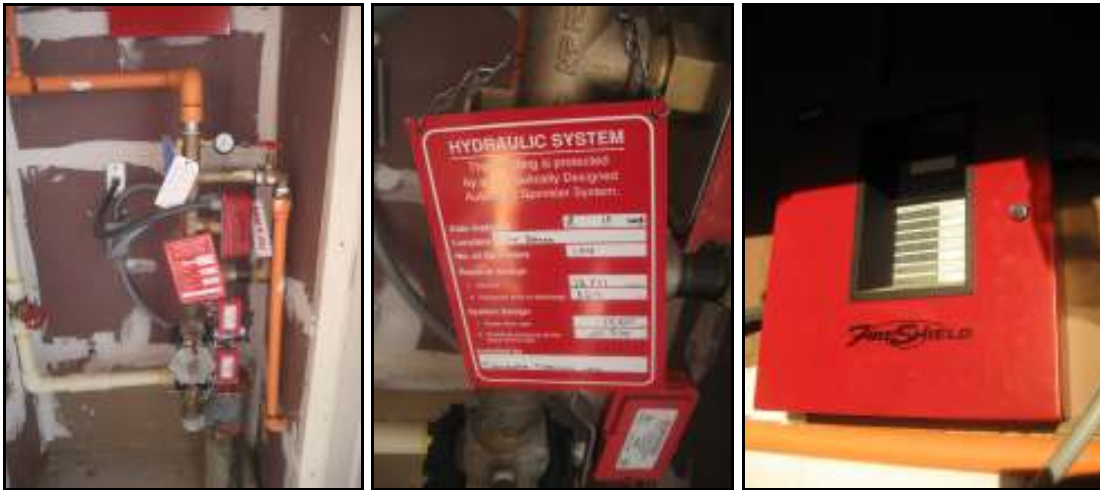
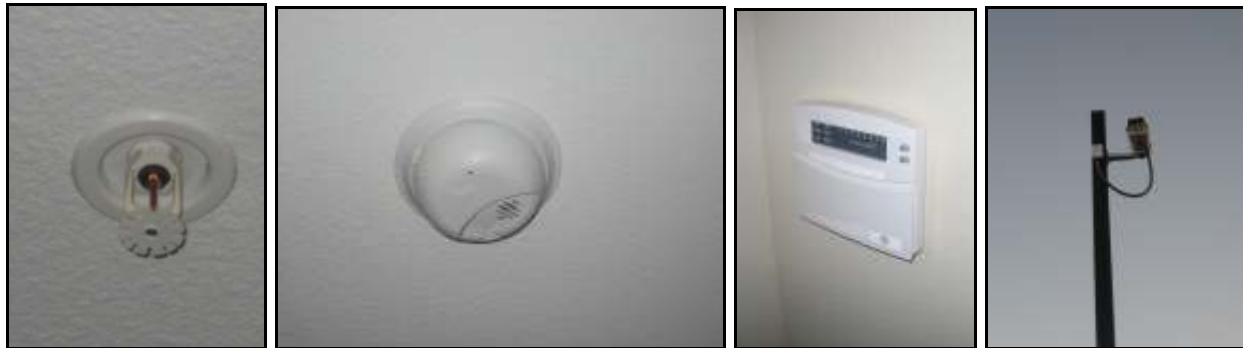
REA observed and property management reported these systems to be in good working order. In addition, property management routinely inspects, services, and maintains the smoke detectors and fire extinguishers.

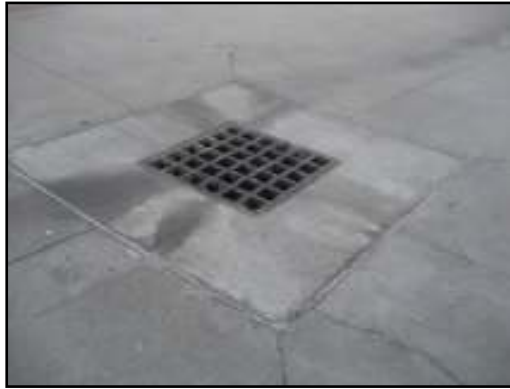
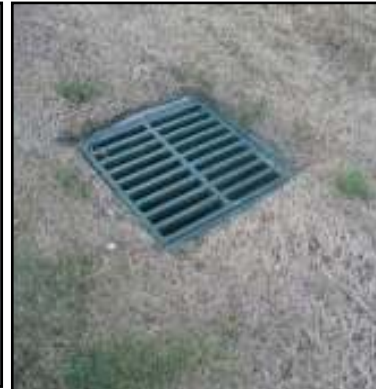
No deficiencies were noted regarding Property drainage. Property management personnel reported no flooding of apartments. REA does not anticipate significant capital expenditures during the term regarding Property drainage.

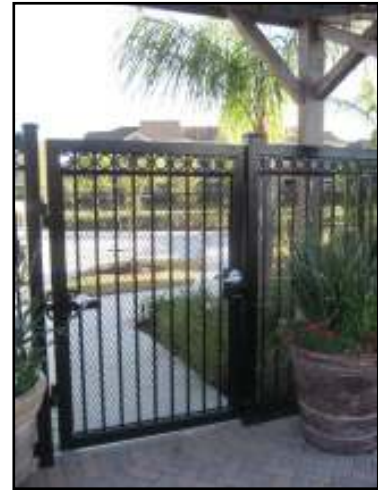
REA noted no significant deficiencies regarding fencing, and REA does not anticipate significant capital expenditures regarding fencing during the term.

The Property features metal grate fencing at the swimming pool and partial site perimeters. Metal access gates are provided at driveways and sidewalks entering the Property. Normal maintenance should be expected over the term.

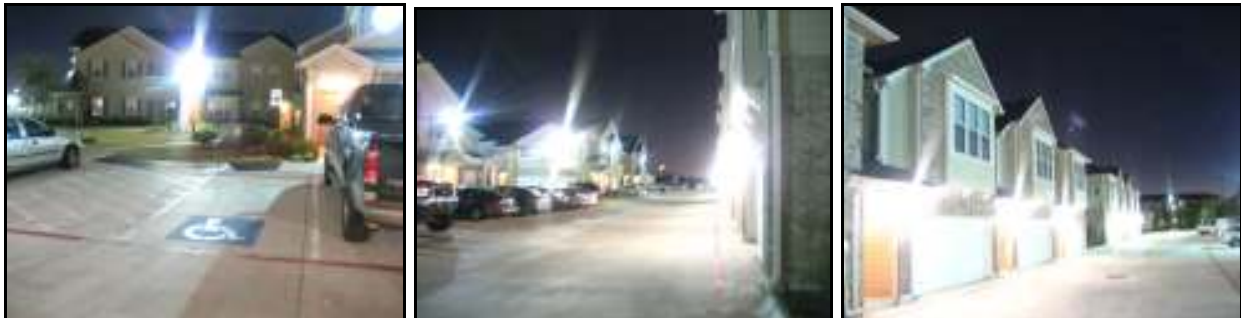
REA noted no deficiencies with respect to lighting at the Property. No significant capital expenditures are anticipated during the term regarding exterior lighting.

Exterior building- and pole-mounted lighting was observed throughout the complex and was noted to be in good condition. Site lighting is performed by pole-mounted high intensity lights located at the driveways and parking lots throughout the Property. All pole-mounted exterior lighting is operated by photo-cell sensors. Building-mounted high intensity lights are located at various areas throughout the Property. Building-mounted lighting is operated by photo-cell sensors or by timers. The lighting appeared to be adequate, although the lights were observed at night.

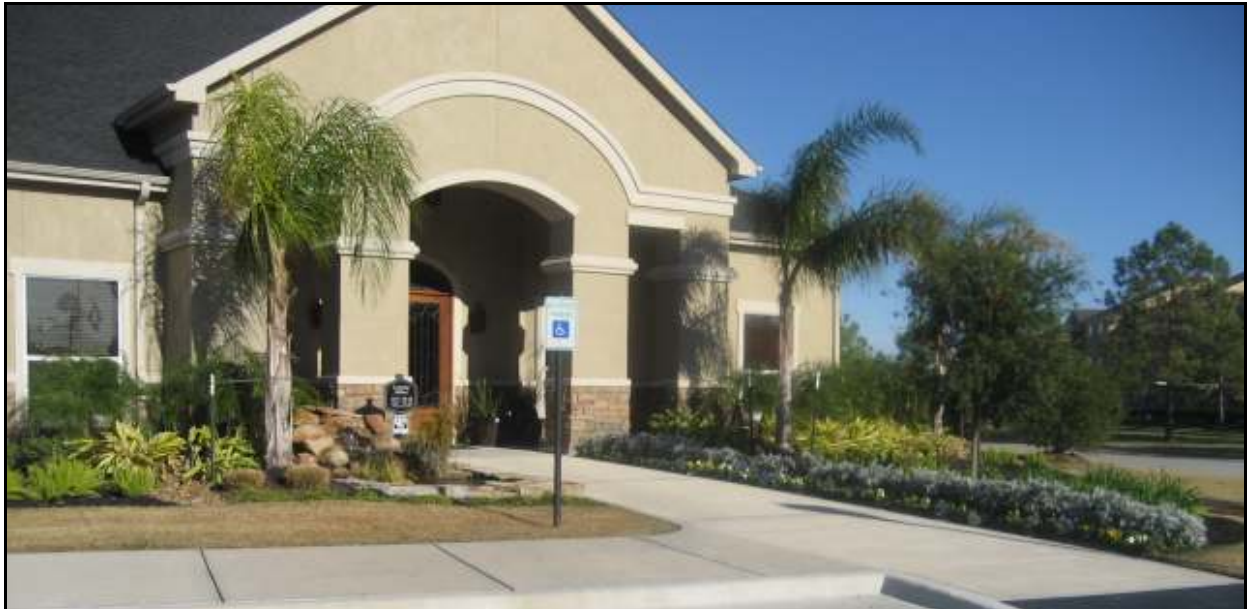
The Property is landscaped with grass, ornamental trees, flowers and shrubs at building elevations throughout the Property. REA noted the landscaping at the Property to be in generally good condition.

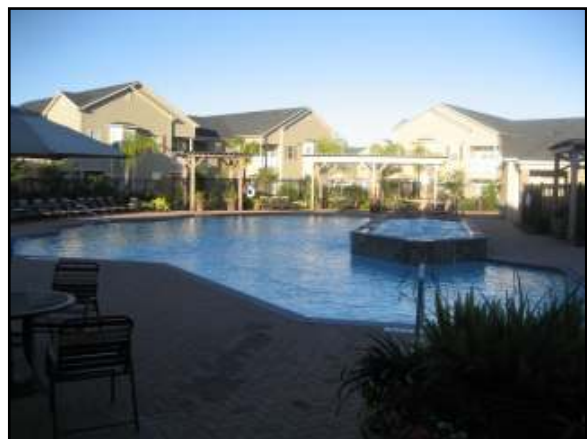
REA noted no significant deficiencies regarding recreational facilities. The Property features one in-ground swimming pool with a gunite type interior and a ceramic tile transition to a concrete coping. The pool has a concrete deck and is surrounded by a painted metal grate fence. Pool equipment (i.e., chlorination, pumping and filtration equipment) is located in a nearby pump room. The pool interior is accessible via steps with handrails. The pool and deck were observed to be in good condition.

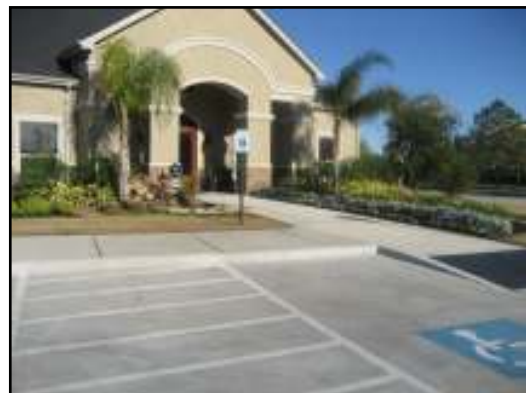
There are fewer than 25 parking spaces at the leasing office. Two spaces have been designated as handicapped accessible at the parking area adjacent to the leasing office and are generally compliant.

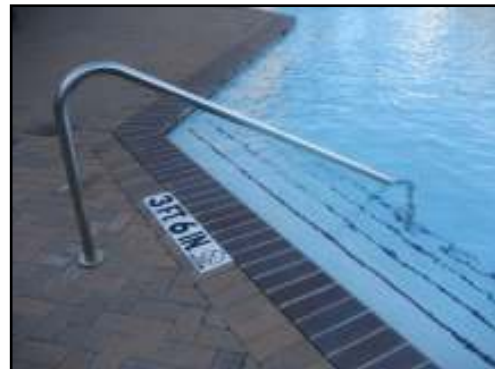
The pool is accessible from adjacent sidewalks. The pool interior is accessed from sets of steps which feature handrails for increased accessibility.

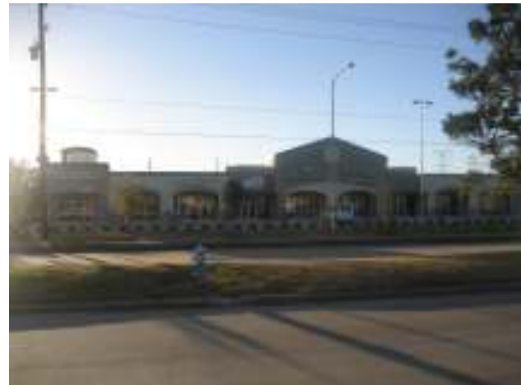
4. COMMERCIAL / RETAIL DEVELOPMENT AT THE WEST PORTION OF THE SITE

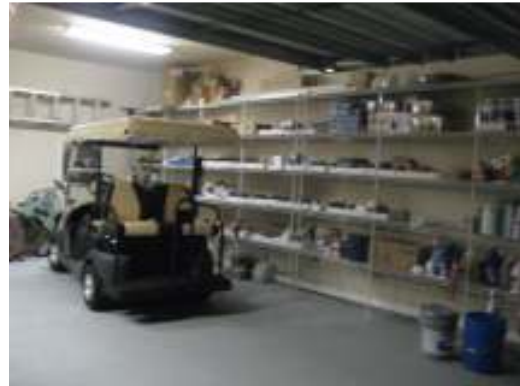
8. MAINTAINANCE SHOP

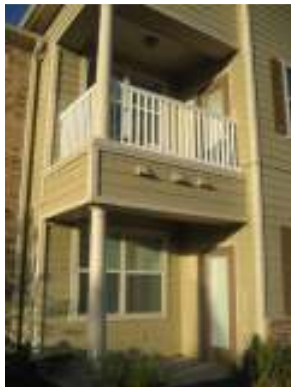
9. PVC RAILINGS AT UPPER LEVEL PATIOS

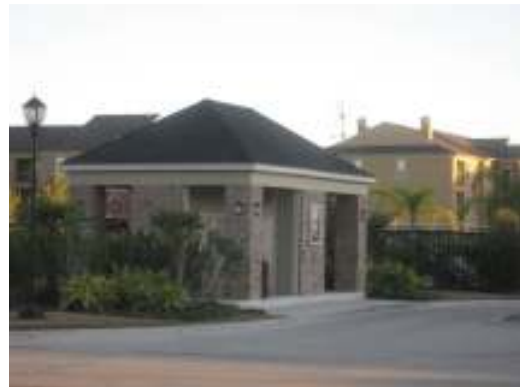
10. CENTRAL MAIL KIOSK

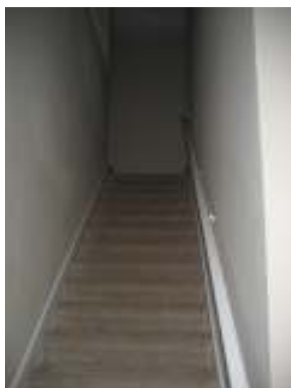
11. TYPICAL INTERIOR STAIRS

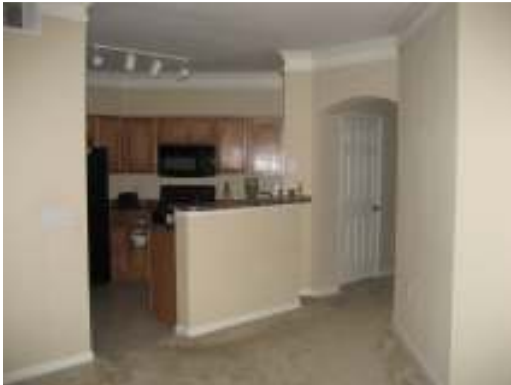
15. DINING AREA IN UNITS

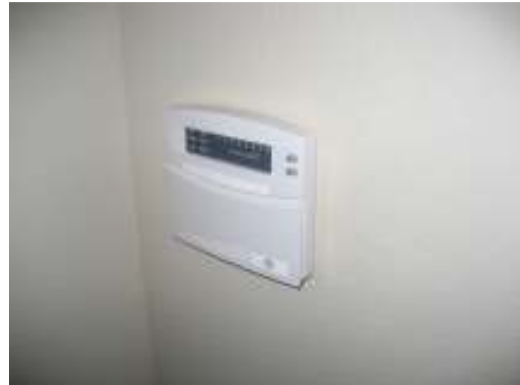
16. INDIVIDUAL SECURITY SYSTEM

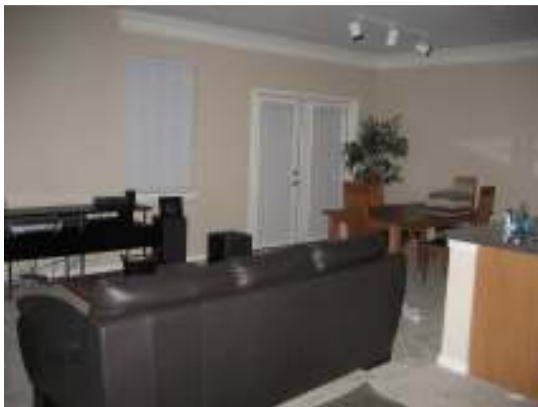
17. LIVING AREA FINISHES

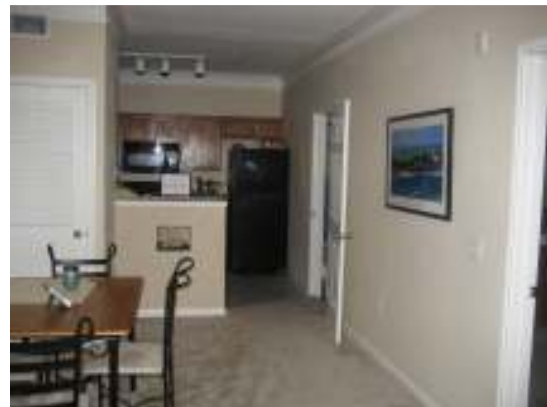
18. TYPICAL INTERIOR FINISHES

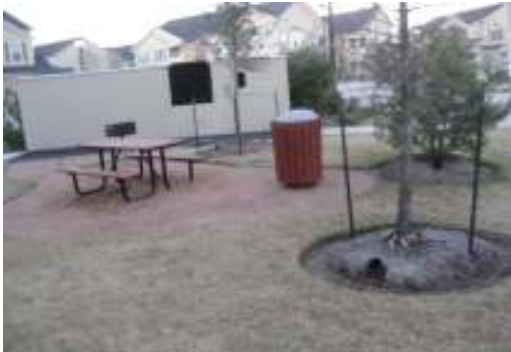
19. PICNIC AREAS (SIX THROUGHOUT THE PROPERTY)

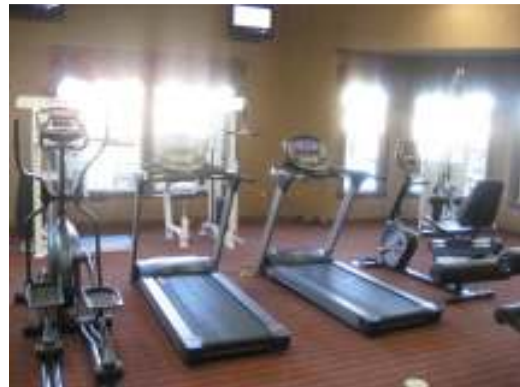
22. FITNESS CENTER AT THE LEASING OFFICE BUILDING

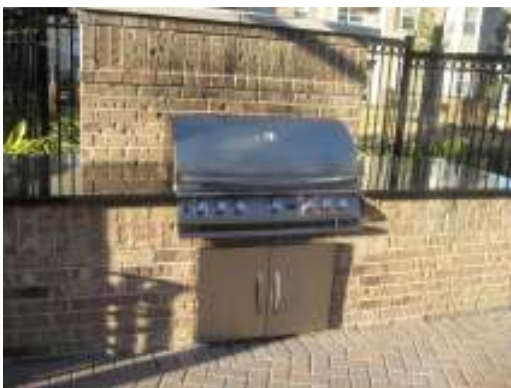
23. SWIMMING POOL AREA BBQ GRILL LOCATED ADJACENT TO THE LEASING OFFICE

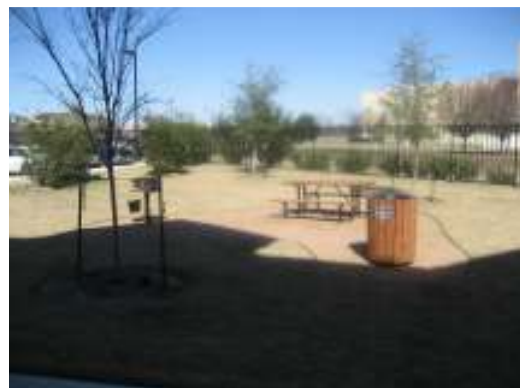
24. SIX- PICNIC AREA THROUGHOUT THE PROPERTY
