**Seabrook at Bear Brand  
56 Sea Terrace  
Dana Point, California 92629**

***PROPERTY CONDITION ASSESSMENT***

**REAL ESTATE ADVISORY, LLC  
PROJECT # 075663**

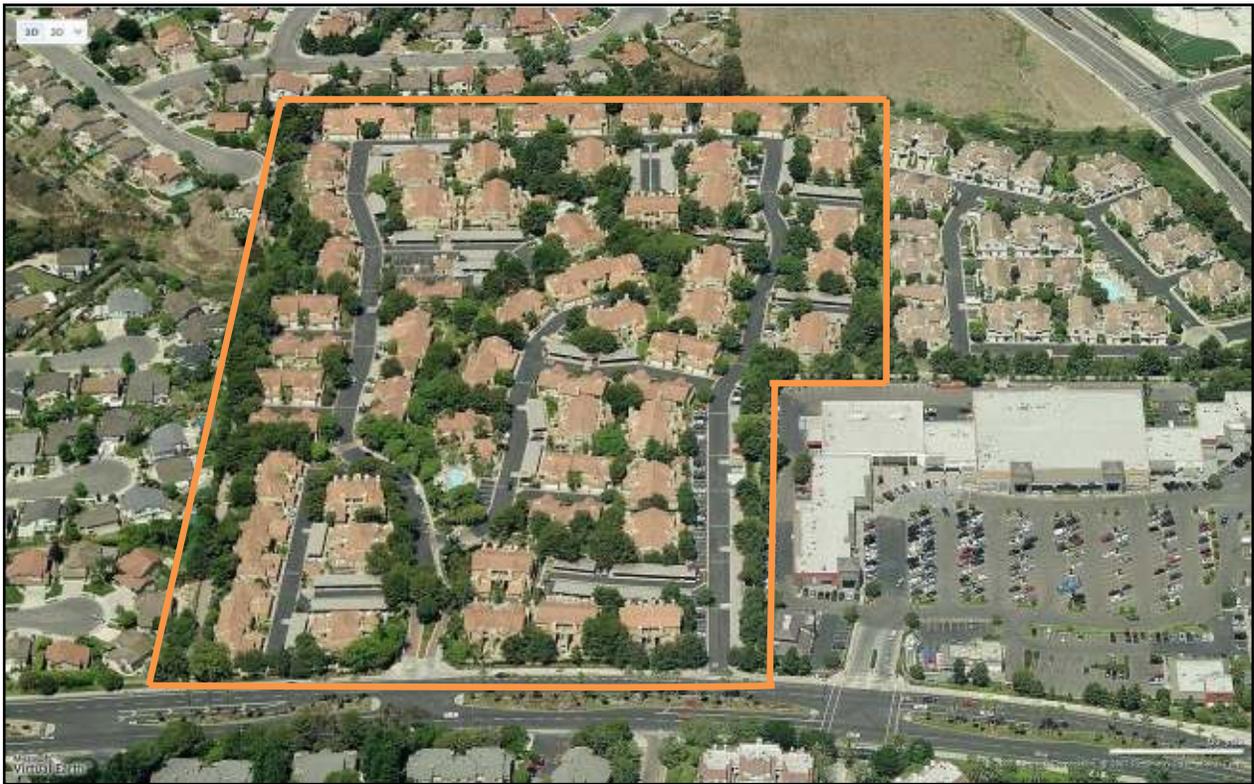
A most current undated west view aerial photograph of the Property, obtained from the internet, is shown below. The aerial depicts the property and the surrounding areas as they currently exist. A shopping center and residential apartments is depicted to the north.

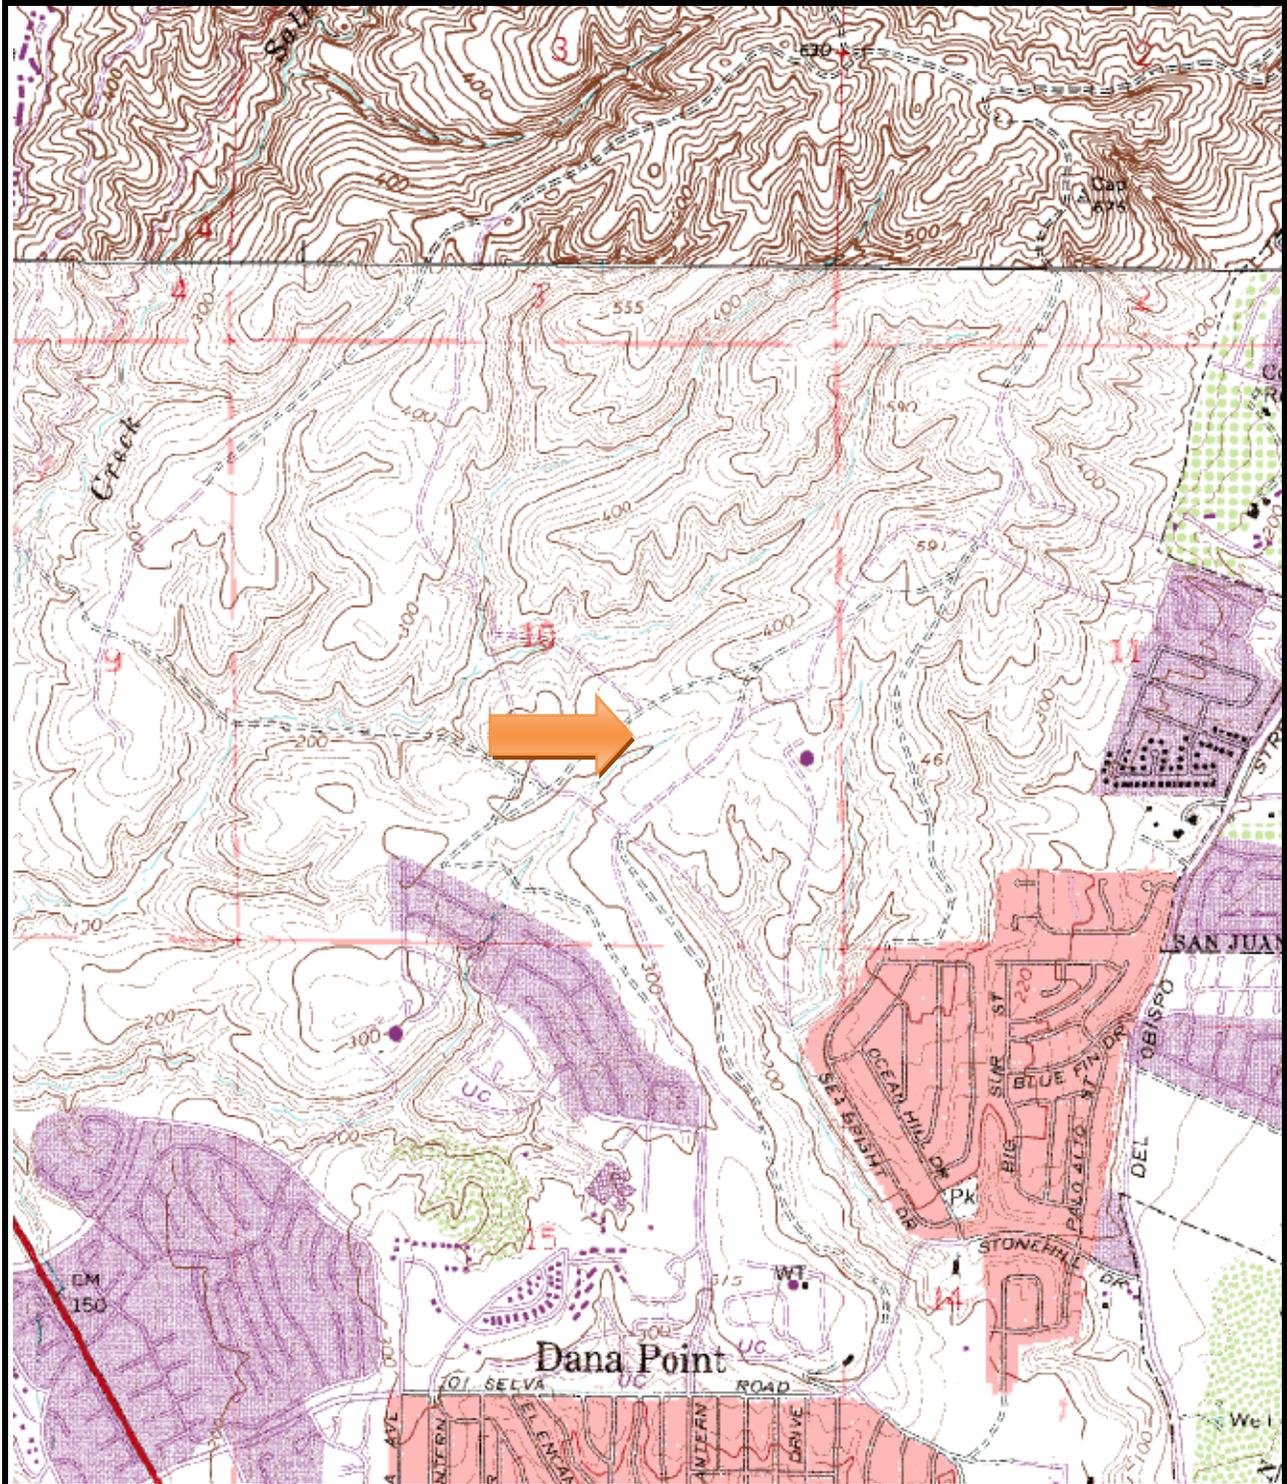
**FIGURE II – TOPOGRAPHIC MAP**

**Seabrook at Bear Brand  
56 Sea Terrace, Dana Point, California 92629  
Project Number 075663  
Dana Point, CA Quadrangle dated 1975**

The Property is located in an area of gently sloping topography at an elevation of approximately +300 to +400 feet National Geodetic Vertical Datum (“NGVD”). Topographic information was gathered upon review of United States Department of Interior, Geological Survey Map of Dana Point, California Quadrangle (1975). The Property exhibits a slight slope to the west. The surrounding areas exhibit an overall slope to the south and west towards Pacific Ocean.

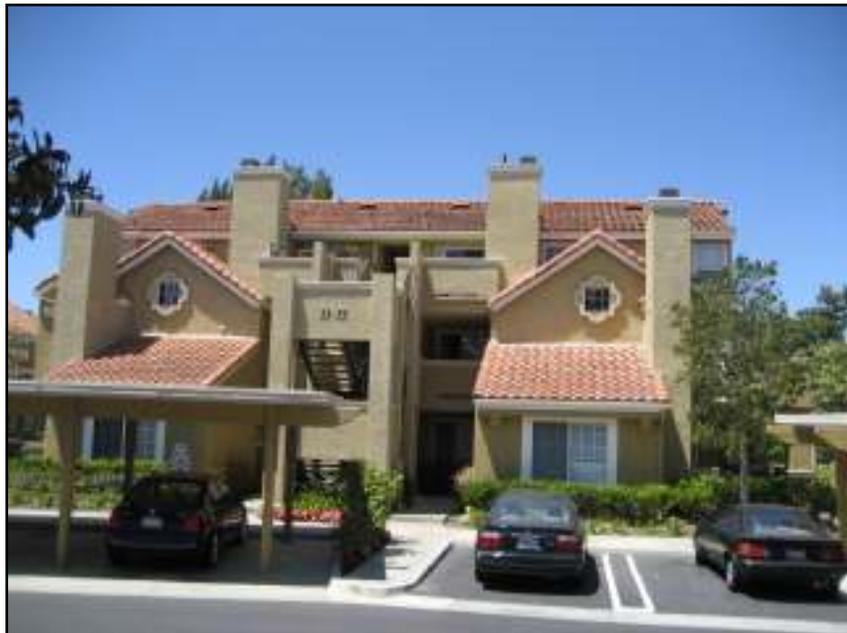
Foundation systems for the apartment building consist of reinforced concrete footings with reinforced concrete slabs. The footings are reportedly installed atop drilled

concrete piers. Property management reported no significant foundation concerns. In addition, REA did not observe evidence of significant foundation movement, such as significant perimeter foundation cracking or significant facade deflection or cracking. Based on the scope of work performed, REA is of the opinion that the building foundation appears to be properly designed for the soil conditions and the Property structure.

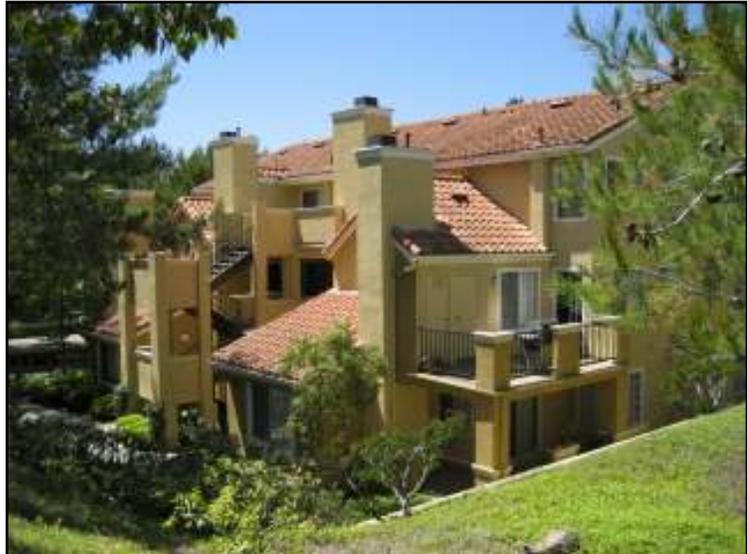
Framing above the foundation is wood and steel. Exterior walls typically consist of wood framing. Wall exteriors are finished with (EIFS – Exterior Insulation and Finish Systems). Interior partitions are wood framed. Roof framing consists of pre-fabricated wood trusses and plywood sheathing. Based on a visual inspection of the building, it does not appear that fire-retardant treated plywood was used for roof sheathing at the Property.

Ground-floor framing consists of poured concrete. Upper-level floor framing consists of wood framing overlain by plywood and a lightweight concrete layer. No significant deficiencies were noted.

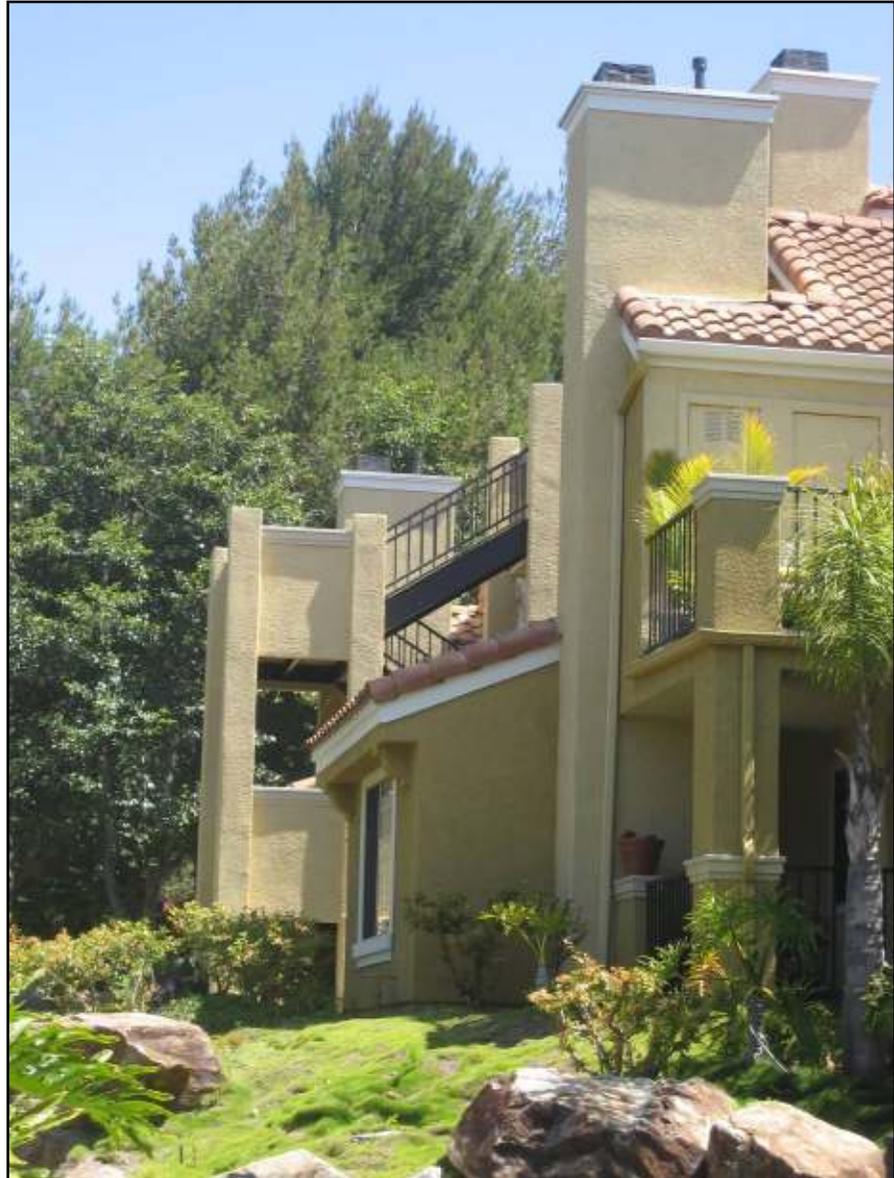
The breezeways for three-story buildings has stairways consist of steel framing with pre-cast, bolted-on concrete treads; stairway railings consist of painted metal (typical breezeway shown at right). The breezeways are lighted by ceiling-mounted, photocell-activated lights and battery-pack emergency lights. The breezeway and landing components were noted to be in good condition. The components are covered by building roofs so that they are not directly exposed to rain.

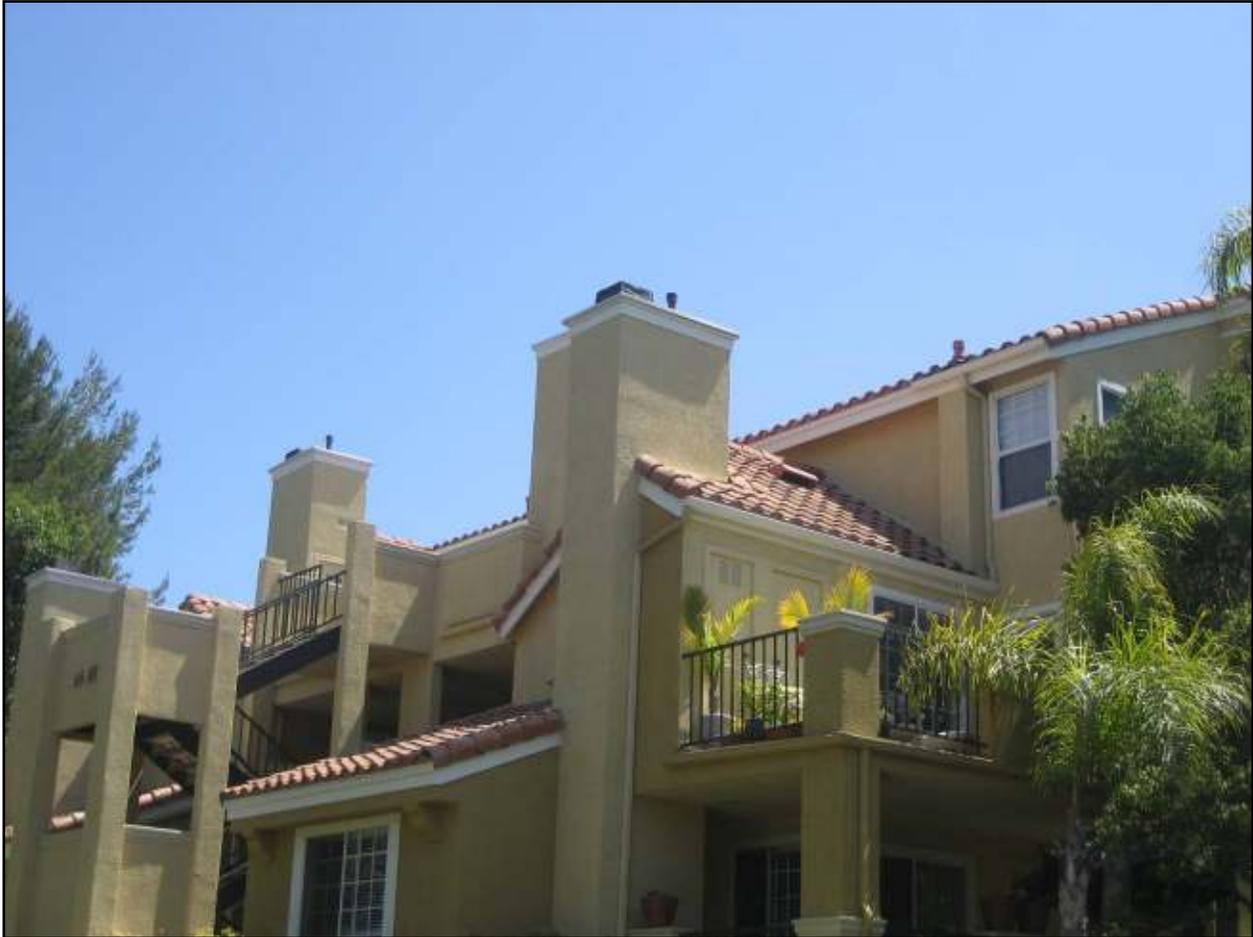
Each apartment has a patio or a balcony. At-grade patios consist of concrete slabs on grade. The Property features concrete patios and balconies. The concrete-decked balconies are built atop wooden framing. The patios and balconies feature metal railings and EIFS privacy

screens. Patios and balconies are accessed via swinging solid wood and glass doors. Both are lighted by incandescent fixtures.

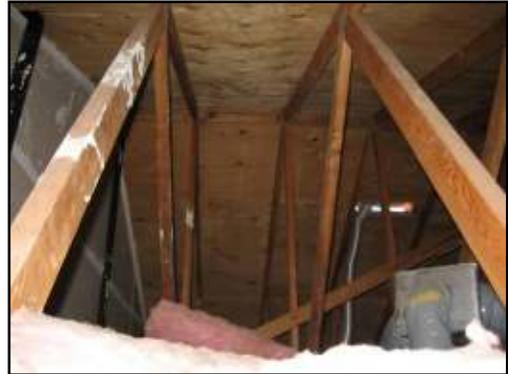
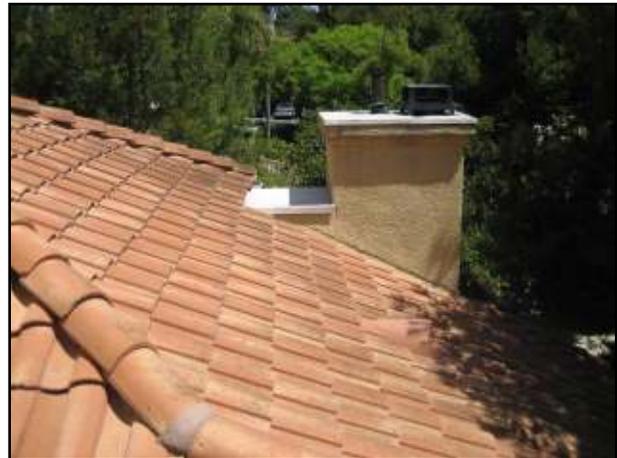
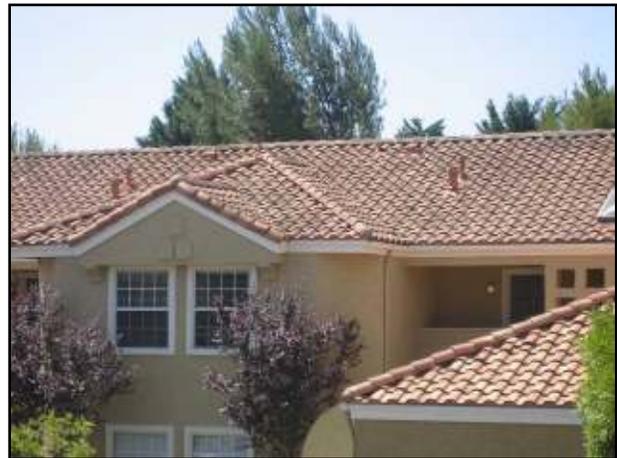
REA did not observe any area of significant damage or signs of past repairs. The building flat roof systems feature modified bitumen roofing. The building flat roof system is constructed atop wood framing and decking. The roof membrane is penetrated by ventilation ducts and plumbing vents. REA inspected these penetrations (as possible) and found them to be in good condition. The roof is designed to drain to gutters and downspouts. No replacement of the concrete tile roofing is anticipated based on its 40+ year estimated useful life. In addition, based on the observed good condition and the mild climate, no significant replacement of the modified bitumen roofing is anticipated.

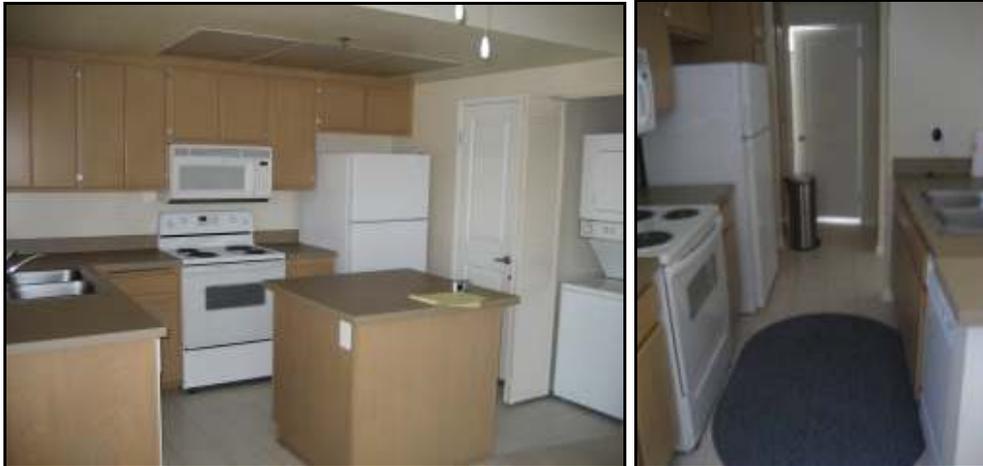
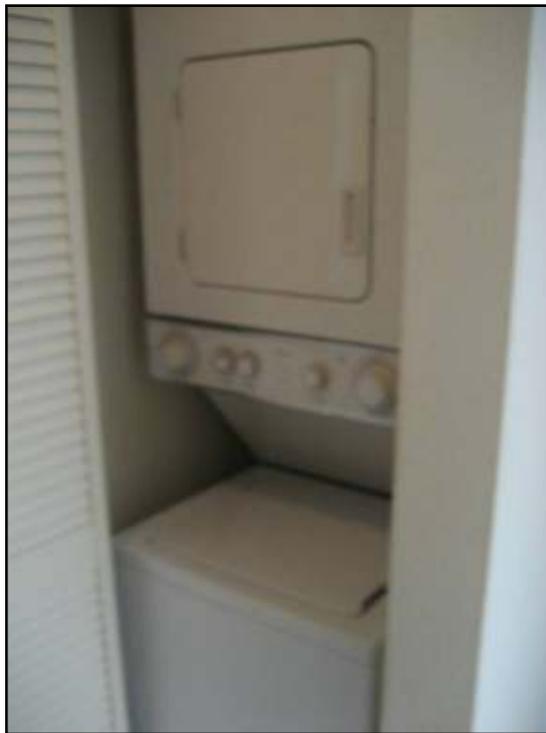
Each apartment has connections for a clothes washer and dryer. There are 68 full size, 334 stackable washer and dryer hookups. In addition, the property also features 269 stackable washer and dryers currently available in units.

Interior finishes were noted to be in good condition (typical apartment kitchen and stackable washer and dryer shown at below).

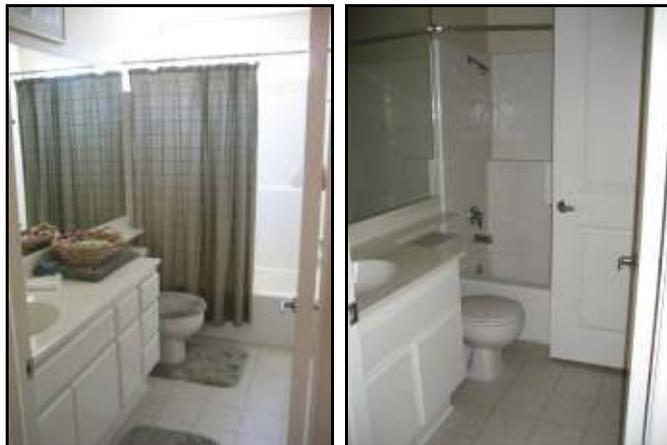
<b>Fixtures:</b>	Fiberglass Tubs or Showerstalls Vitreous China Toilets Laminated Sinks/Countertops
<b>Cabinetry:</b>	Laminated Wood
<b>Counter Tops:</b>	Laminated Sinks/Countertops
<b>Ceilings:</b>	Painted Drywall (Light Texture)
<b>Walls:</b>	Painted Drywall
<b>Wet Walls:</b>	Fiberglass (Some with Shower Doors)
<b>Flooring:</b>	Vinyl

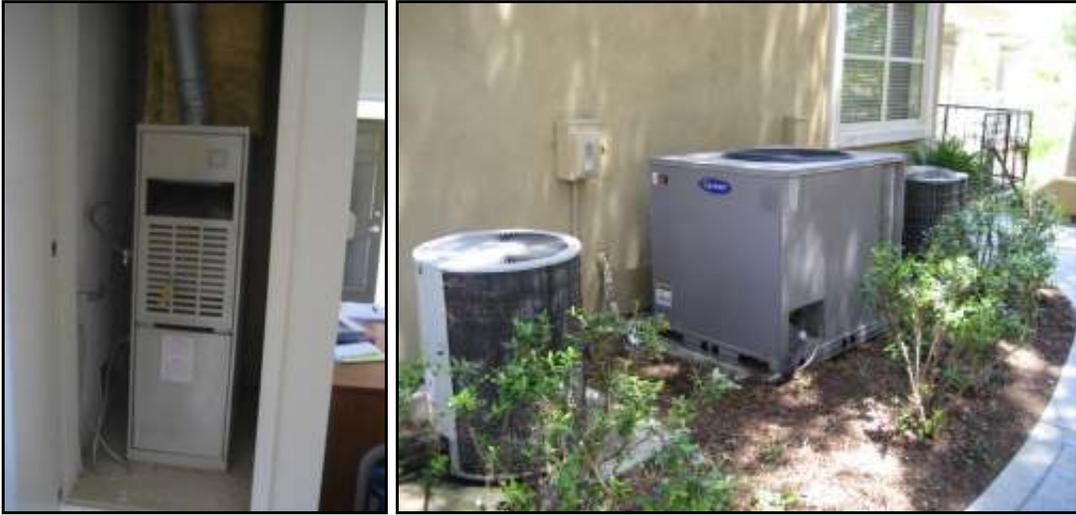
Heating is provided to each individual apartment by a Carrier, gas heating system. Heating units are located inside a separate closet usually located by the bedrooms. The heating capacities are rated at approximately 2.0 tons. No AC condensers at the units. One 5-ton and two 2-ton pad-mounted AC condensers are located at the Leasing Office Building.

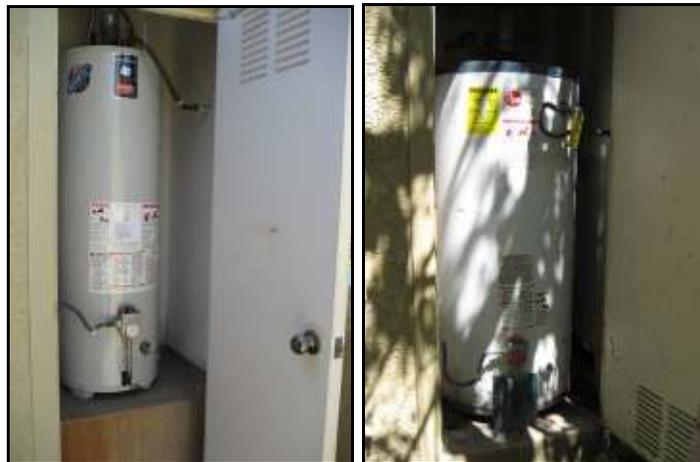
Each apartment is served by a 40-gallon gas fired water heater. The laundry room and swimming pool restrooms are served by 75-gallon gas fired water heaters.

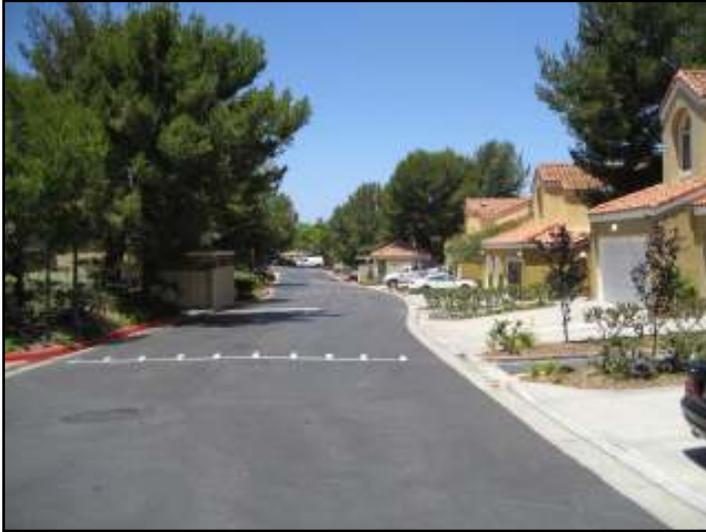
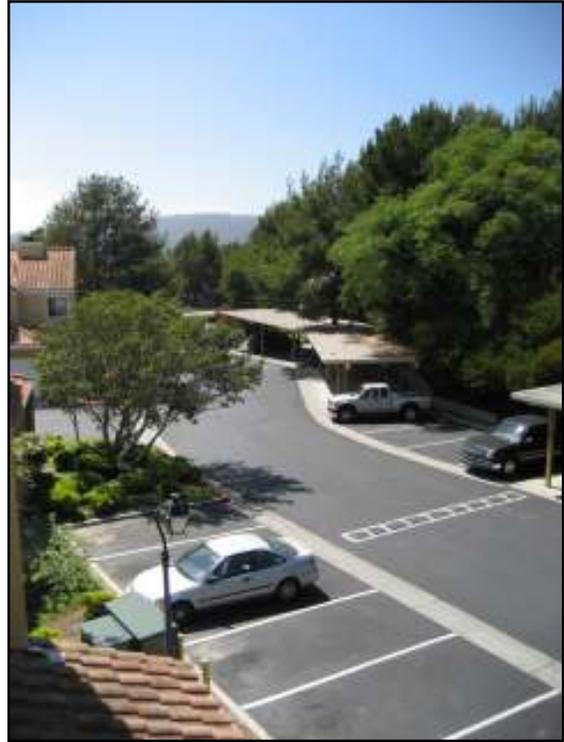
REA noted no deficiencies regarding driveways, parking lots or sidewalks (typical asphalt paving and curbing shown at right). During the term considered, REA anticipates periodic sealing and striping of the asphalt. No other significant capital expenditures are anticipated during the term. Costs for sealing and striping are accounted for in the Replacement Reserve Worksheet.

The parking lots and driveways of the Property consist of asphalt installed over a stabilized base. REA observed the asphalt surfaces and painted striping associated with parking stalls and other markings to be in good condition.

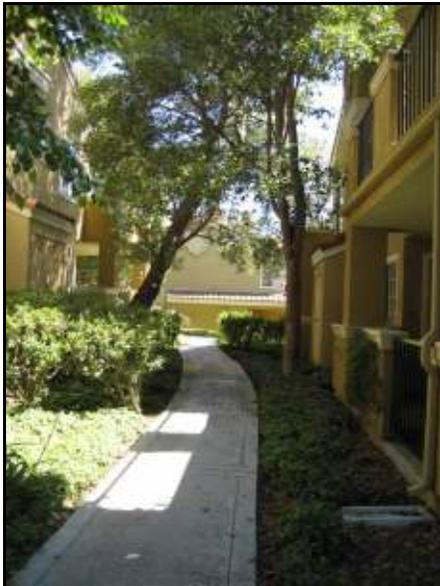
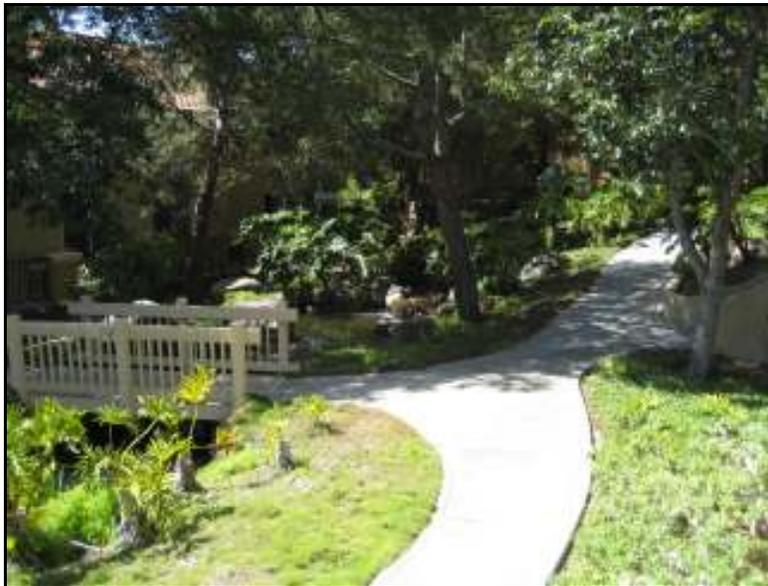
Sidewalks and curbs, which consist of poured-in-place concrete, are located throughout the Property and were noted to be in very good condition.

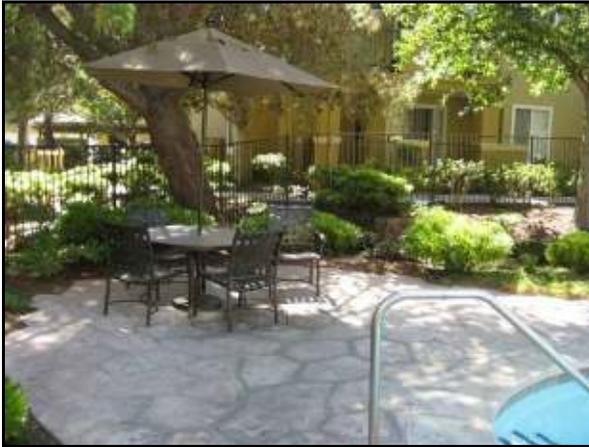
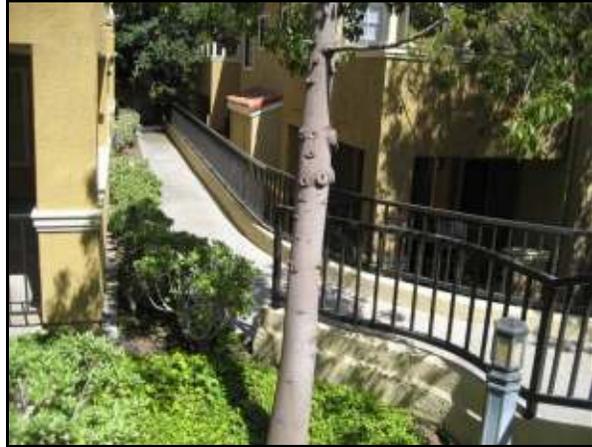
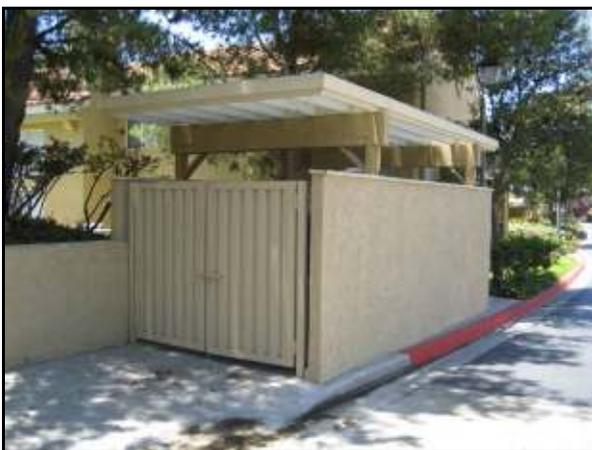
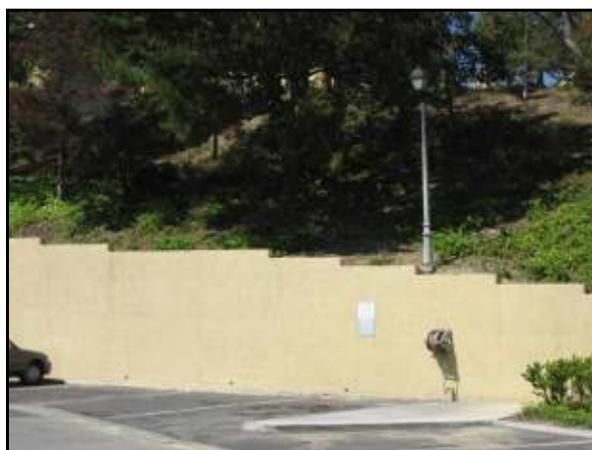
- Approximately 5-foot tall painted metal grate fencing with metal posts surrounds the swimming pool.
- Approximately 4-foot tall painted metal grate fencing on metal posts is located atop most retaining walls to prevent falls.
- A 5-foot tall concrete with stucco finish fence around the solid waste areas.
- A 5-20 foot tall concrete with stucco finish fence around Property boundary.

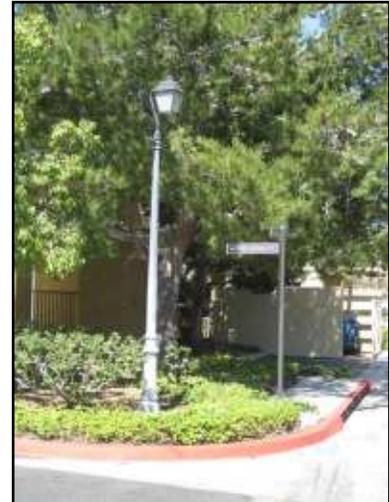
Exterior pole-mounted high intensity lighting was observed throughout the complex and was noted to be in good condition. Light fixtures are located atop the metal posts that surround the swimming pool. Ceiling-mounted incandescent or fluorescent lights are located in the building breezeways. Exterior lighting is operated by photo-cell sensors. The lighting appeared to be adequate, although the lights were not observed at night.

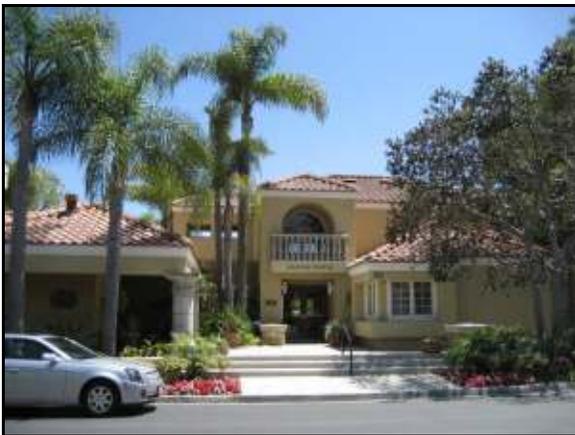
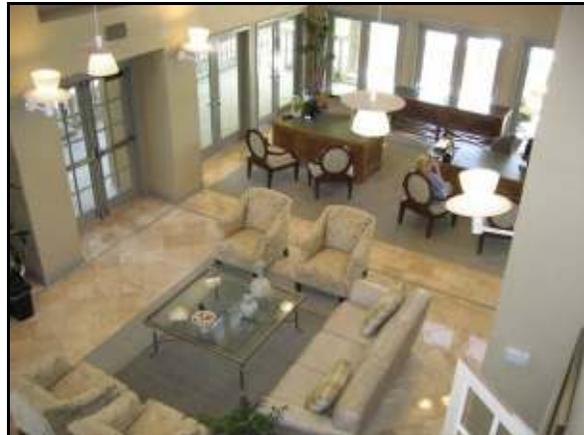
- One two-story leasing office/clubhouse building that houses the management offices, fitness center, business center and public restrooms. The building is constructed of wood framing over a concrete slab-on-grade foundation and is finished on the exterior with EFIS system. The building has a wood framed, sloped, concrete tile roof. The building interior is finished mostly with ceramic tile and carpeted floors and painted gypsum board walls and ceilings. Clubhouse also has a full size kitchen with laminated counter tops and kitchen appliances.

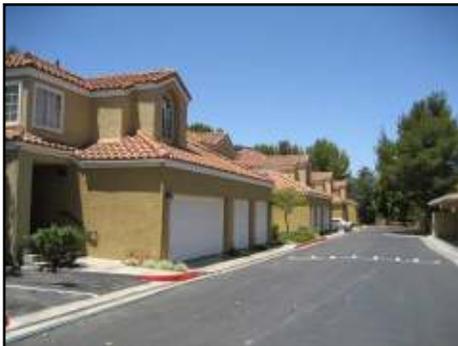
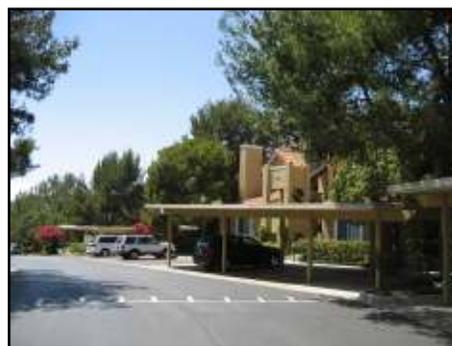
- 124 attach garage spaces. All are located on the bottom floors of apartment buildings and are attached to specific apartments. Garage interiors are finished with painted gypsum board walls and ceilings. The garages are accessed by aluminum sectional overhead doors with electric garage door openers. In addition, there are 288 carports with 190 marked open spaces located throughout the property.

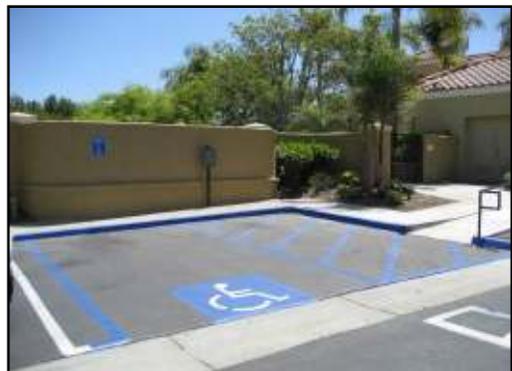
In addition to standard accessible parking, at least one in every eight standard accessible spaces is required to be van accessible. Van accessible spaces are also 96 inches wide, but require wider aisles (96 inches) and higher vertical clearances (98 inches versus 80 inches) than standard accessible spaces. All accessible parking spaces are to be designated as reserved by appropriate signage.

Less than 25 parking spaces are provided at the leasing office/clubhouse. One space is properly designated with pole-mounted signs and pavement markings. In addition, designated handicapped parking spaces were noted throughout the Property.

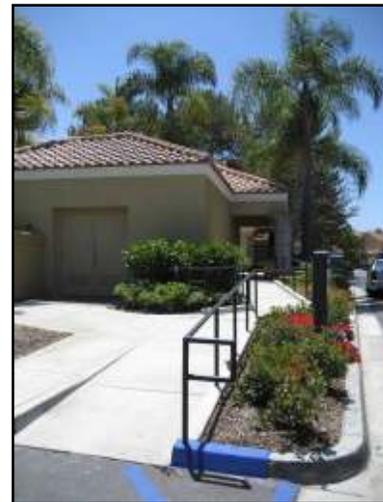
Accessible exterior routes were noted leading to the leasing office/clubhouse, swimming pool, mail facility and apartment building breezeways.

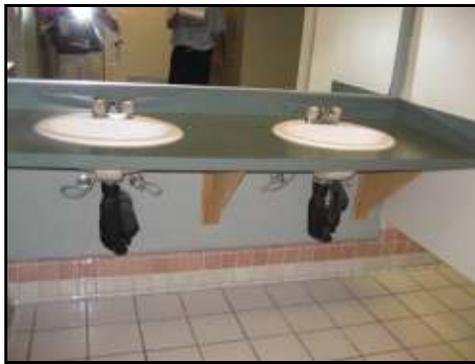
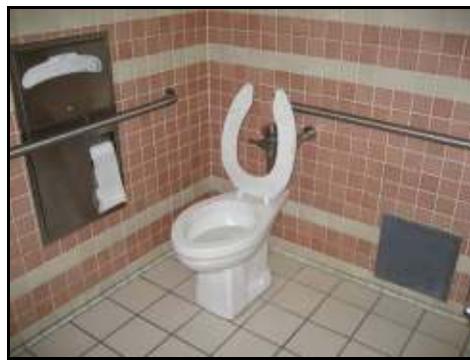
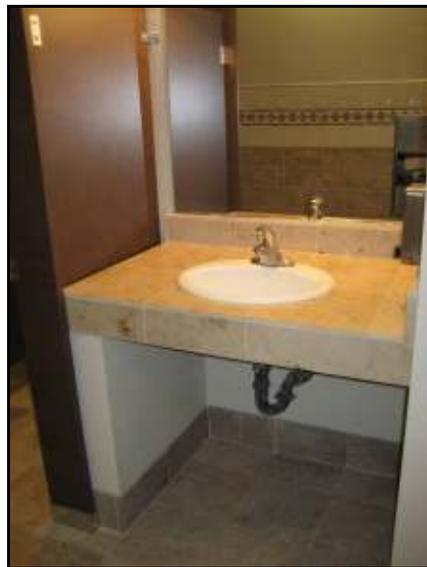
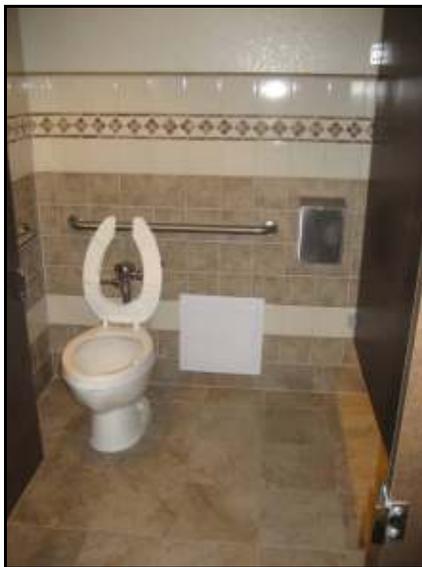
Accessible restrooms are located at the leasing office/clubhouse and at the poolhouse. Washrooms in ground floor units appear to meet FHAA guidelines.

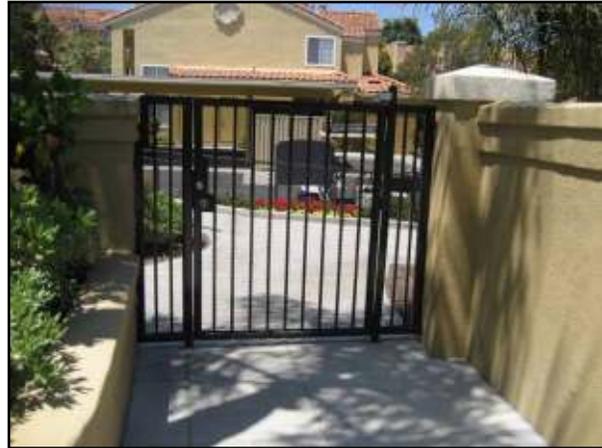
The swimming pool area is accessible from a parking lot near the leasing office/clubhouse. The pool has two sets of steps with rails and one wall-mounted ladder to allow access to the pool interior.

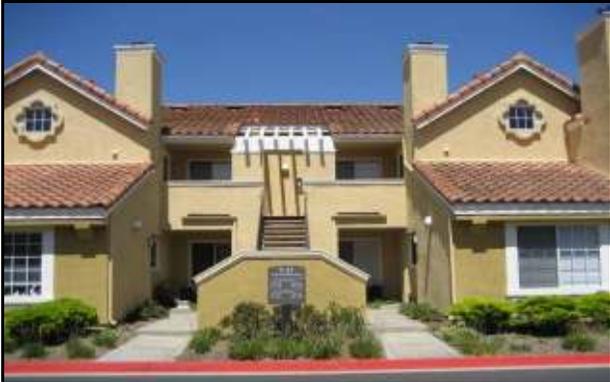
1. View of typical front elevation apartment building.

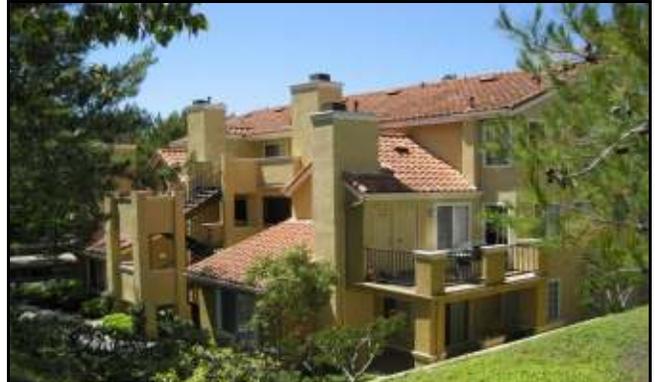
2. View of typical rear elevation apartment building.

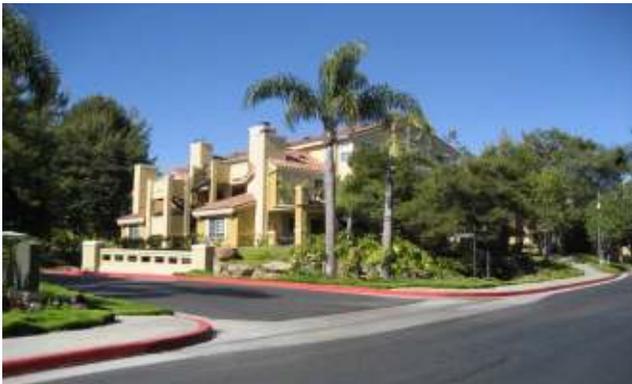
3. View of typical front/side elevation apartment building.

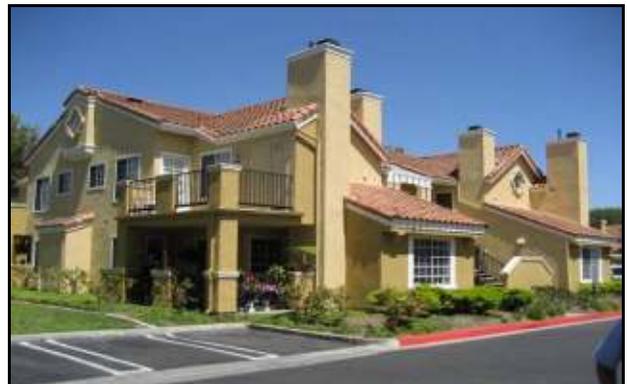
4. View of typical front/side elevation apartment building.

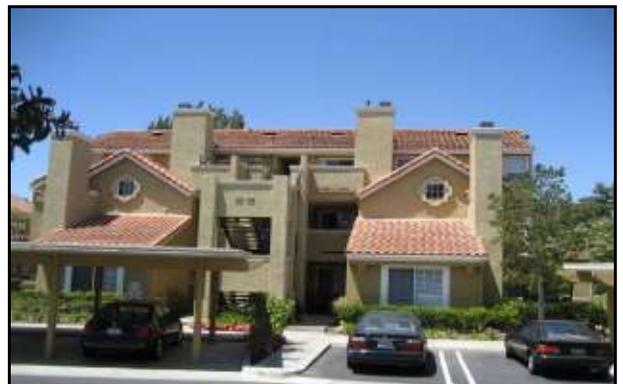
6. View of typical front/side elevation apartment building.

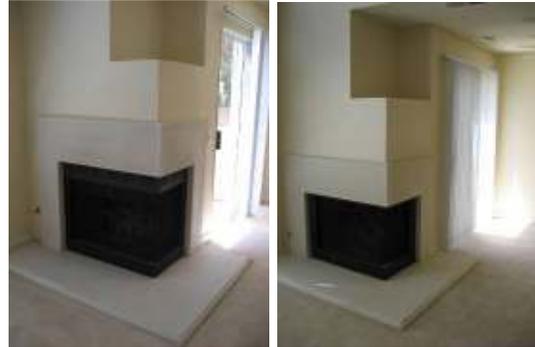
20. View of typical fireplace.

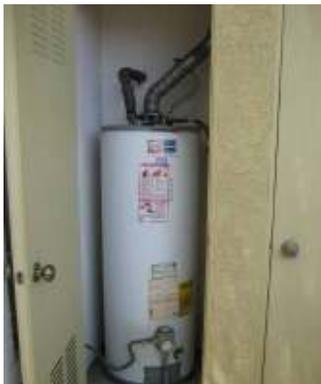
23. View of typical water heater in the water heater closet.

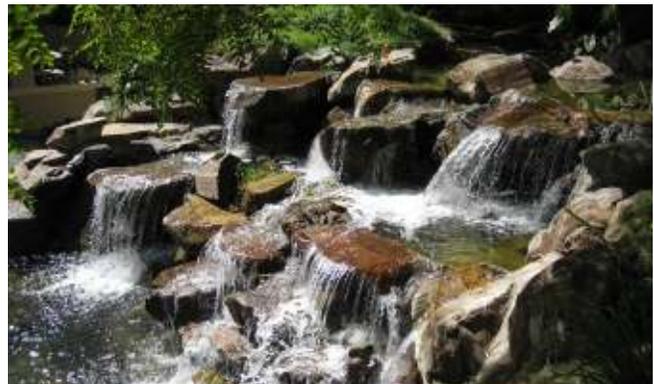
24. View of typical Water Works.
