**Talon Hill Apartments
1640 Peregrine Vista Heights
Colorado Springs, Colorado 80921**

PROPERTY CONDITION ASSESSMENT

**REAL ESTATE ADVISORY, LLC
PROJECT # 075562**

April 26, 2007

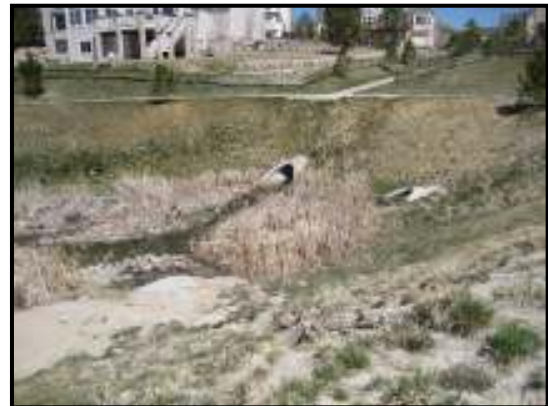
The Property has a detention pond located northwest of the Property. It was dry at the time of the on-site assessment and is designed not to hold water for extended periods of time. The detention ponds receive surface water runoff from the Property and possibly from the westerly abutting undeveloped land.

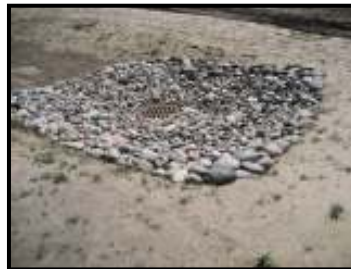
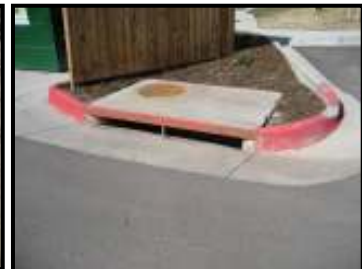
Surface water on the Property drains overland mostly to curb inlets and drop inlets located throughout the paved areas or to drop inlets located in the lawn areas. Some water drains overland by concrete flumes directly to one of the two on-site ponds, and some surface water percolates into the on-site soils.

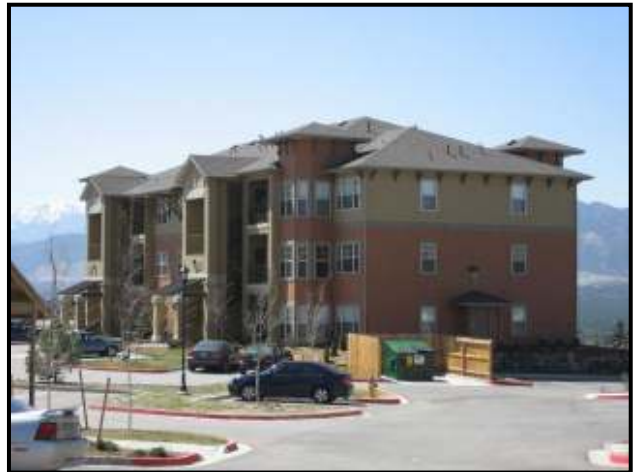
On all buildings, framing above the foundations is trusses on center with gypcrete wood decking. Exterior walls typically consist of stucco with faux stone accents and limited Hard-plank siding over 2x4 wood studs at various spacing (typical exterior shown at top picture).

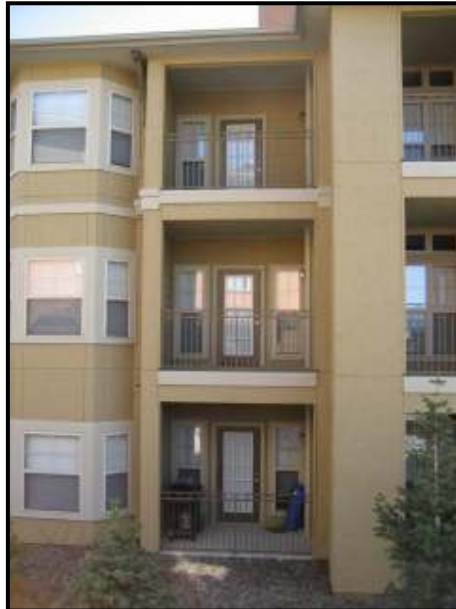
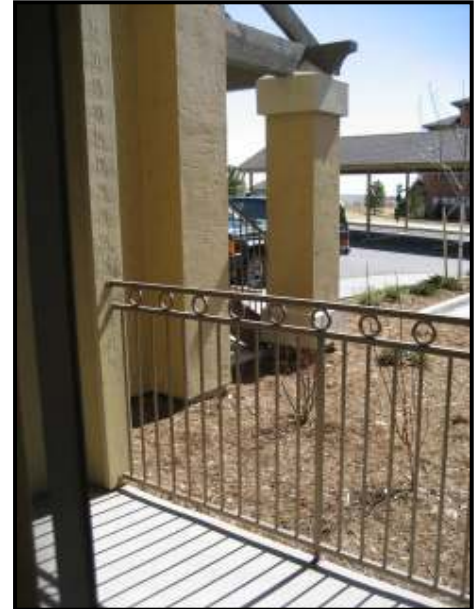
Each apartment has a patio or a balcony. At-grade patios consist of concrete slabs on grade. Balcony construction consists of wood framing and lightweight concrete at upper levels. Patio and balcony walls are mostly finished with cementitious siding. Patios and balcony railings consist of metal railings. Painted gypsum soffits are present beneath roof overhangs, upper level entrance patios, and balconies. The patios and balconies are accessed from the apartments by swinging metal and double-pane glass doors set in wood frames. The soffits were observed to be in good condition. REA anticipates normal painting of exterior components over the term. Costs have been included in the Reserve Table.

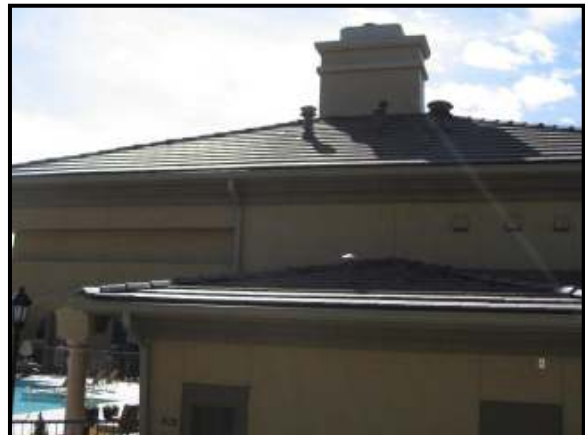
The buildings have wood framed, sloped roofs. Roofing consists of high definition composition roof shingles supported by wood trusses and 15/32" sub-roof plywood decking and asphalt shingles. The roof shingles are rated for 30 years. The clubhouse building features a concrete tile roof. The attic spaces are ventilated by continuous ridge vents, intermittently spaced off-ridge vents, perforated vinyl soffits and louvered gable vents. Attic ventilation appeared to be good. Aluminum gutter and downspout systems are present at horizontal roof lines. The gutters direct stormwater to downspouts, which in turn mostly discharge to splash blocks at grade or to asphalt paving. Property personnel reported no current or persistent roof leakage problems. No evidence of fire retardant roof sheathing was observed or reported at the Property.

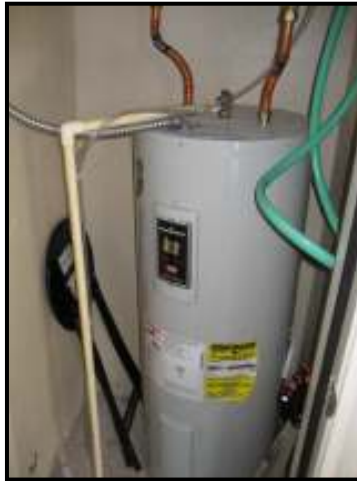
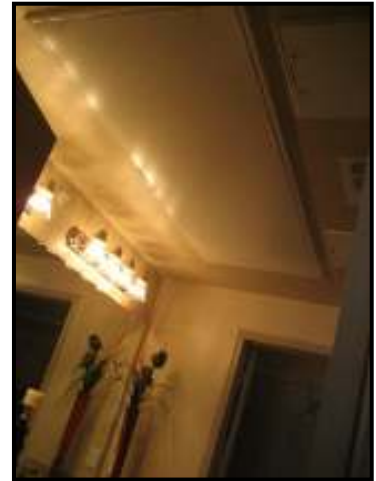
Heating and cooling is provided to each individual apartment by a thermostatically controlled, electric heat pump system (typical aquatherm heating system in the ceiling at bathrooms and water heater shown at right). Condensing units are located on pads outside the buildings. The cooling capacities are rated at approximately 1.5 to 2.5 tons.

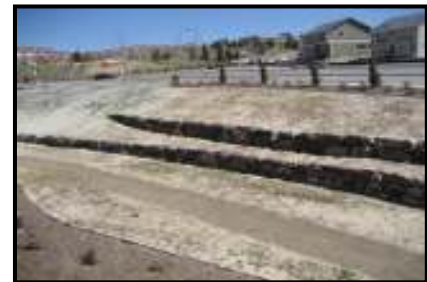
Retaining walls at the Property are limited to the leasing office/clubhouse area and Buildings 1, 3, 5 and 6. Most of the natural stone retaining walls have painted metal fences atop them to serve as fall barriers. The walls were observed to be in good condition.

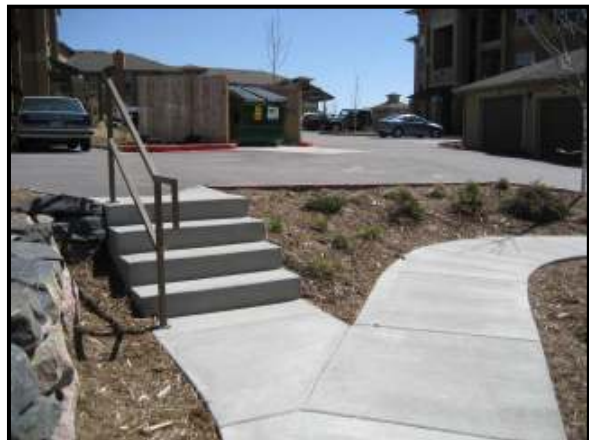
REA noted no deficiencies regarding driveways, parking lots or sidewalks (typical asphalt paving and curbing shown at right). During the term considered, REA anticipates periodic sealing and striping of the asphalt. No other significant capital expenditures are anticipated during the term. Costs for sealing and striping are accounted for in the Replacement Reserve Worksheet.

The parking lots and driveways of the Property consist of asphalt installed over a stabilized base. REA observed the asphalt surfaces and painted striping associated with parking stalls and other markings to be in good condition.

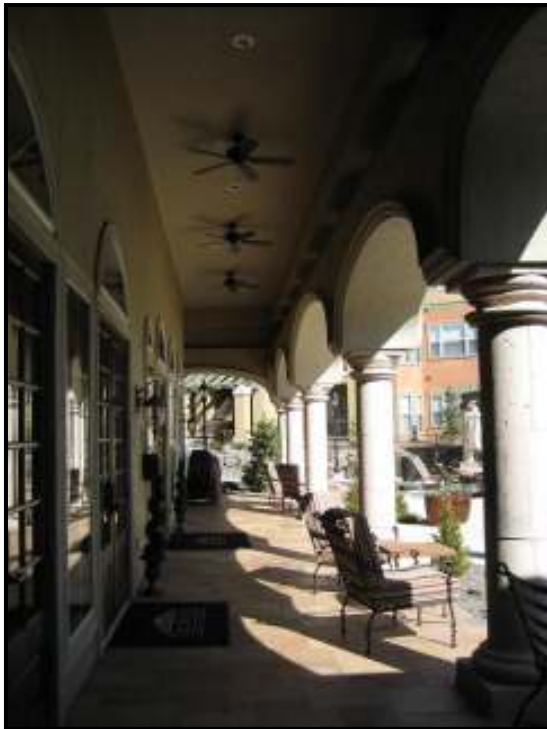
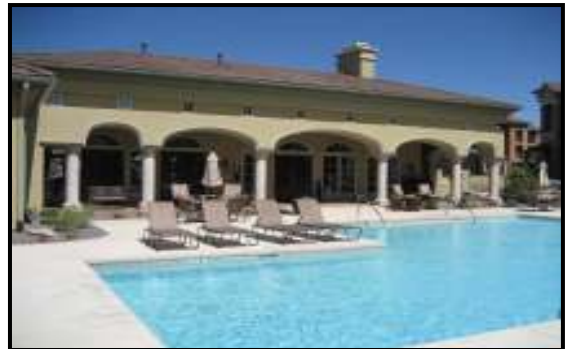
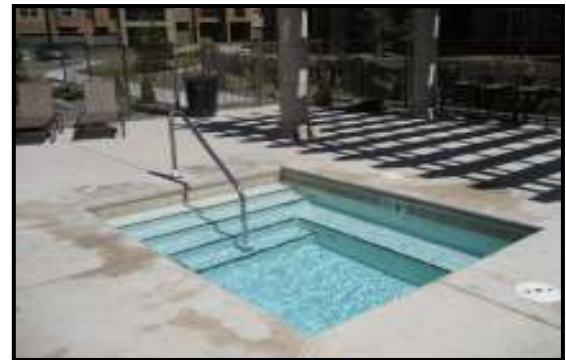
- One in-ground resort-style swimming pool and spa, with a gunite type interior and a ceramic tile transition to brick/terra cotta coping. The pool has a concrete deck and is surrounded by approximately 5-foot tall painted metal grate fencing. Pool equipment (i.e., chlorination, pumping and filtration equipment) is located in a Clubhouse building closet near the pool. The pool interior is accessible via two sets of steps with rails and one wall-mounted ladder. The pool and spa is maintained by in-house staff.

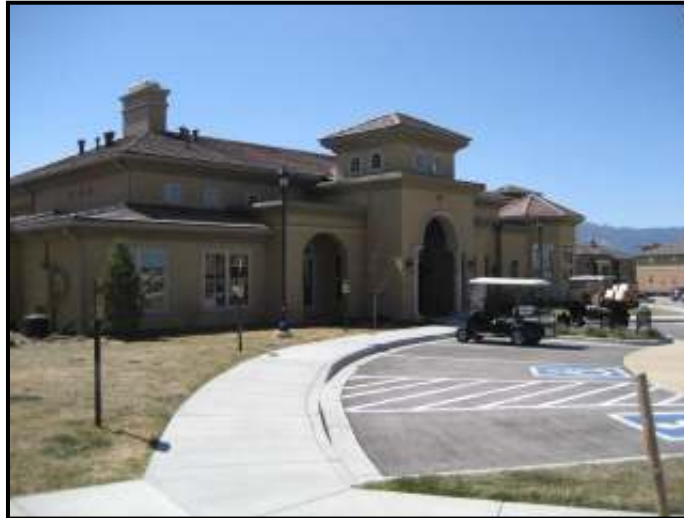
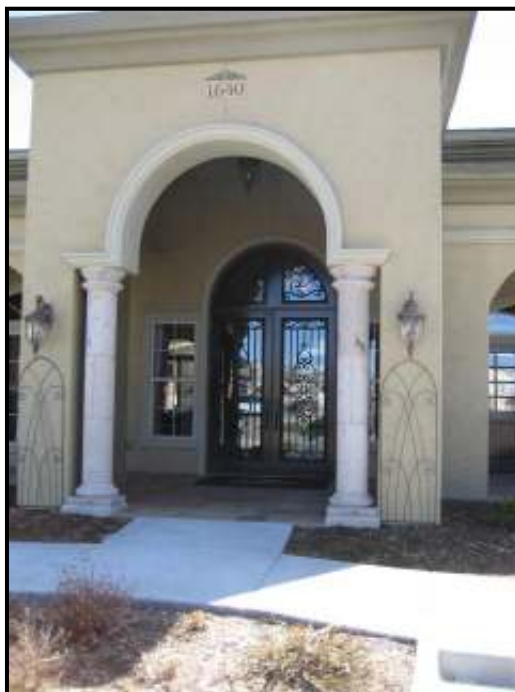
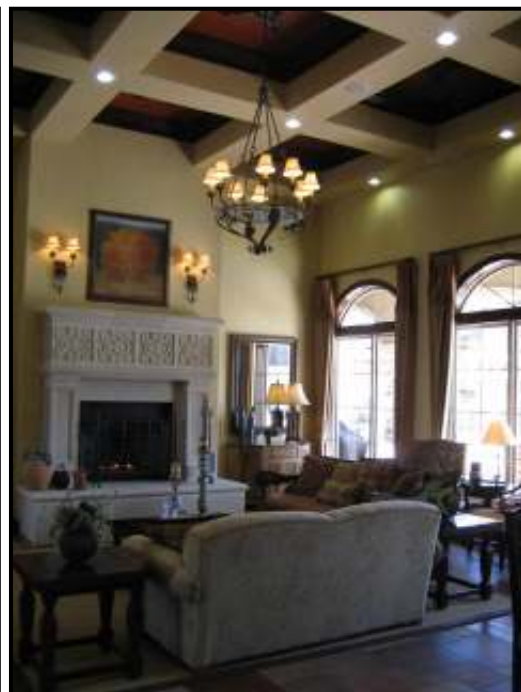
Site amenities were observed to be in very good condition; no deficiencies were noted. During the term considered, REA anticipates the replacement of common area laundry equipment. Costs have been accounted for in the Replacement Reserve Worksheet.

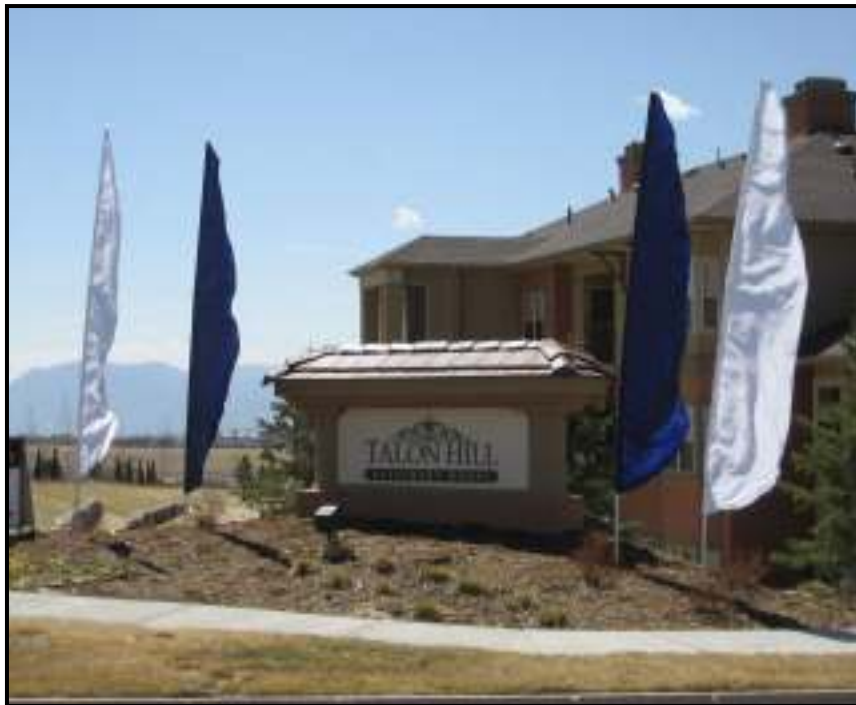
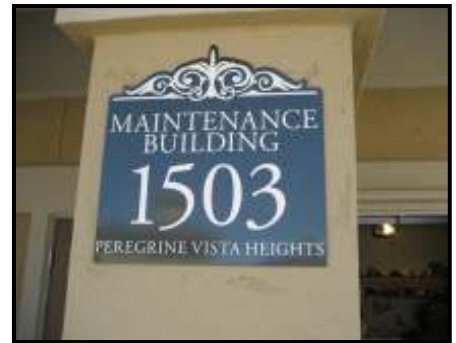
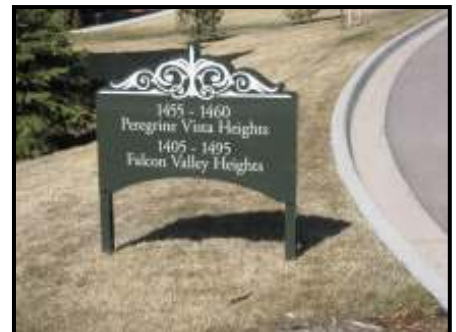
No significant deficiencies were noted regarding Property signage. REA does not anticipate significant capital expenditures during the term regarding signage.

The Property is marked with an engraved composite pedestal sign mounted on a cultured stone base and set in a landscaped bed at the entrance from Ramtron Drive. Composite plaques with the building number and range of apartments served are located at the breezeways. Plastic plaques are located at each entry door.

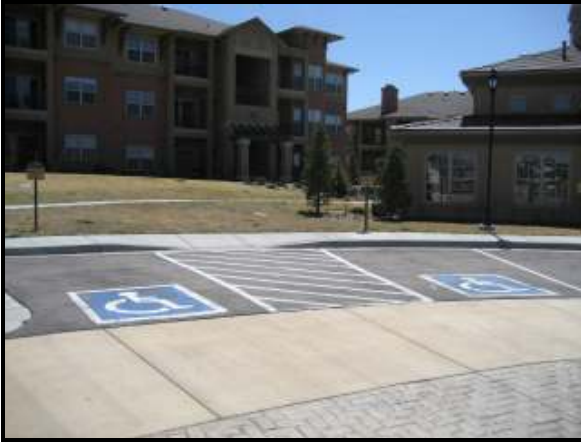
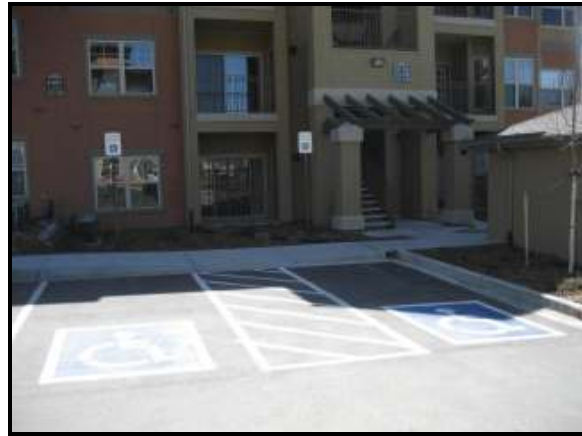
Less than 25 parking spaces are provided at the leasing office/clubhouse. Two spaces are properly designated with pole-mounted signs and pavement markings. In addition, designated handicapped parking spaces were noted throughout the Property.

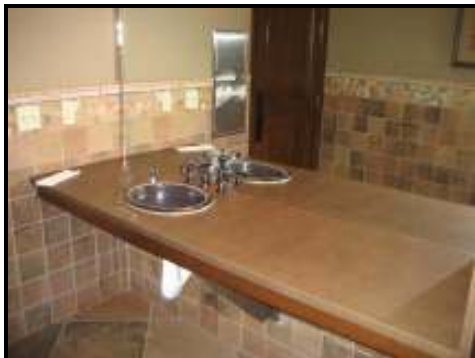
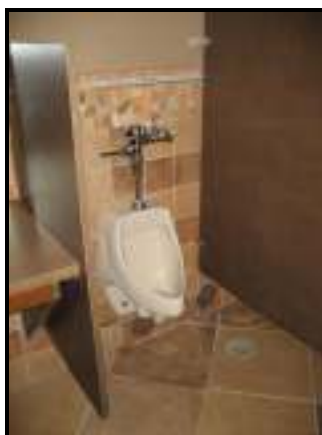
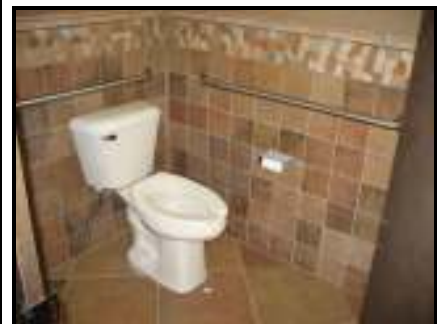
Accessible restrooms are located at the leasing office/clubhouse and at the poolhouse. Washrooms in ground floor units appear to meet FHAA guidelines.

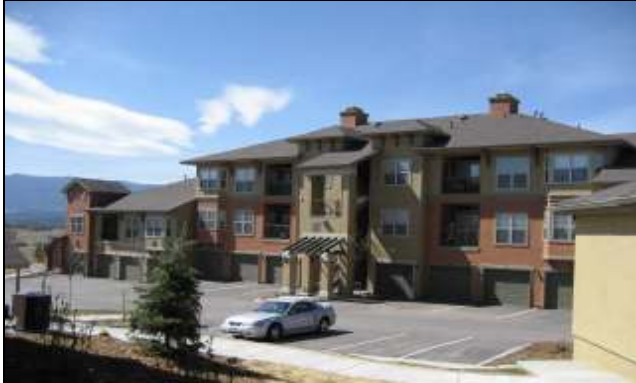
1. View of typical front elevation apartment building.

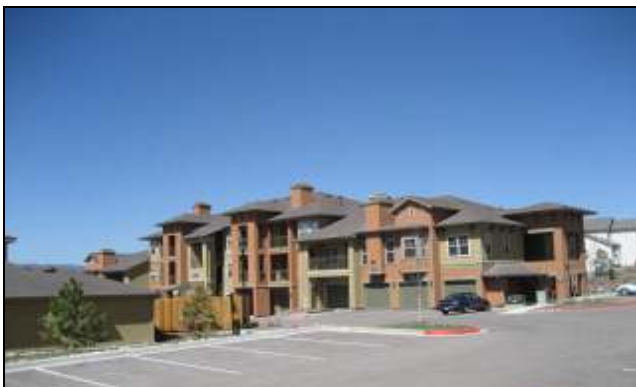
5. View of Property.

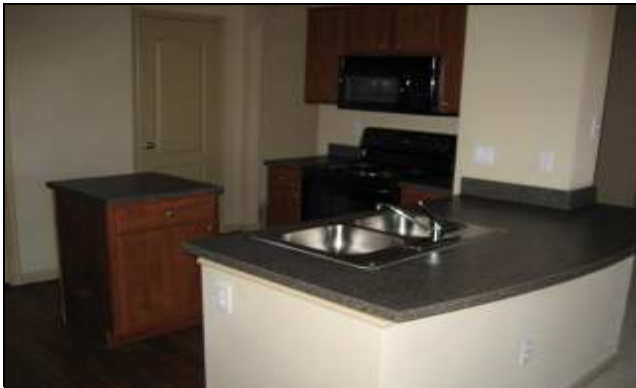
7. View of typical kitchen area.

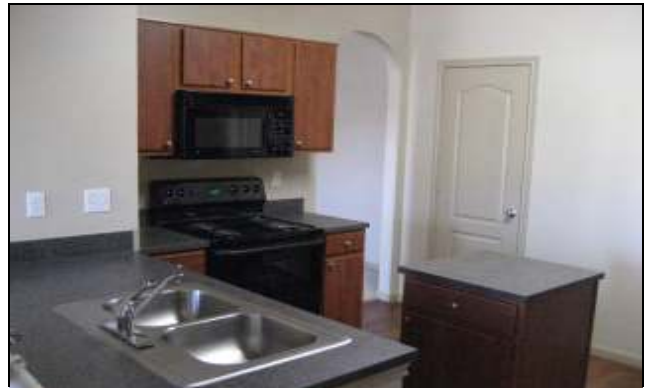
8. View of typical kitchen area.

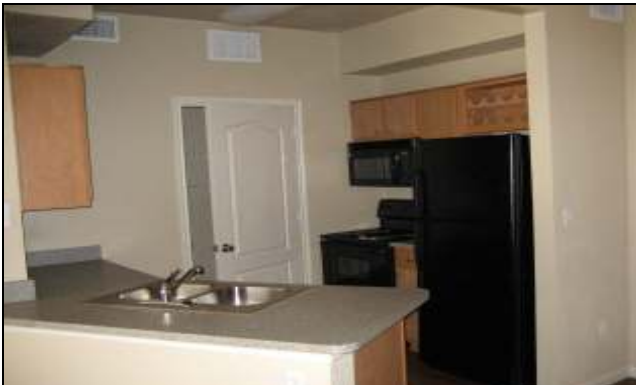
9. View of typical kitchen area.

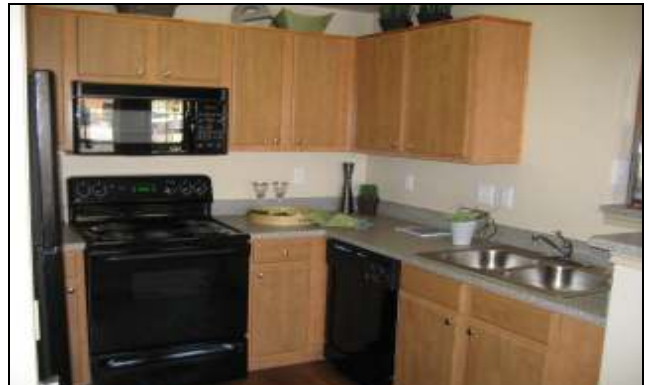
10. View of typical kitchen area.

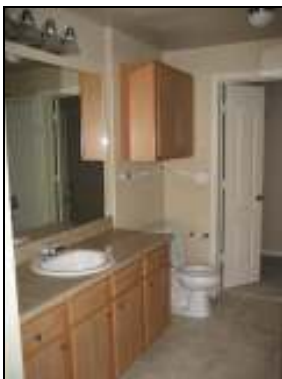
11. View of typical bathroom area.

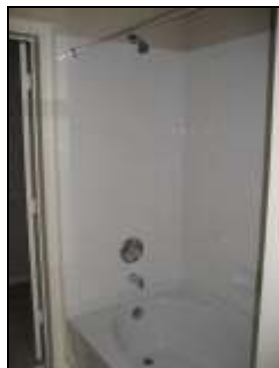
12. View of typical bathroom area.

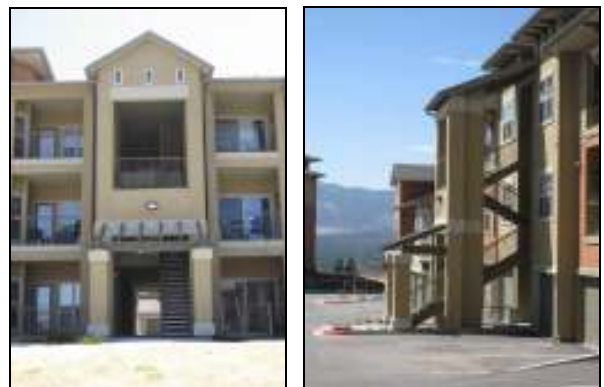
24. View of typical breezeways.
